28 October 2024

**Conservation Examination and Assessment of Public Art
Burnaby Mountain, Kamui Mintara Sculpture Park
Burnaby Art Gallery**

***Project Report 2024 for Kamui Mintara, “Playground of the Gods” Burnaby Mountain,
Kushiro Park.***

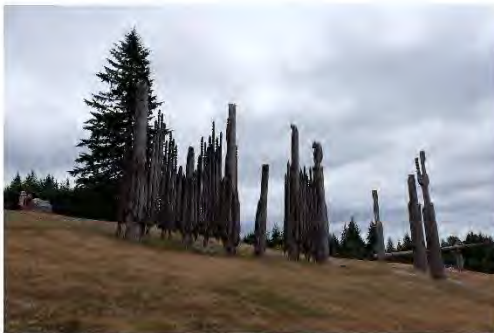
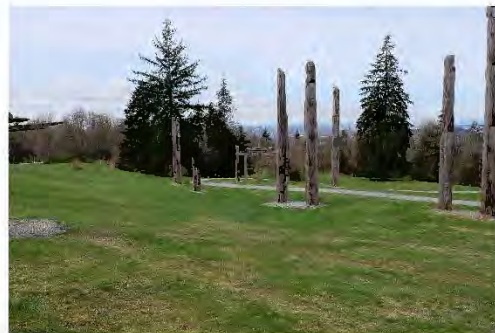
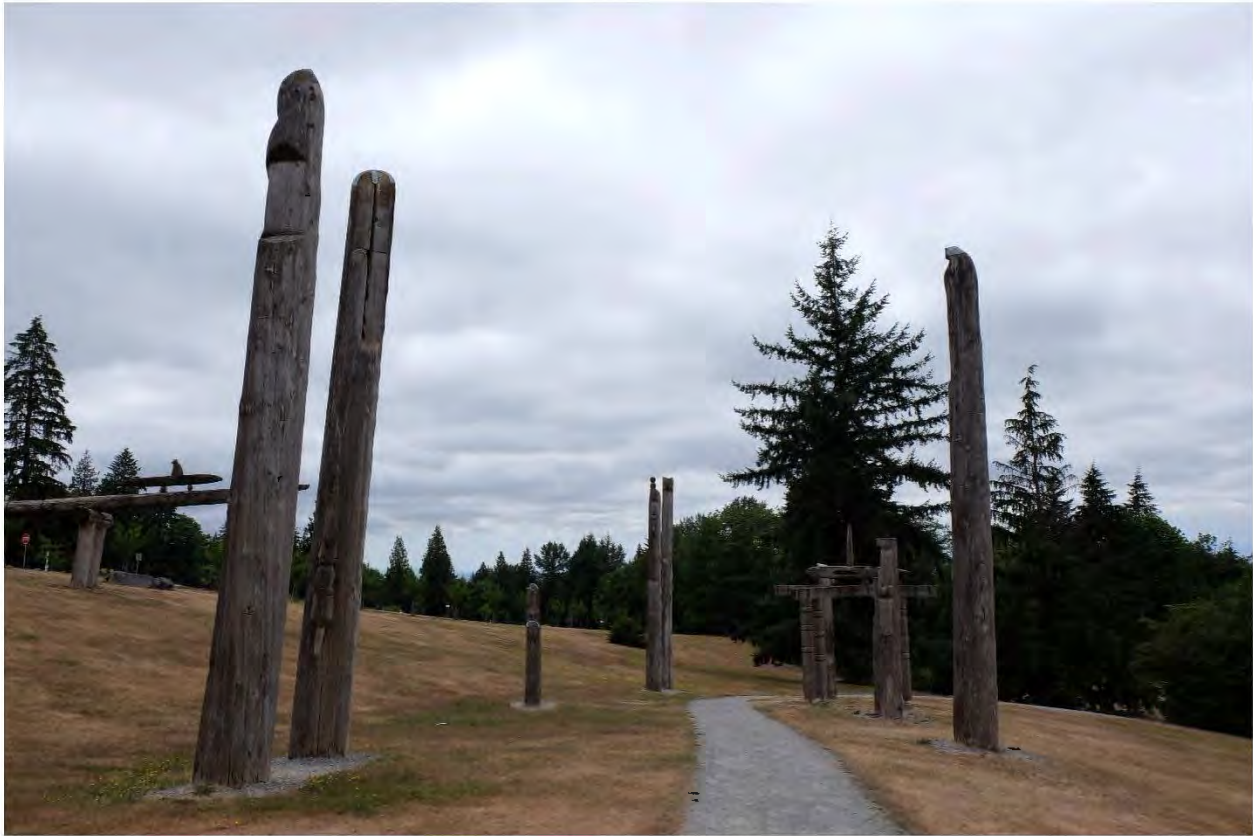
There have been 2 significant issues that have occurred in this area. In 2007, Unit #7 “Whole Ocean” (whale on frame), totally collapsed in a windstorm. Structural failure occurred at the base of all four vertical beams of this unit and were observed at the time to be the result of active fungal rot taking place at the ground level. This collapse was followed by a total rebuild of the original structure with all new, engineered products, and the reinstallation of an original sculptural form (the whale), on top of the new sculptural structure. This new installation took place in 2015 and photos of the preparation of the in-ground concrete foundations for the structure reveal apparently moist soil. Attention to analysis of the soil conditions were not considered important at this time as concrete foundations were being cast in place for support of the new wood columns.

The second serious issue in the landscape category, was the collapse of a standing pole unto its mate pole of Section A, Unit #7, part of the ensemble “Whole Ocean” which was noted for the first time 15 October 2020. The collapsed pole ended up leaning safely against the other half of the two part unit. The pole had to be removed from its location as soon as it was recognized as a failure and danger. During the removal in July 2021, it was observed and photo-documented that the ground level area of the pole was completely infiltrated with the same fungal rot as witnessed earlier in the very close-by location. The 2nd remaining standing pole appears to still be stable in the ground, but it is of concern now given these observations of possible ground water build-up in the area below the large slope of the parkland. The possibility of ground water retention in this area would contribute to the growth of fungal rot leading to deterioration at ground level.

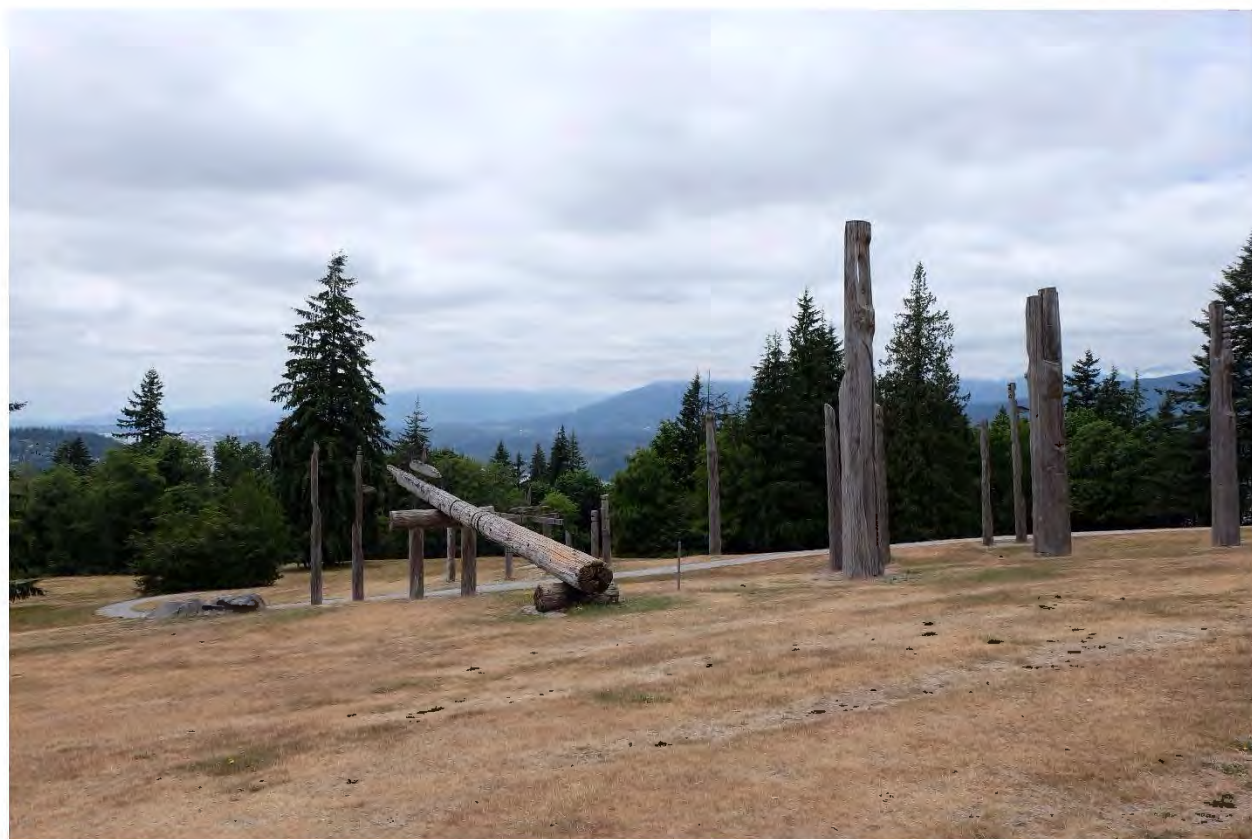
In-ground issues remain constant around the whole site, but the above defined areas encompass a significant part of the collection and further monitoring needs to be carried out. Another part of the whole installation, referred to as Unit #2, “The Direction” is also a sculptural unit requiring further investigation and on-going monitoring. This 2024 report concludes with the same recommendation for on-going monitoring and further testing. This unit with the long extended pole is supported by a 2 post and cross beam structure which have been observed with deteriorating conditions in the past. Other issues, involving access and climbing have gone on for years with difficulties in terms of management of the public and the potential for harm from falling. The 2023 report states the structure itself is a concern for its stability. This 2024 report concludes that it is still an on-going concern.

Overall, of the western slope of the site, Unit #2, “The Direction”, centre, is noted as in need of monitoring on a regular basis.

To address the potential structural issues, on-going monitoring of the site should be taken to a professional level with special notice of conditions in the vulnerable landscape locations. Monitoring methods should be moved to an engineering level in order to receive precise measurements. The recommendation to monitor sloping pole units in the central main grouping (the Gods and the People”) is important. This should be done at a professional level.

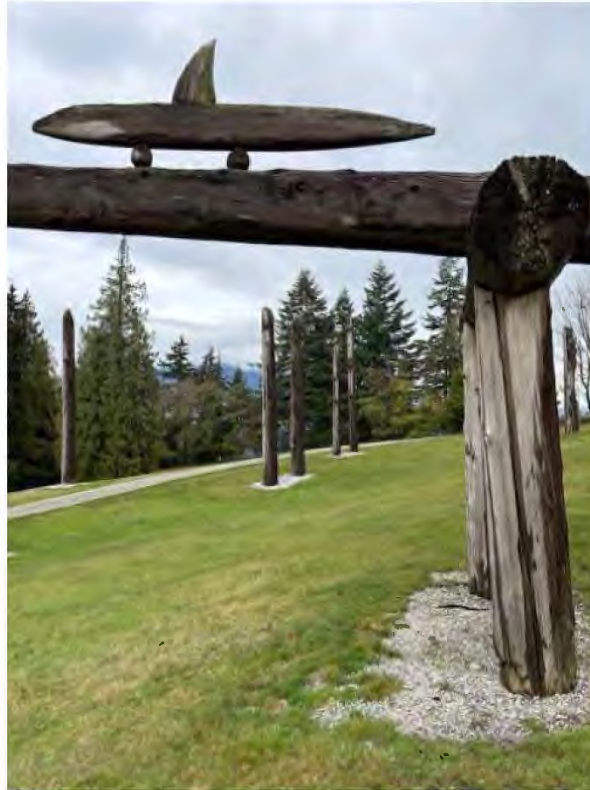
Unit #2, "The Direction", is noted as in need of monitoring on a regular basis.

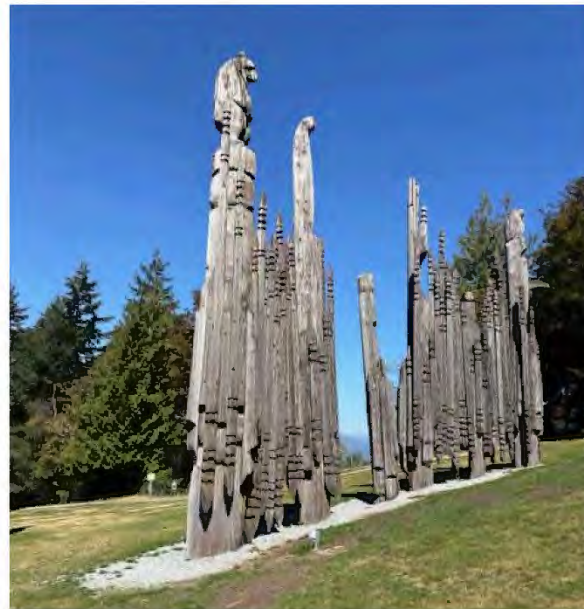
Unit #1, "The Gods & the People", is noted as in need of monitoring on a regular basis.

Structural conditions as noted from frequent and recent 2024 examinations appear to be relatively stable at present around the site in general. The central Unit #1 "The Gods and the People", has deterioration in the attachment areas of the added poles attached to the principal 6

In this 2024 report, it is being noted for the first time that the central solo pole column appears to be sloping more than in previous photo records. A recommendation to monitor movement of this unit and the poles in this area is a new addition to the overall monitoring of the elements of the installation.

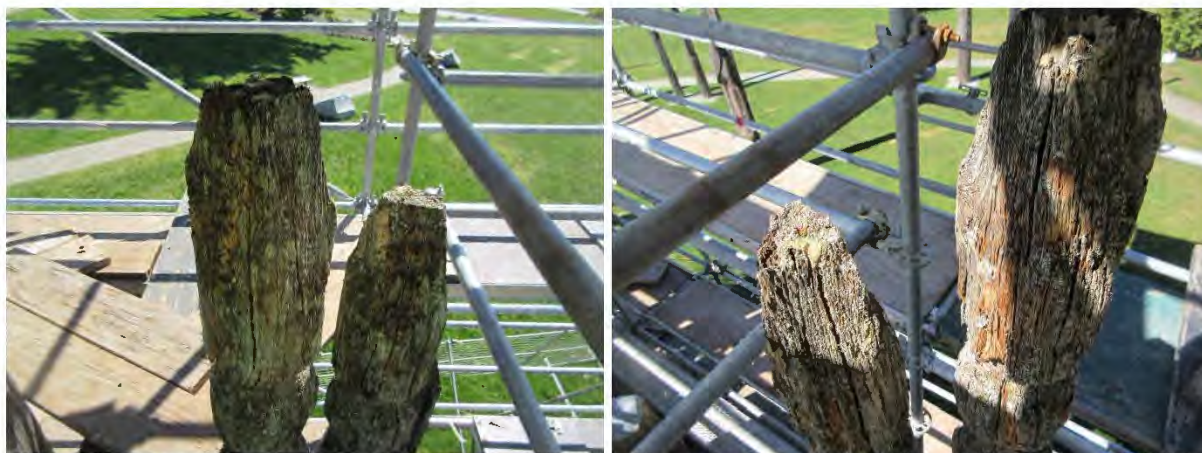
Unit #1, detail of “The Gods and the People”. Note conditions of exfoliation of surface wood grain and surface weathering.

In 2016, during treatment, it was reported that the Playground of the Gods was suffering from extensive deterioration especially of the “The Gods and The People”, Unit #1. This principal Unit #1 of the Playground of the Gods, as mentioned, is composed of 6 large cedar poles set in the ground with a large number of smaller, thinner carved poles attached between 5 of the 6 larger poles. It was suggested that some of these attachment poles be replaced, as it was felt then that they were definitely deteriorating at a rate faster than the larger, red cedar structural poles in the ground.

To address surface deterioration issues an overall conservation plan needs to be developed for the site with cleaning and borate preservation treatment recommended based on a new treatment proposal for a conservation program in 2025. Due to past cases of insect infestation a re-newed treatment with Tim-bor is advised to be included again in a new Treatment Proposal for the maintenance steps.

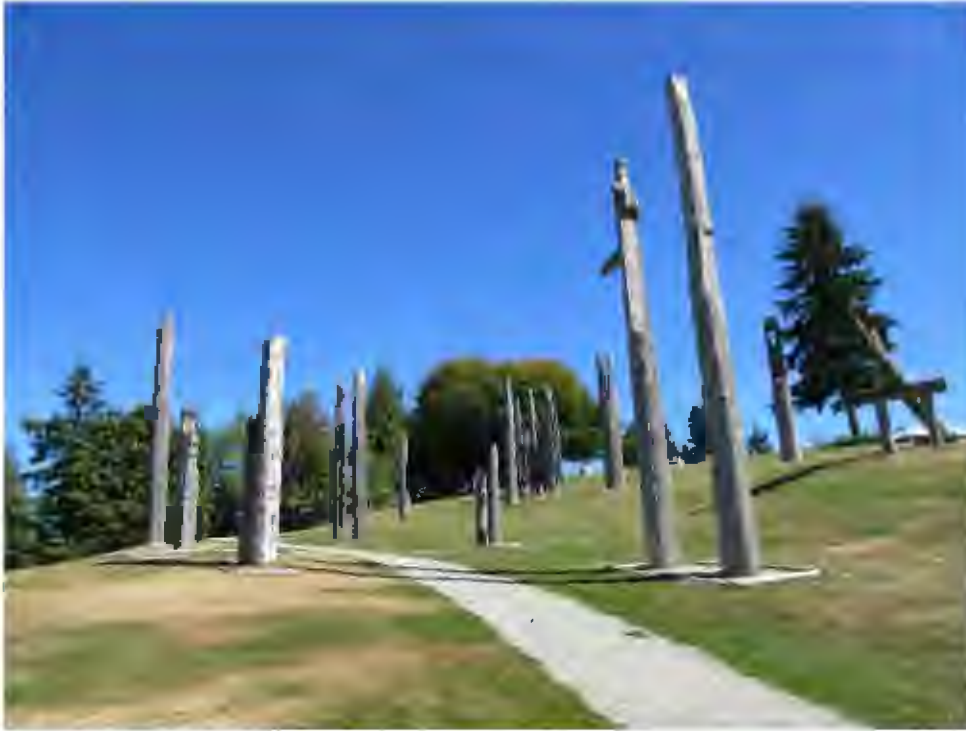
These two incidents of natural failure due to fungal rot caused by excessive moisture and lack of drainage in the area are cause for further concern. I continue to monitor this location and the remaining poles in the vicinity, but it is difficult to ascertain the extent of potential failure without conducting serious intervention to the bases of the poles in the area. I also am recommending ground stratification testing in these areas with moisture level readings taken at the same time.

The totem poles on the lower slope of the hillside are on flatter ground and are a concern for moisture retention and subsequent fungal rot of wood at ground level.

Curatorial input is needed to discuss a reinforcement system for the vertical poles. Security support intervention is recommended from engineering input for best methods. A conservation suggestion for discussion is to provide pole support by inserting new in-ground application of up to 3 new support poles per unit of vertical pole, to a recommended depth to be determined up to 4 feet (1.2meters), of a 4 inch (10cm.) diameter round support metal pipe to be driven into the ground next to the surface of the vertical pole units. Equipment is available to perform this operation after planning and approval. A structural metal band wrap could be considered if deemed necessary.

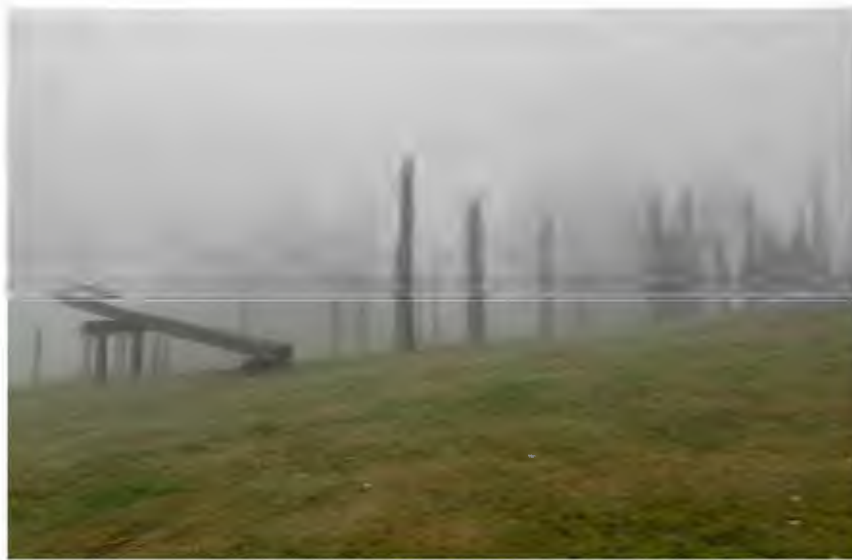
The location of the sculptures on Burnaby Mountain is difficult to access with lift equipment due to the angle of the slope. As a result, treatments in the past have been undertaken from scaffolding. It has been observed through on-site practical treatment work, that the poles imbedded in the slope of the hill appear to be more stable than those located on the lower flatter area of the installation.
