**TO:** CITY MANAGER **DATE:** 2015 November 17

**FROM:** DIRECTOR ENGINEERING **FILE:** 31000 06  
*Ref: Stoney Creek*

**SUBJECT: STONEY CREEK CULVERT AND CREEK REHABILITATION PROJECT**

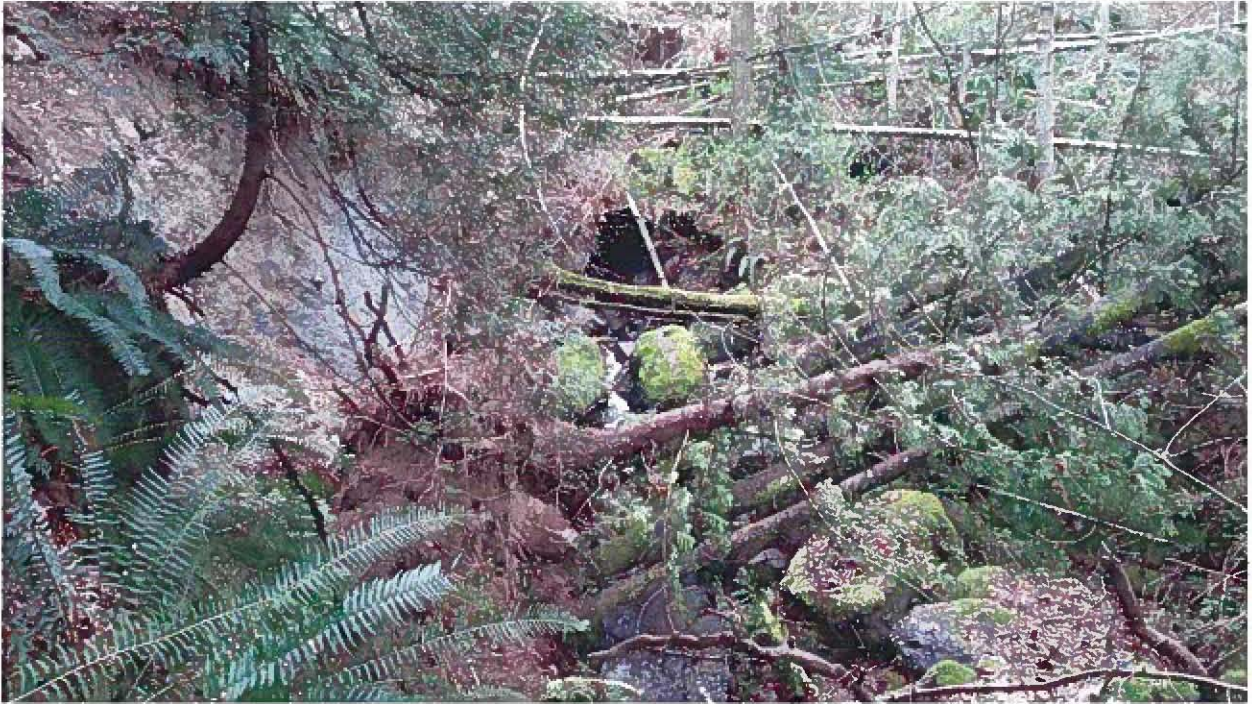
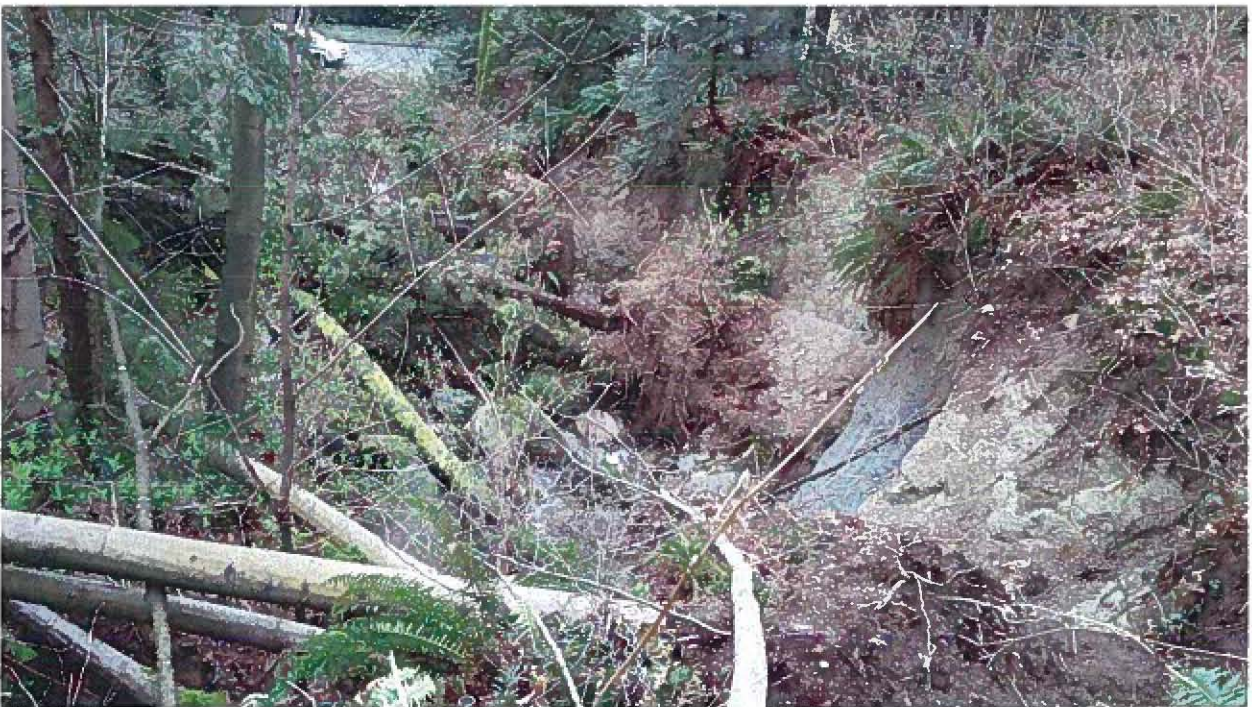
In early March 2015, monitoring showed increased erosion to the creek bank. Erosion had progressed to a point where trees in the Construction Area had fallen as a result of their roots being undermined (see Attachment #2). Video inspection of the culvert found that the bottom of the corrugated pipe showed signs of corrosion necessitating culvert repair in addition to the creek rehabilitation (see Attachment #3).

Picture of fallen tress found in the construction area due to erosion of the slope.

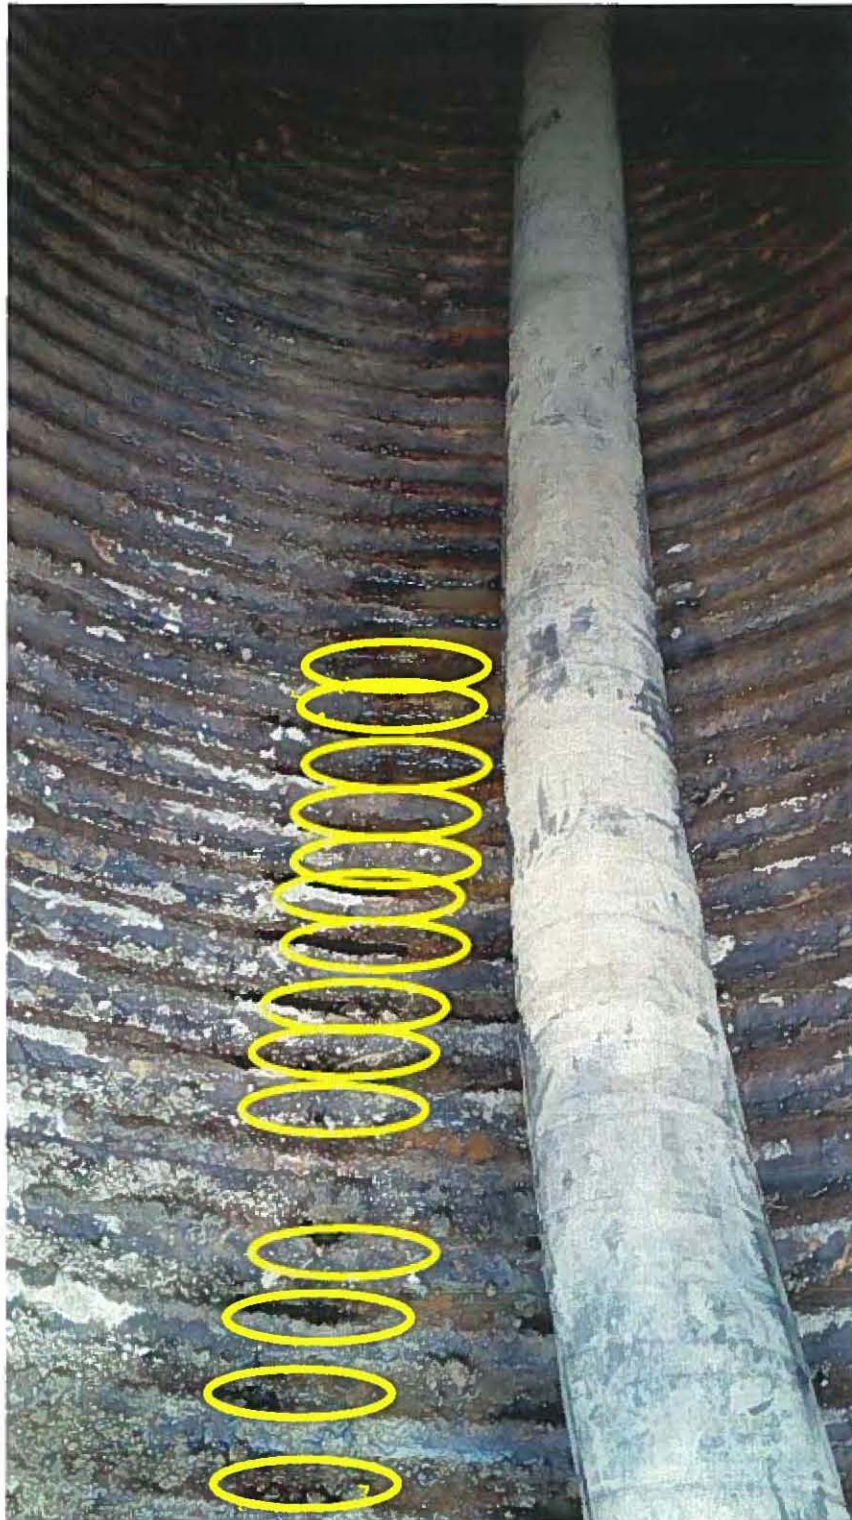
Culvert showing signs of corrosion with holes at bottom of the pipe

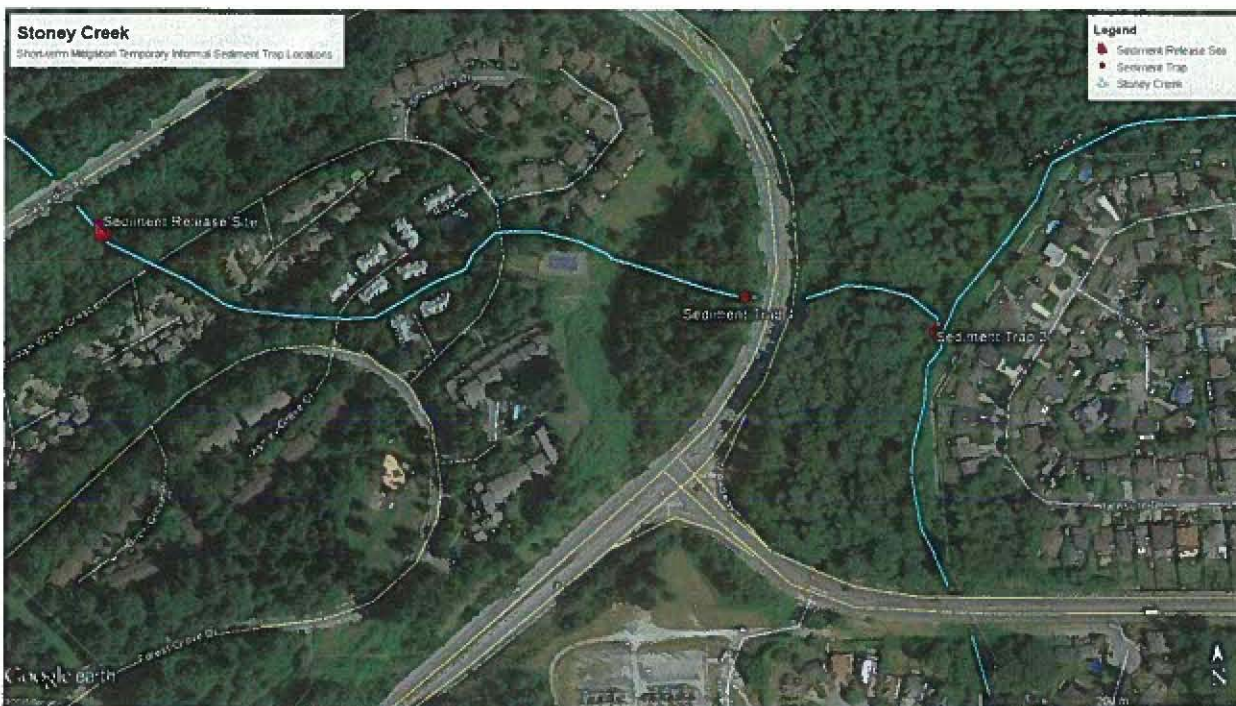
In response to this event, ISL and AC Paving's environmental staff undertook assessment of downstream impacts of the slope failure. Initial investigations identified two areas where fine sediment was pooling and would benefit from immediate removal (see Attachment #4). On 2015 November 10, removal of deposited sediment fines was undertaken at these locations by AC paving to minimize further downstream impacts. ISL is following up with AC Paving regarding potential mid to long term mitigation measures within and downstream of Tributary 3A of Stoney Creek. Any agreed upon mitigation measures would be undertaken during 2016 instream window. Staff have met with Stoney Creek Streamkeeper representatives and provided them with an update on project timing, cause of the key incident and remedial measures which address impacts attributable to this incident.

Areas where sediment naturally pooled were cleaned out by vacuum truck on November 10<sup>th</sup>.
