DATE: 2016 February 23

SUBJECT: CROSSWALK – PARKER ST AT MADISON AVE

PURPOSE: To review pedestrian safety concerns at the intersection of Parker and Madison.

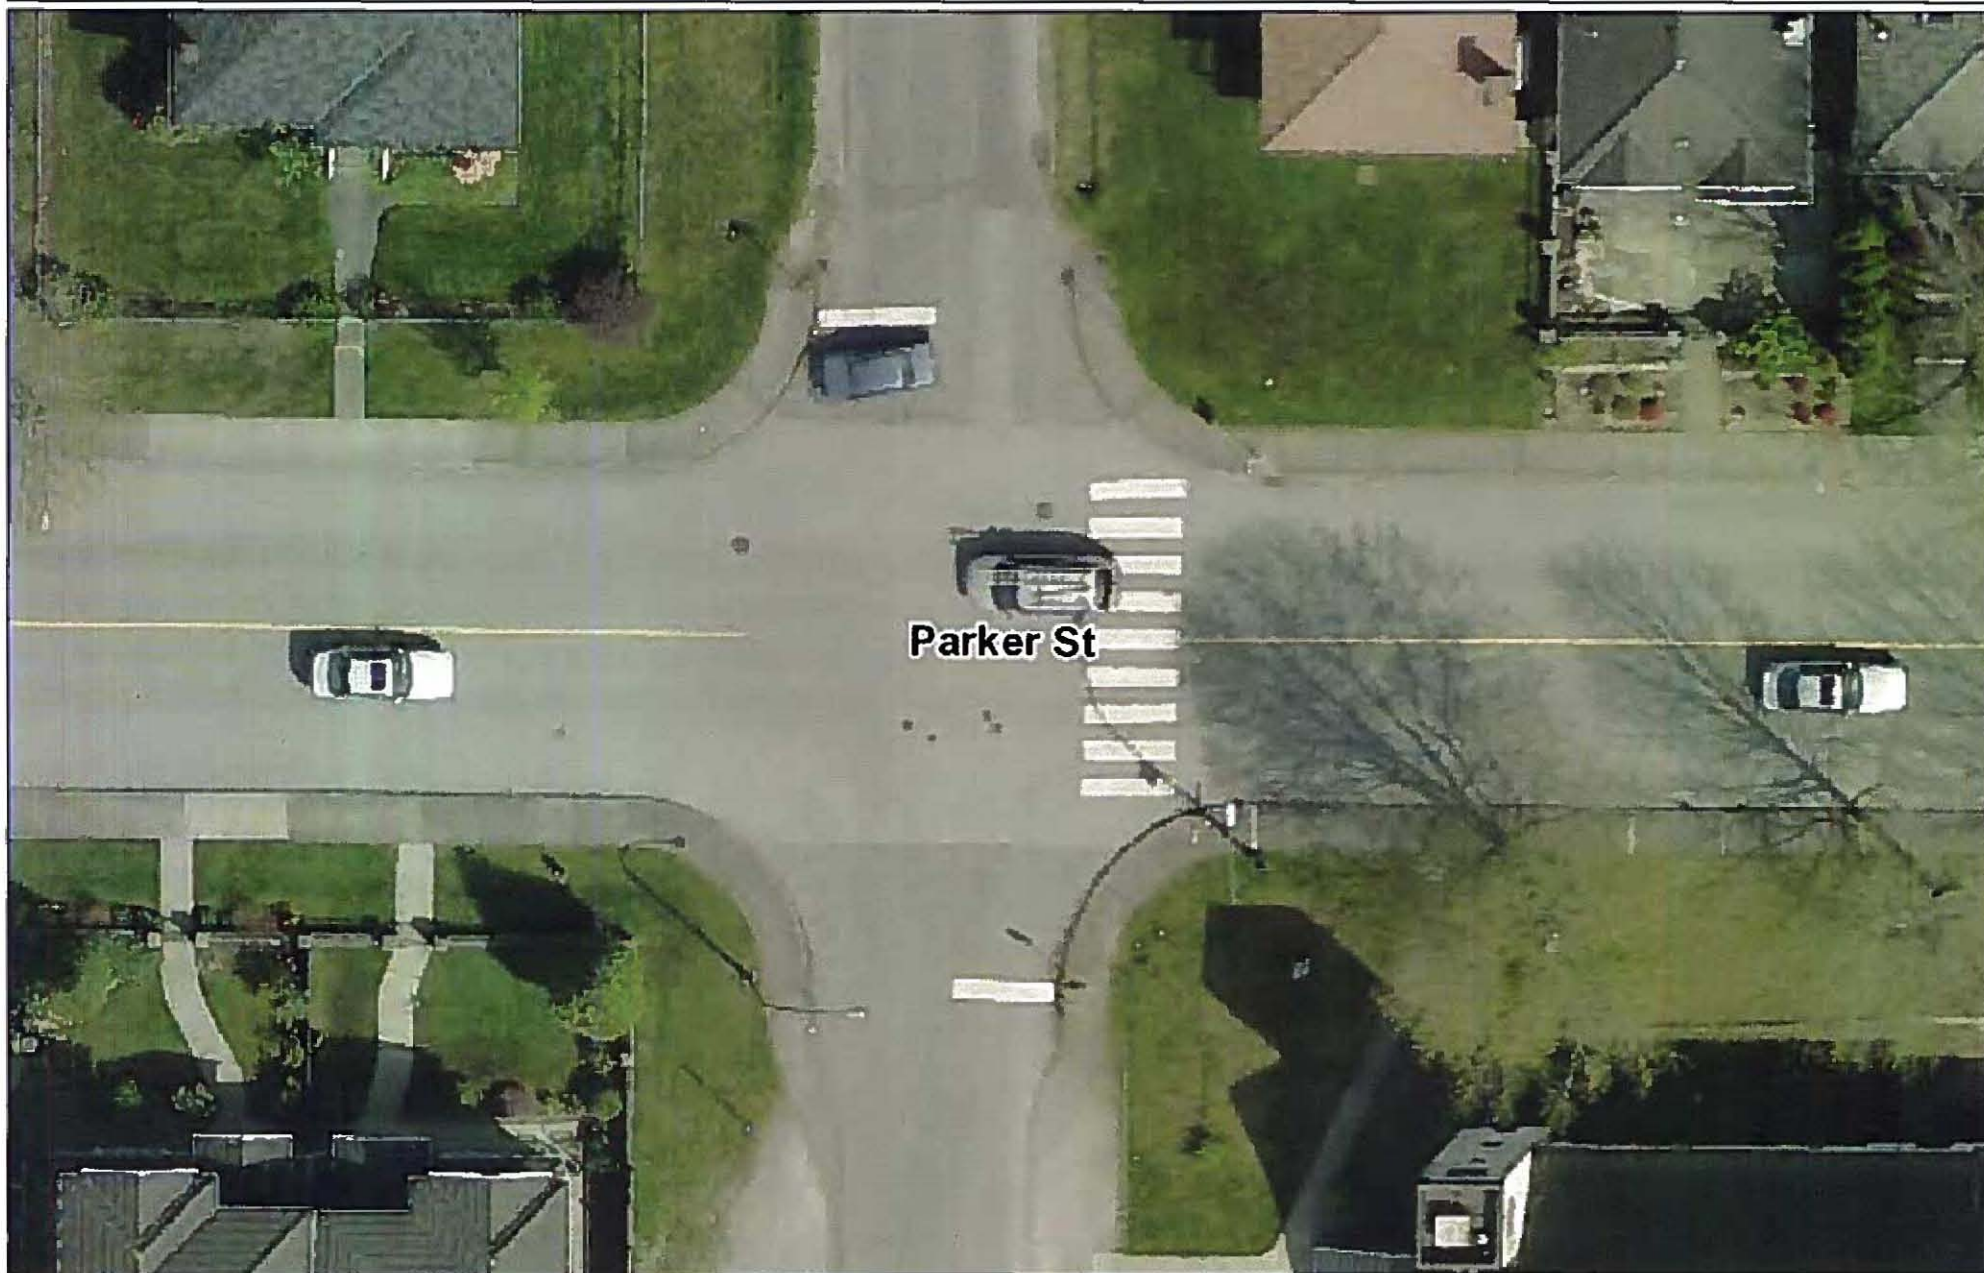
The intersection of Parker St at Madison Ave is a standard four legged intersection with Madison Ave being stop controlled in favour of Parker St (see Figure 1). Parker St is classified as the Major Collector and Madison Ave is classified as a Local Street. Parker St is relatively flat at the intersection and the straight alignment of the road provides good sight lines for both pedestrian and motorists, despite the slight roadway undulations when looking east from the crosswalk. Crosswalk pavement markings exist on the east leg of the intersection along with two crosswalk signs, one either side of Parker St.
