SUBJECT: DEER LAKE CENTRE

PURPOSE: To obtain Council approval to proceed with an emergency envelope repair at Deer Lake Centre II.

Attachment: 1 – Pictures of the shift in the vertical precast panels

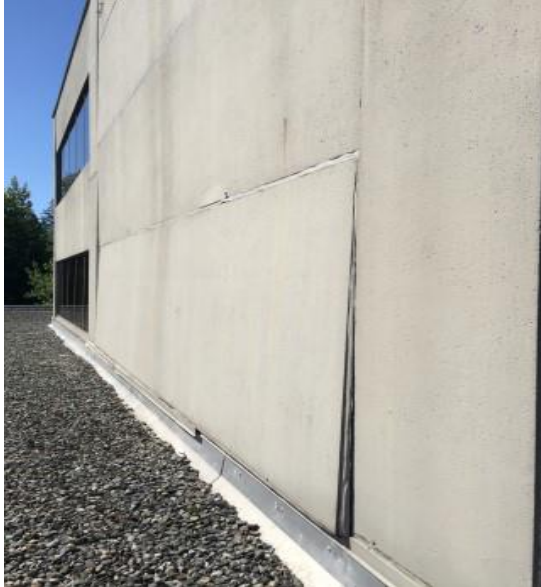
In early August Colliers onsite technician noted a shift in one of the vertical precast panels on the roof between the 4th and 5th floors at the City owned building at Deer Lake Centre II, 4940 Canada Way. Consulting Engineers Read Jones Christoffersen Ltd. (RJC) investigated the reason for this shift. Exploratory openings were created from inside the 4th floor washroom to expose the rear side of the precast panel connections. Visual inspection indicated corrosion and rust at the steel plate connections between the two concrete panels.

Observed lower panel shift:

RJC is recommending that the lower panel be replaced and that new connections and bracing be installed between the upper panel and the base structure. The Engineers are currently preparing the engineered drawings required for the building permits and they have recommended that since

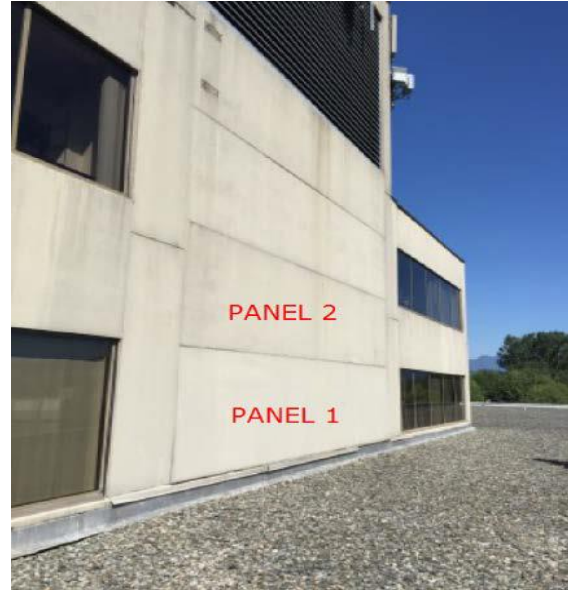
RJC advises that the lower panels are designed to sit on the 4th floor curb and the panel above is connected to the 5th floor slab. This flashed concrete curbing, which holds some of the weight of the lower panel, has deteriorated causing the panel to shift. Although affixed to the 5th floor slab, the upper panel does rest on the lower panel. The shift of the lower panel has put some additional stress on the connections for the upper panel. Attachment 1 shows the panels, the curbing deterioration and the temporary bracing.

Upper and lower panels:

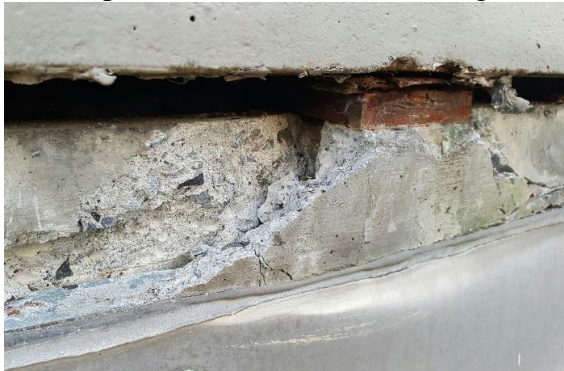
Close-up view of deteriorated curbing:

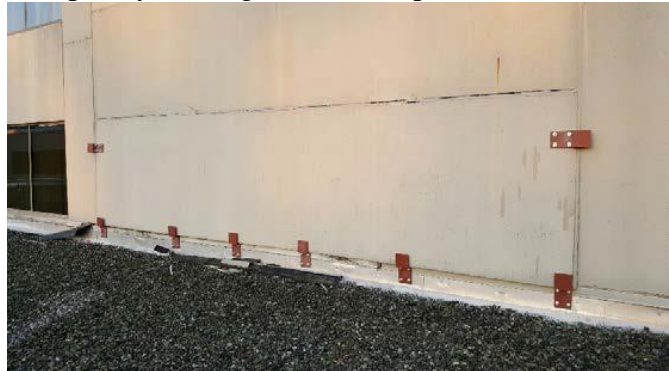
On the Engineers recommendation a contractor, WCBCI was engaged to install bracing of the panel to prevent further slippage. Additional exploratory openings were made in the wall of the 5th floor washroom. The upper panel connection to the base structure consists of steel plates and angles embedded in the precast panel, welded to embedded plates in the structural slab. Some rust was noted on the connections.

Temporary bracing – interim repair:
