INTERSECTION OPERATIONS - BERESFORD ST AT WILLINGDON

AVE

REPORT

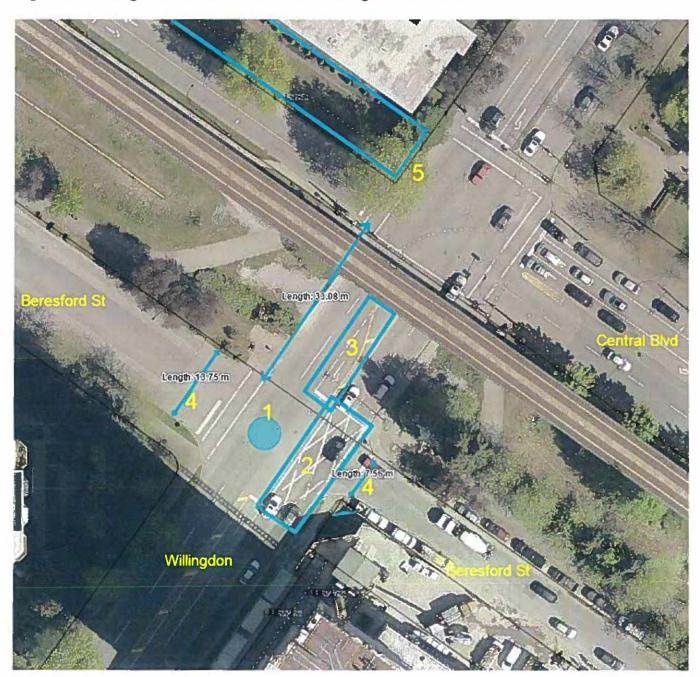
Figure 2: Existing Issues at the Beresford St/Willingdon Ave Intersection

The key safety and operational issues at the Beresford /Willingdon intersection are illustrated on Figure 2 and include:

- 1. The stop-controlled approaches experience long delays and this causes driver frustration and encourages them to attempt unsafe turning and crossing manoeuvres. With growing traffic volumes, a higher number of crashes could be expected in the future;

- 2. This intersection is only 33 metres from a major signalized intersection at Central Blvd/Willingdon Ave. Because of this the queue of northbound traffic on Willingdon Ave stopped for red lights often blocks Beresford St. Despite pavement markings and traffic signs, this is a recurring issue that impedes drivers on Beresford from turning onto or going across Willingdon;

- 3. For southbound left turn from Willingdon onto Beresford a very short left turn lane is provided with storage for only one vehicle (7.0 m long). Therefore any additional vehicle waiting to make the same left turn from Willingdon onto Beresford would block a travel lane on Willingdon Ave. This increases the potential for rear end and side swipe crashes, and also reduces the capacity of Willingdon Ave and the signalized intersection;

- 4. The east and west legs of Beresford St at Willingdon Ave have an inconsistent crosssection geometry and do not align properly. Due to limited road right-of-way, Beresford St does not have standard urban design features and parking encroaches onto the adjacent BC Parkway corridor;

5. Central Blvd/Willingdon Ave is a key four-leg signalized intersection with a major right-of-way constraint on the northwest corner of this intersection. This affects the geometry and laning at this intersection and impedes signal operations. Separate signal phases for eastbound and westbound traffic have to be used due to the alignment problem which worsens operational conditions at this location.
