COMMISSION REPORT

**SUBJECT: REMEDIATION AND RESTORATION OF CAPITOL HILL
CONSERVATION AREA – UNAUTHORIZED BMX TRAIL
CONSTRUCTION**

PURPOSE: To provide a remediation and restoration plan for Capitol Hill
Conservation Area due to unauthorized BMX trail construction.

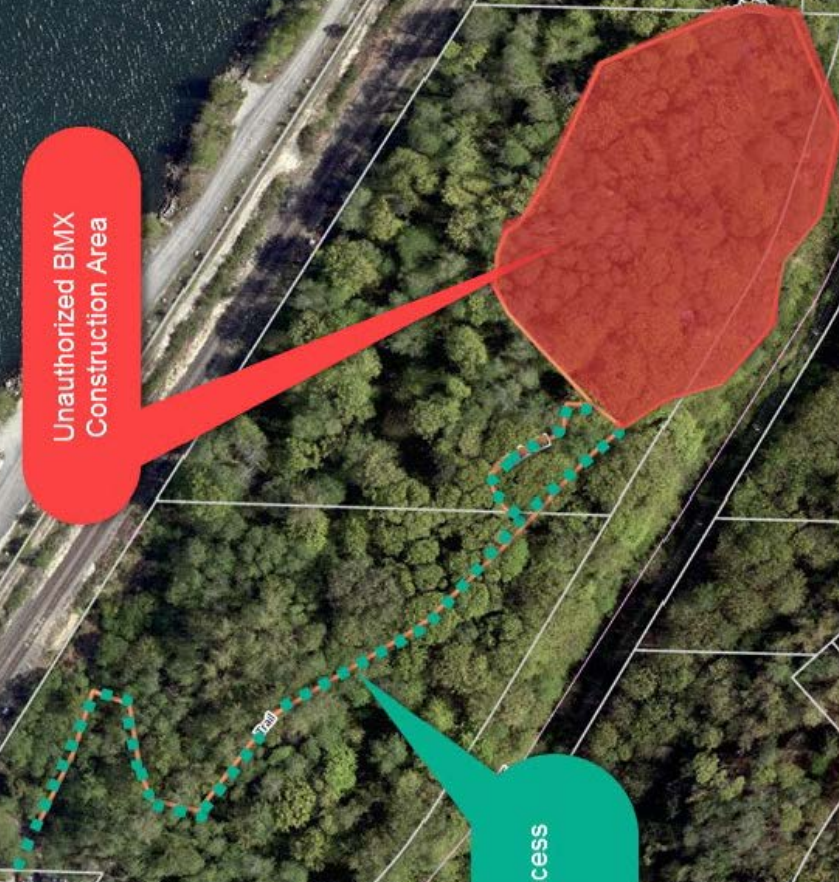
Unauthorized BMX
Construction Area

Unauthorized Access
Route

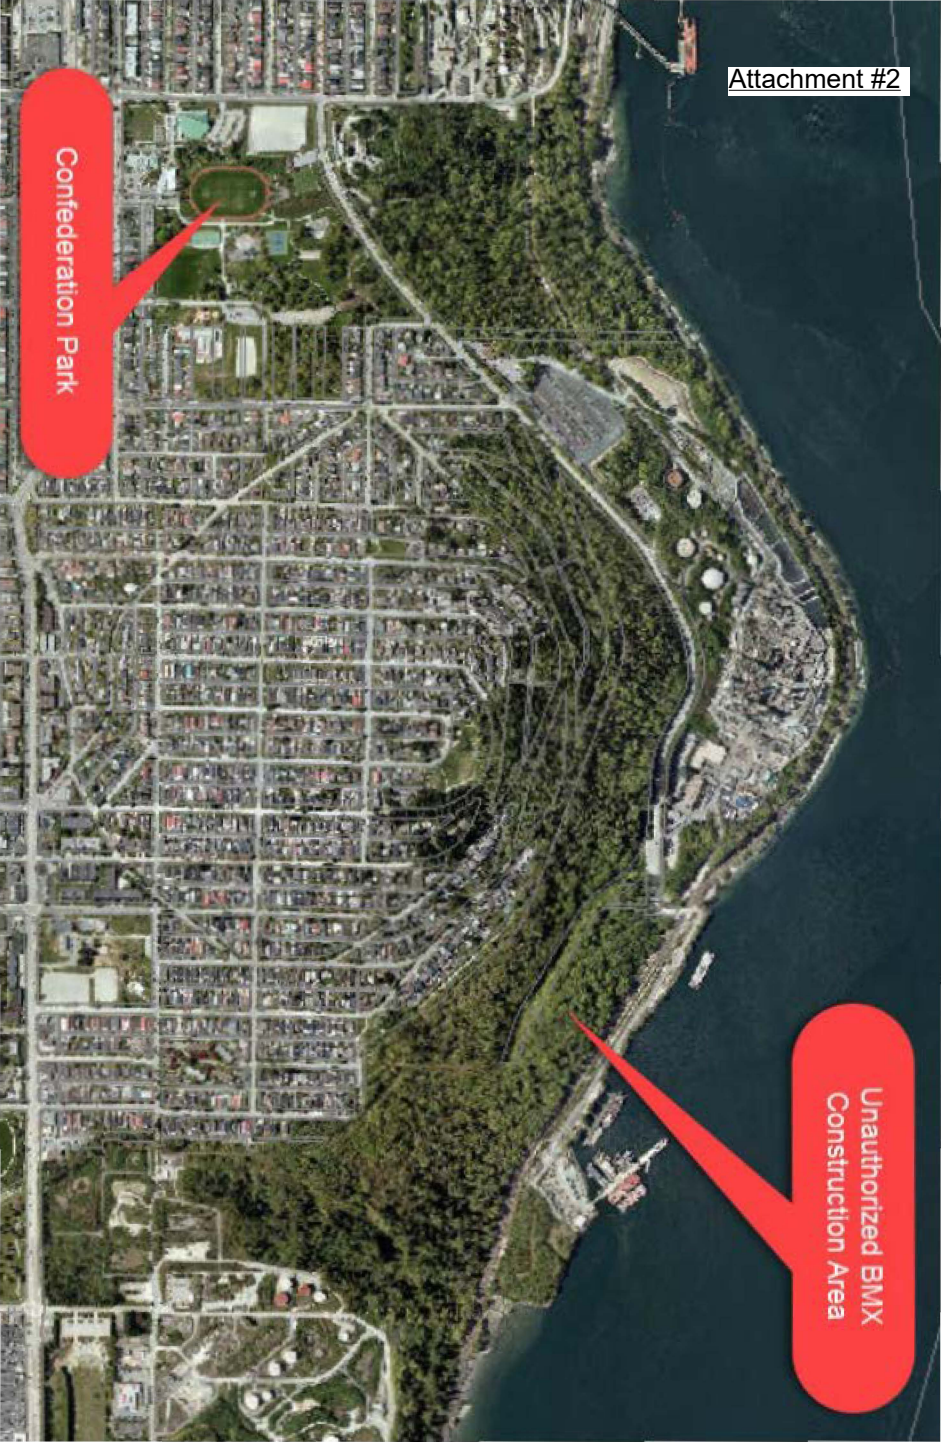
Unauthorized BMX
Construction Area
