LOUIS & ANNIE HILL COTTAGE ADAPTIVE RE-USE STUDY

City of Burnaby

REPORT DATE	December 20, 2023		
PROJECT NAME	Louis & Annie Hill Cottage Adaptive re-use	PROJECT NUMBER	23051
PROJECT ADDRESS	6584 Deer Lake Ave		
PREPARED FOR	City of Burnaby		
	Lisa Codd, Heritage Planner, City of Burnaby		
	Lisa.Codd@burnaby.ca		
PREPARED BY	Iredale Architecture		
	James Emery, Architect AIBC		
	james@iredale.ca

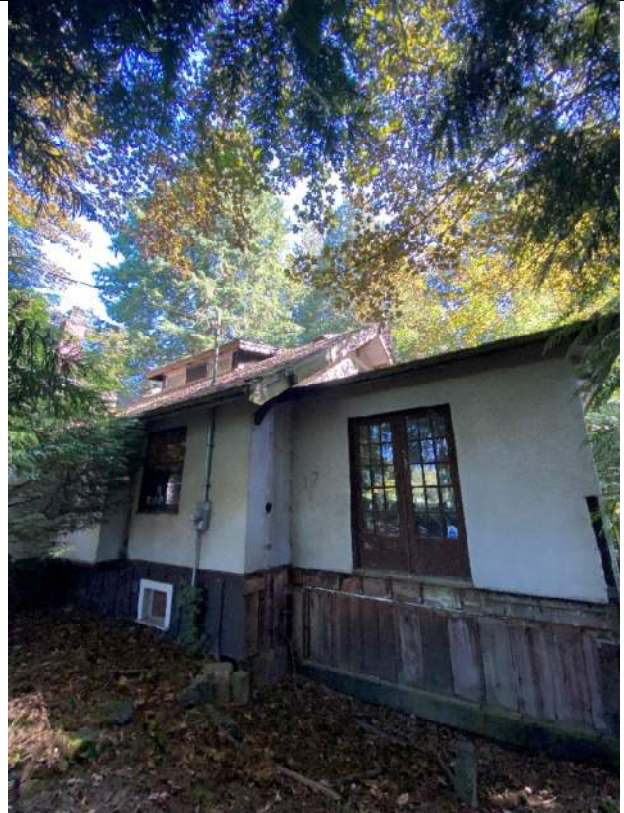
Figure 5: 2023 west elevation. Rear yard, including the addition (sunroom) with the missing patio.

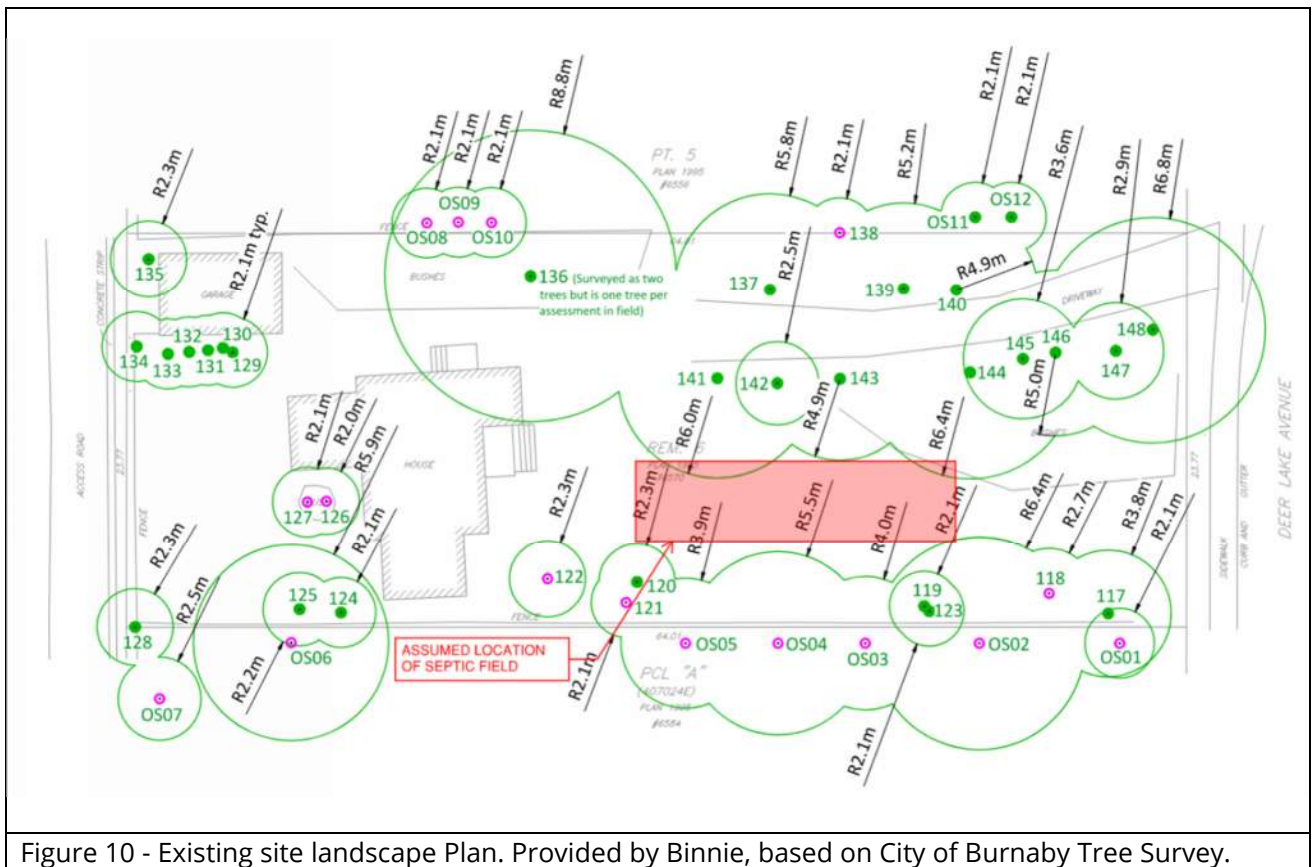
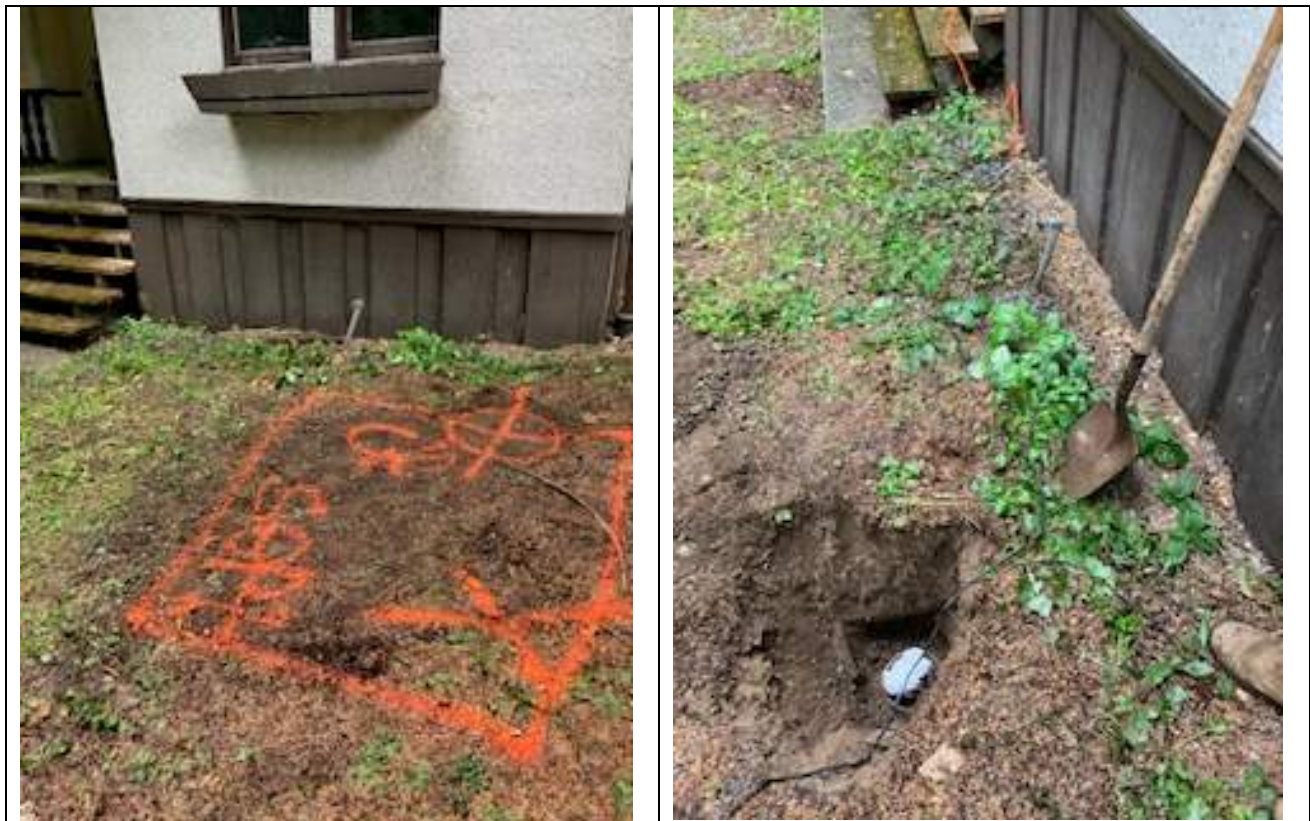
Figures 11 & 12 – Location of the existing Septic Tank in front of Hill Cottage (east elevation).

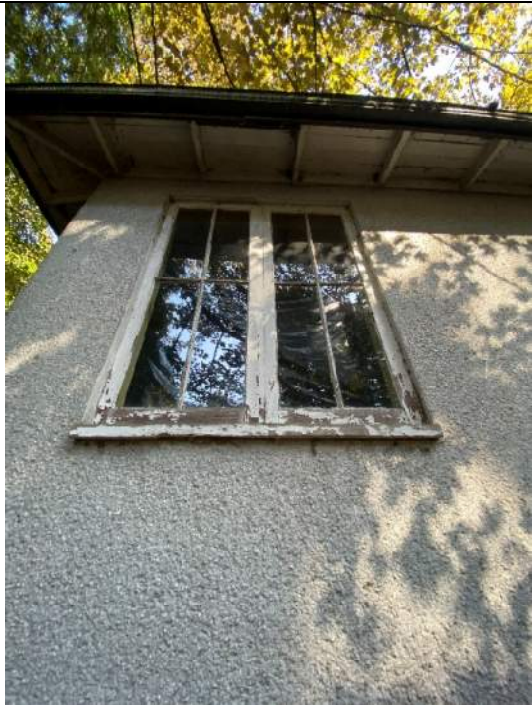
- Window paint is peeling significantly in places and sills are showing signs of significant weathering and some rot. Window sills at basement level where the grade is at the same level are in poor condition.

- Glazing putty is cracking and spalling in certain locations. Old glazing putty can contain asbestos and would need to be tested and if found containing, abated properly. All glazing putty needs to be replaced.

Figure 13: Cottage windows. (different types)

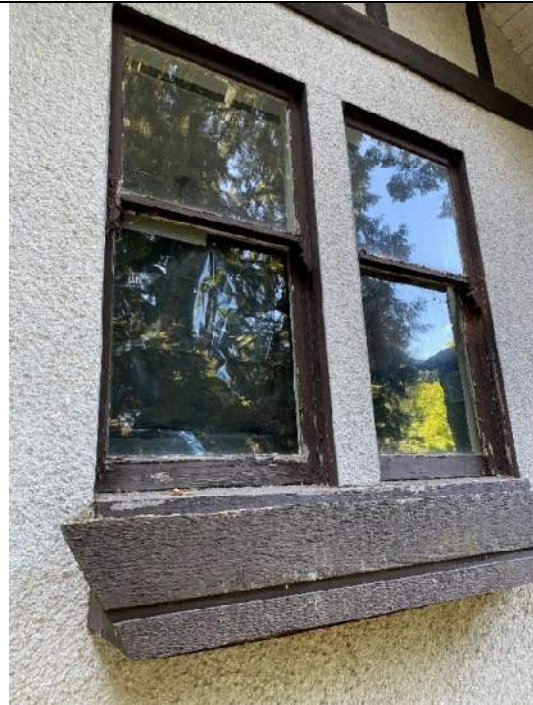
Figure 14: Cottage windows. (different types)

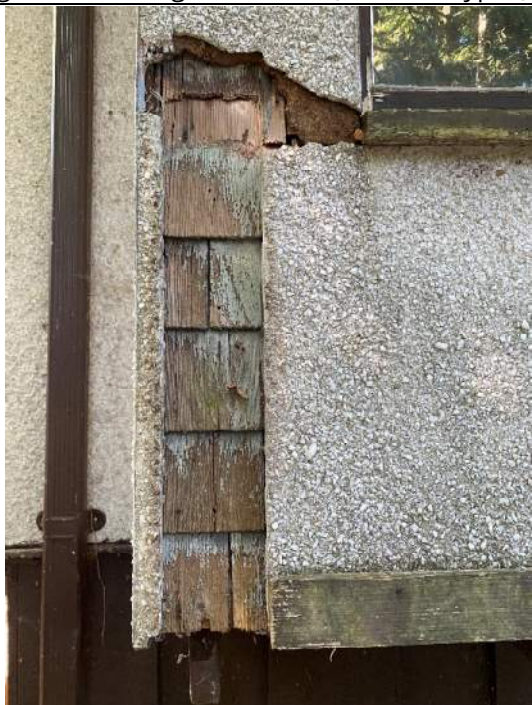
- Assembly appears to be 2x4 walls, diagonal wood sheathing, original shakes, more recent stucco, complete with metal beads, trim, etc. Not known if insulation (period or modern) is present. Condition of the original cedar shake siding is unknown.

Figure 15: Concealed cladding. (original)

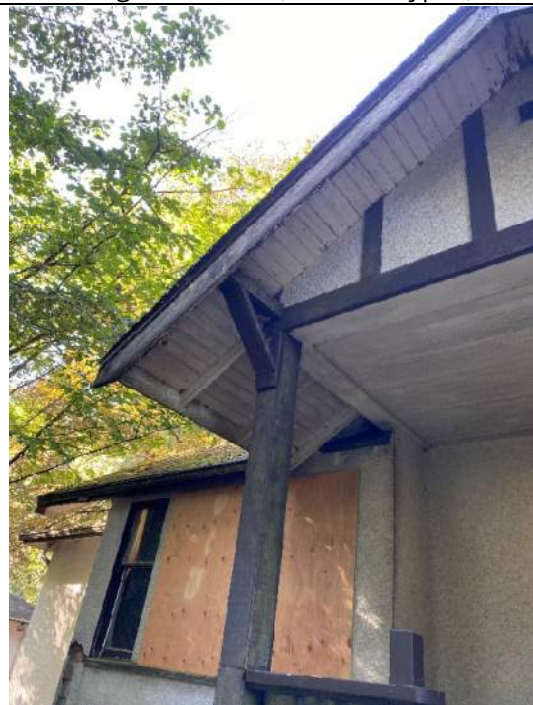
- Exposed wood soffits and rafter tails are in fair condition. Facias are in poor to fair condition.

Figure 16: Soffit and roof details.

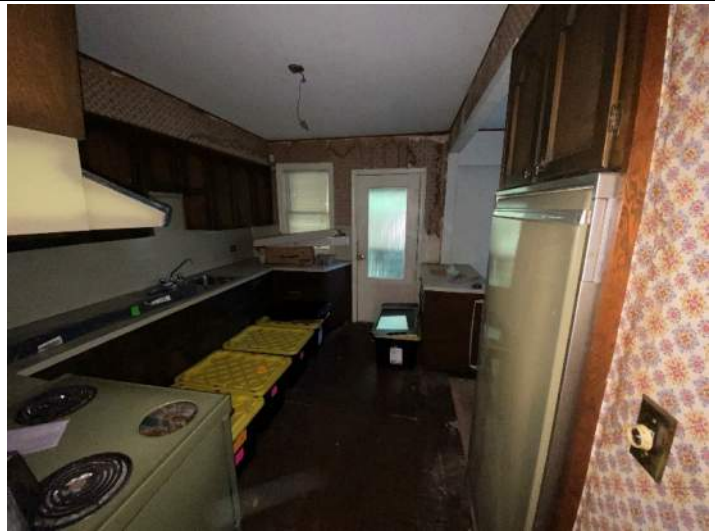
Figure 18: Kitchen, with non-original millwork.

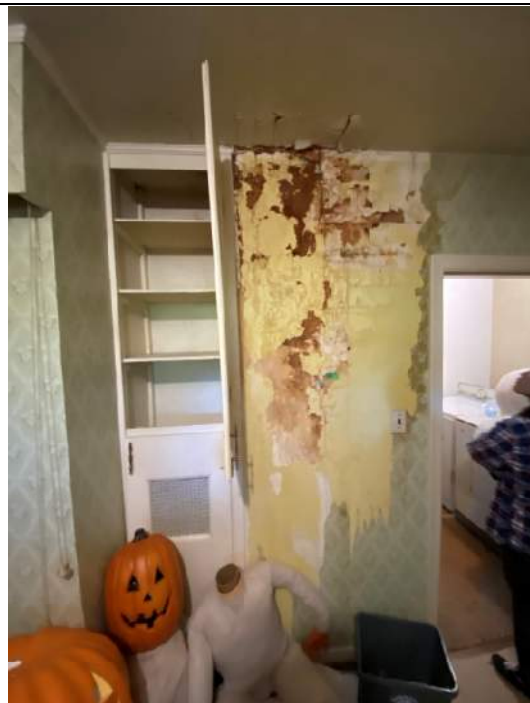
- In the middle bedroom, a minor vertical hairline crack was found at the bedroom wall adjacent to the bathroom and ceiling was found slightly bulged with localized cracks, which is possibly due to ceiling joist deformation and/or differential settlement. The cracks appear to be stabilized.
- Cracks found at the ceiling above hallway outside the bathroom, which is possibly due to ceiling joist deformation and/or differential settlement.
- Stains and minor cracks found at bulkhead over laundry room door, which appears to be due to water infiltration from the lower roof along the interface joint adjacent to the north attic wall and differential settlement. Wall finishing found peeled off along the south wall of the north bedroom, which is likely due to potential water leaking from the lower roof along the interface adjacent to the north attic wall.

Figure 20: Bed Room, showing water leak.

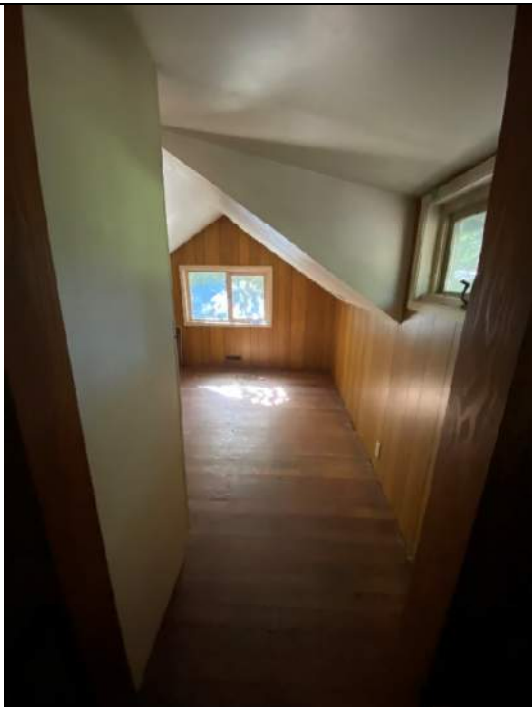
Figure 21: Room in Attic, low ceiling.

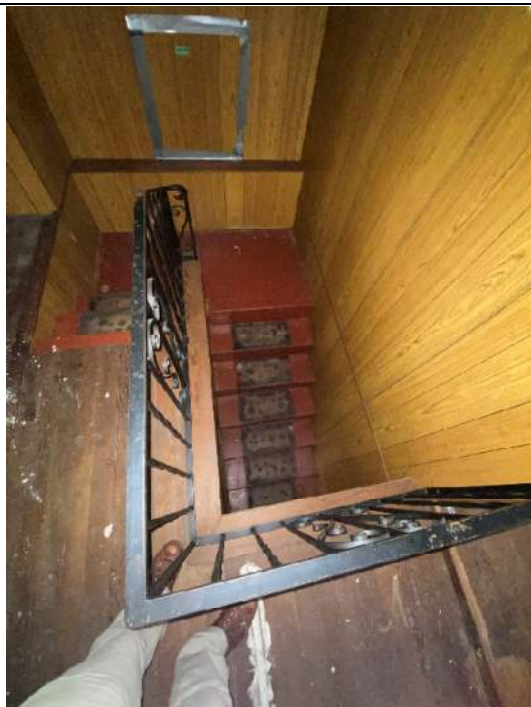
Figure 22: Stairs to Attic, non-original railings.

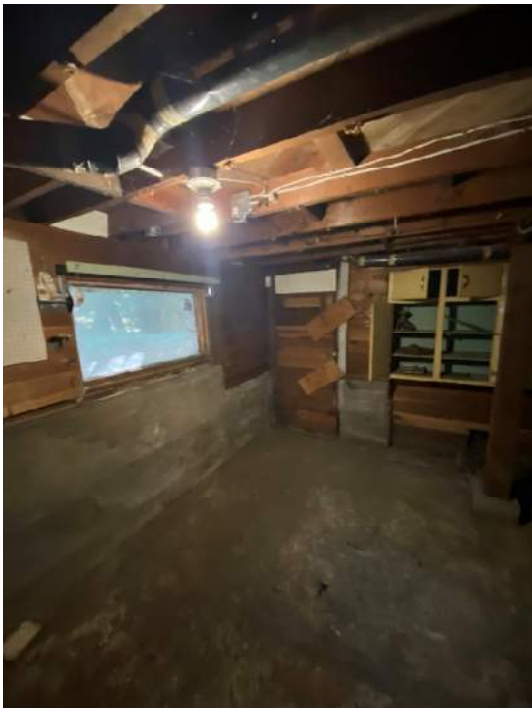
- Signs of animal infiltrations, including rats and possibly other animals from a hole in the basement, under the cottage extension crawl space.
- The concrete foundations (later construction?) also appear to be parged in some locations.
- Near the newer heating system, the wall appears to show possible water infiltration, draining in from grade.
- Taped poly barriers are installed in the long room with the newer heating equipment.
- An access hatch allows access into the crawlspace under the kitchen, bathroom, and main hallway. There is a concrete structure (likely under the 2nd chimney) with significant “honeycombing” and larger rocks, which can affect the integrity of the foundation and will need to be assessed in detail. The crawlspace does appear to be dry.

Figure 23: Basement and foundations.

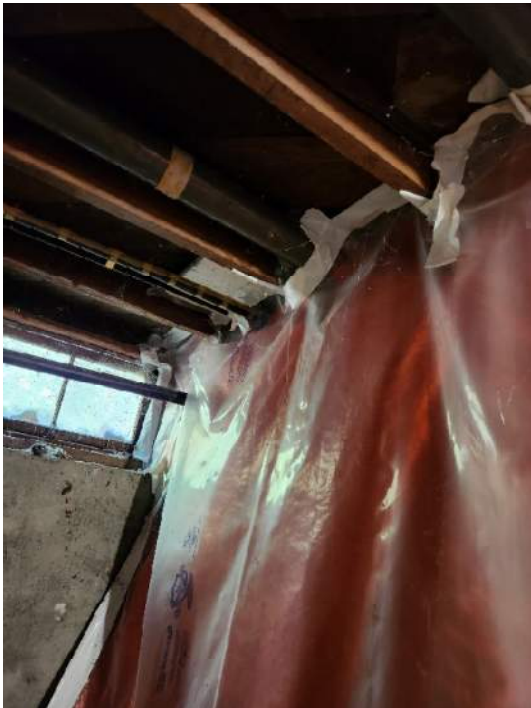
Figure 24: Basement with modern interventions.
