## OBSERVATION REPORT

Project:	Mathers House – Chimney Review	Report:	<b>OR-1</b>
Location:	6490 Deer Lake Ave., Burnaby, BC V5G 3T6	Date of Review:	Oct. 28, 2025
Client:	Alfred Horie Construction Co. Ltd.	Date of Issue:	Nov. 6, 2025
Contractor:	Alfred Horie Construction Co. Ltd.	Project No.:	L25-212.1
Observations and Remarks by: Cameron Robinson P.Eng.			
Reviewed by: Bryan Reilly, P.Eng.			
Report Distribution			
Name	Company	Contact	
Allan Greene	Alfred Horie Construction Co. Ltd.	<a href="mailto:allan@ahc1893.com">allan@ahc1893.com</a>

Cameron Robinson P.Eng., of Latera Engineering Inc. (Latera), attended the site to review the condition of the existing masonry chimneys at the above-noted address.

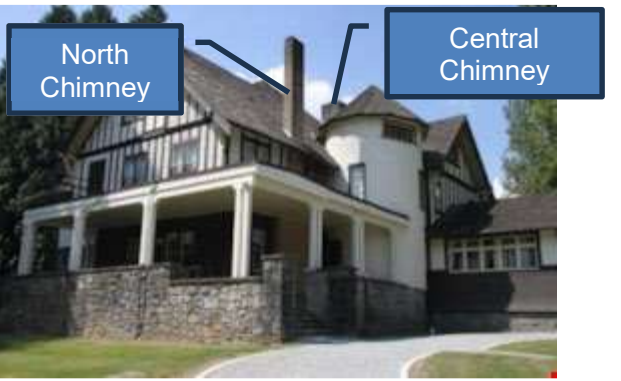
<p>1. Photo shown is copied from the Heritage Burnaby website displaying the W. J. Mathers house. The North and Central chimneys are identified. The South chimney is not shown in this view and is located on the opposite side of the building.</p>

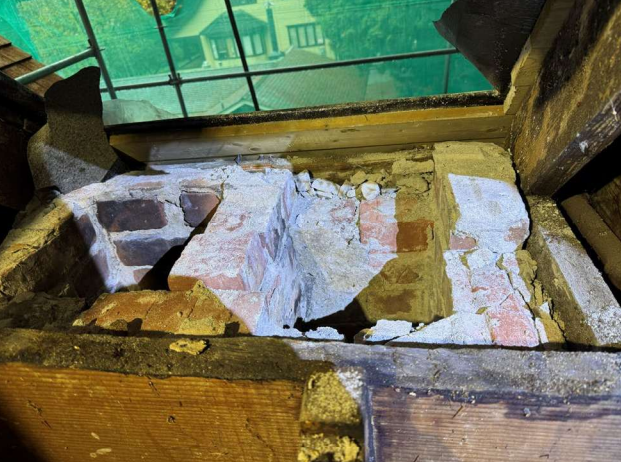
<p>2. Photo shows the brick masonry of the south chimney after the chimney was removed to the top of the roof structure. This chimney is not being used as the fireplaces, this chimney serves, are not in operation.</p>

- A. The most cost effective solution would be to remove the brick of the North and South chimneys to below the roof level and extend the roof over the existing chimneys. The North and South chimneys are not being used and could be abandoned within the walls of the building. Similarly, the Central chimney could also be dismantled to below the roof level and roofed over with the boiler venting rerouted and replaced with a metal stack.

- B. A tall chimney such as the North and South Chimneys are very vulnerable to seismic forces if they are rebuilt. Seismic forces are proportional to the mass of the structure. Heavy tall chimneys generate significant forces where the chimney meets the roof, likely leading to collapse and potential injury in a seismic event. External bracing of the chimneys is possible using 2 steel braces extending from the roof to the chimney at approximately 90 degrees to each other, extending to the approximate mid-point of the chimney. Each brace would be at approximately 45 degrees to the line of the roof. All loose masonry would need to be disassembled and reconstructed. The masonry can be reinforced internally with galvanized steel angles to maintain strength for the entire length of the chimney. In addition, reinforcing wire can be embedded in the mortar joints to further reinforce the chimney and ensure that it does not break apart internally in a seismic event. We would recommend that the braces be hot dip galvanized steel to limit corrosion then painted black to minimize their visual impact. Bracing of the central chimney could be done in a similar way from the roof structure; however, since this chimney is at the corner of a roof hip, it would be relatively easy to hide the braces within the roof structure.

- C. A third option would be to remove all loose brick and rebuild the chimney around an internal structure that would extend down the chimney for support and form a backup wall above the roof line to support the masonry. This would require the most engineering, labour on the part of the masons and a combination of custom structural steel and a cold form steel stud back-up wall. Capping at the top of the chimney would be required to keep the inside of the chimney dry.

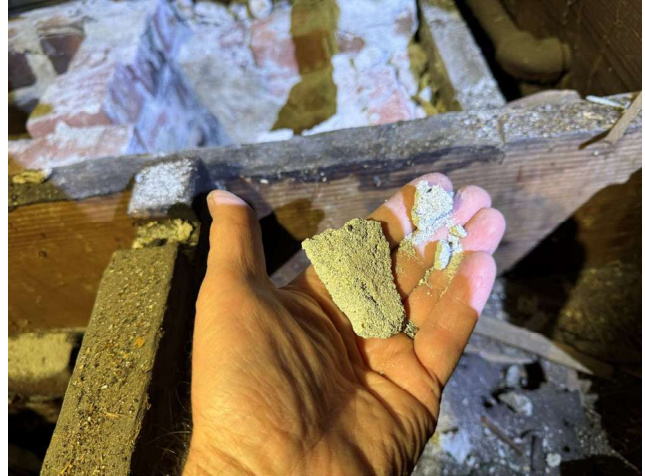
3. The mortar of the south chimney at the top of the roof level was easily compressed into powder with little force. There is essentially no strength to the mortar at this location. The soft mortar could be identified using a pick as far as could be reached down the flues (approximately 18-inches).

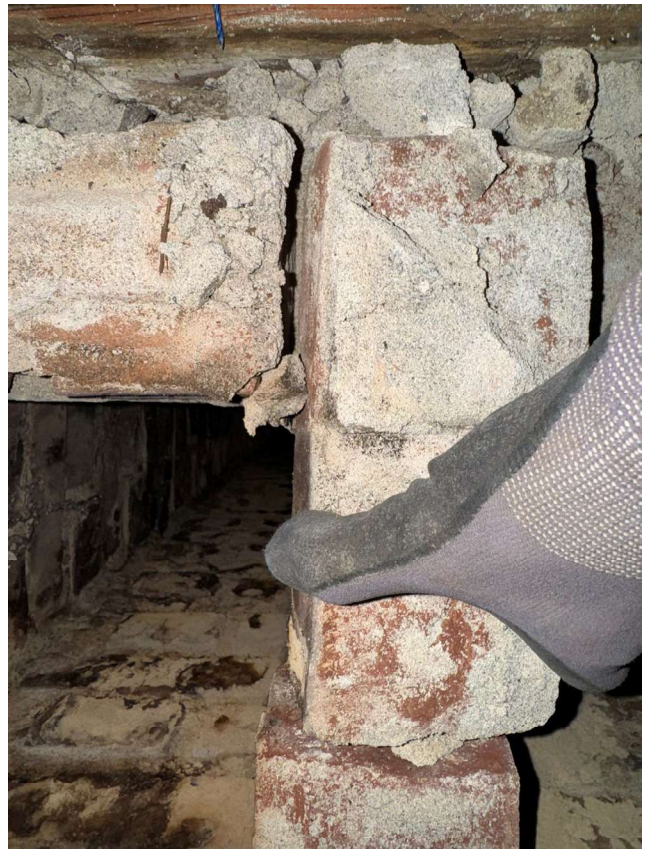
4. The bricks can be easily dislodged by hand. The chimney was held in place by its own weight only. The chimney, in its previous state, would likely have collapsed in a seismic event.

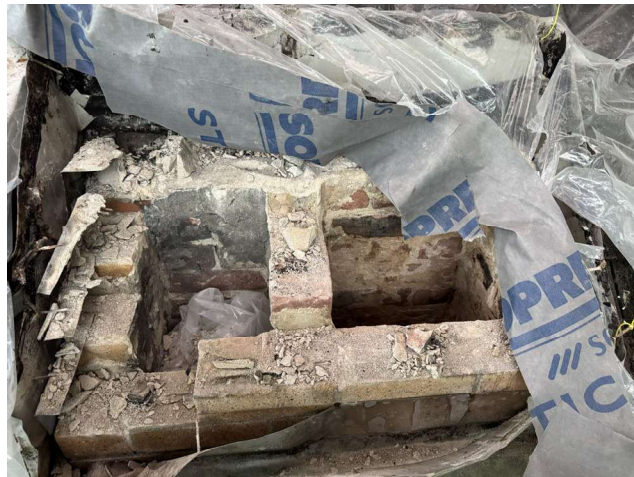
5. Photo shows the north chimney with the brick removed down to the roof level. The mortar at this location was found to be considerably stronger than the south chimney; however, masonry has very little tensile strength therefore, a tall chimney is still likely to collapse in a seismic event. This chimney is not being used as the fireplaces, this chimney serves, are not in operation.

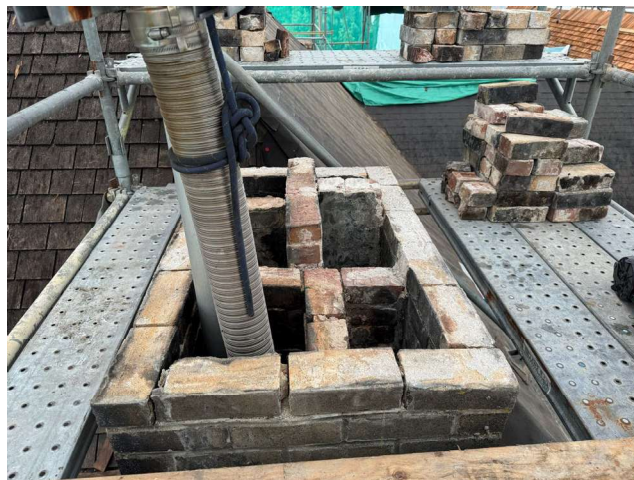
6. Photo shows the top of the central chimney. At the time the photo was taken, approximately 6 rows of bricks were removed. The central chimney is currently being used to vent the boiler. Note the proximity of this chimney to the existing roof structure behind.

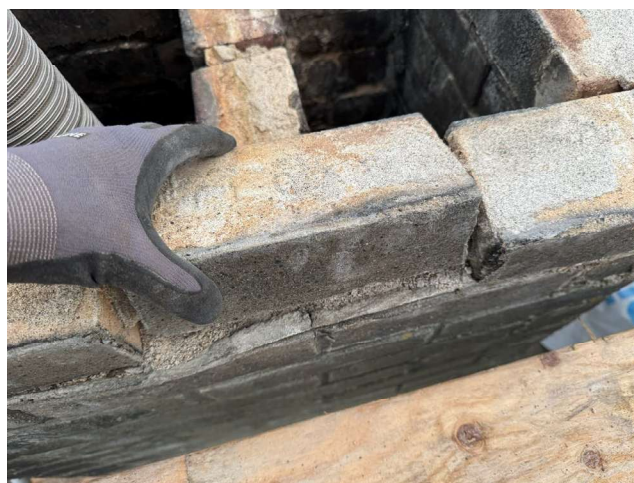
7. The mortar is deteriorated similarly to the south chimney. The bricks could be easily separated by hand.

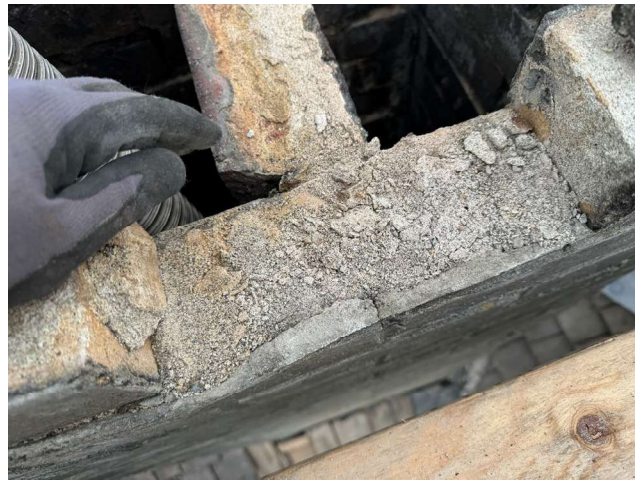
8. The mortar is powdery and has lost essentially all strength at locations.
