**FROM:** DIRECTOR ENGINEERING

**SUBJECT: REVIEW OF PEDESTRIAN CROSSWALKS AT FOUR LOCATIONS**

**PURPOSE:** To review existing crosswalk operations at North Fraser Way/Fraserton Ct, North Fraser Way/Fraserwood Ct, Eastlake Rd/Centaurus Dr, and Halifax/Augusta Ave.

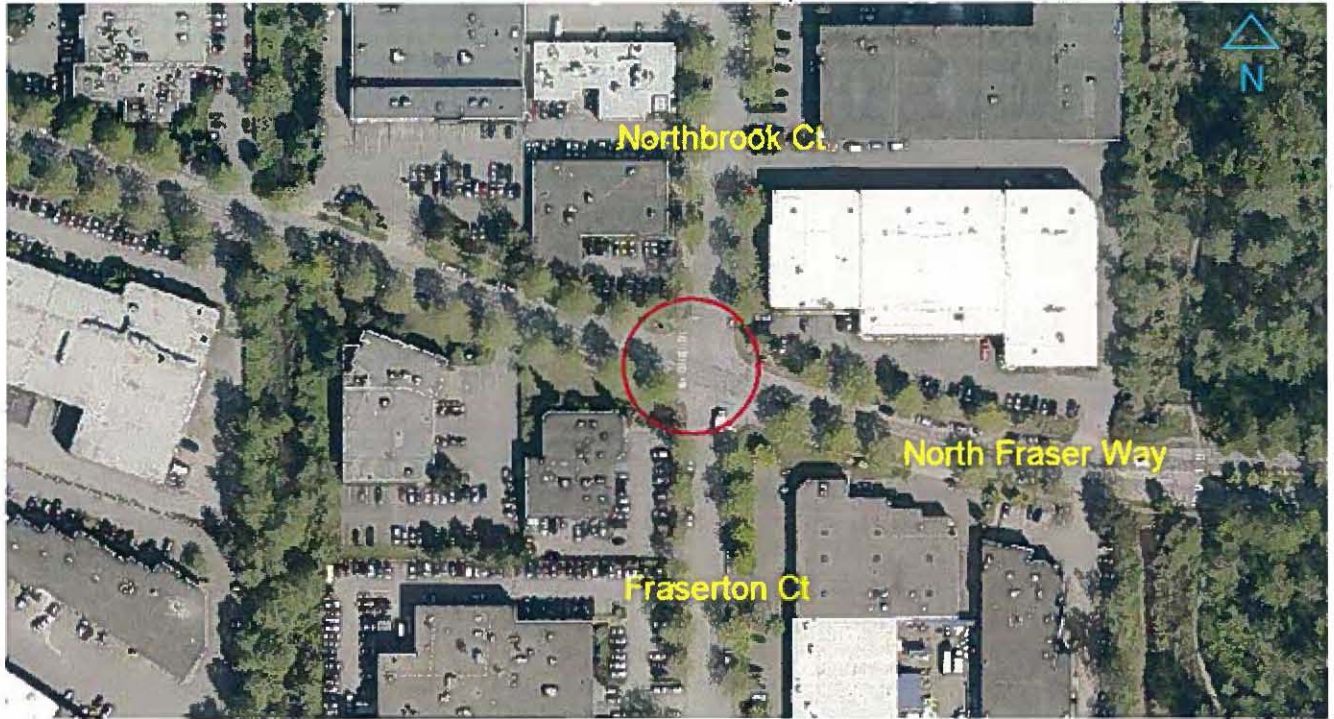
**Figure 1: Existing Crosswalk at North Fraser Way/ Fraserton Ct/ Northbrook Ct**

Figures 1 to 4 illustrate the location of these existing crosswalks. All of these crosswalks are simple marked crosswalks located at unsignalized intersections, and have zebra pavement markings and roadside signs. The two crosswalks on North Fraser Way at Fraserton Ct and at Fraserwood Ct serve employees and transit users within the industrial park. The crosswalk on Eastlake Dr at Centaurus Dr is at the entrance to Burnaby Mountain Secondary School and a multi-family residential community across the street. The fourth location on Halifax St is at Augusta Ave approximately halfway between Duthie and Phillips Ave. This crosswalk serves a large seniors' complex. All four crosswalk locations have transit bus stop on both side of the main road (i.e. North Fraser Way, Eastlake Rd, and Halifax St).

Based on a traffic engineering review upgrades are recommended at four existing marked crosswalks in Burnaby. Each of the following four crosswalks will be upgraded to special crosswalk with the addition of roadside mounted RRFBs:

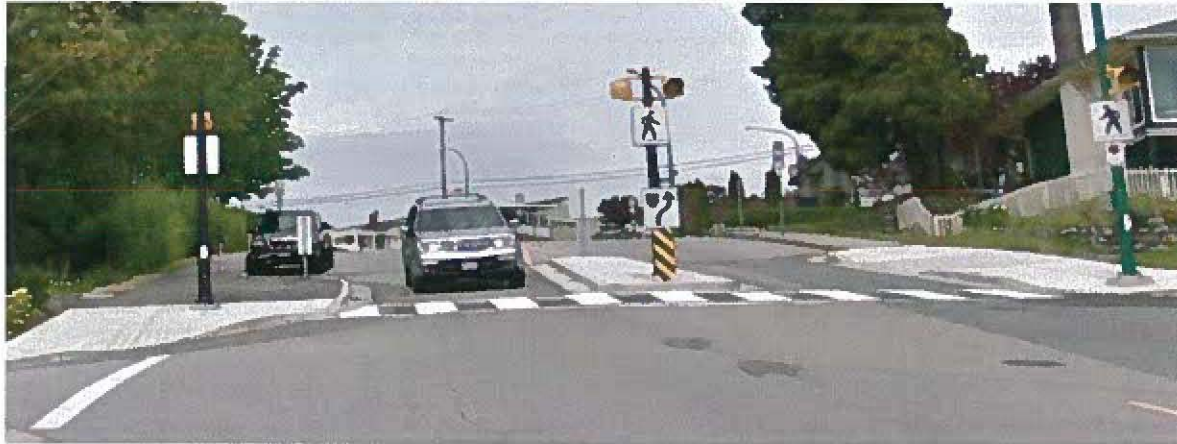
**Figure 5: Existing Roadside-mounted Special Crosswalk at Beta Ave/Brentwood Dr**

Based on the analysis, all four locations meet the minimum hourly and daily volume thresholds to justify a marked crosswalk with zebra pavement markings and roadside signs which currently exist. The warrant for a special crosswalk with overhead flashing beacons was not satisfied at this time. However, considering the wide crossing distance (11 – 14 meters) and vehicular operating speeds greater than 50 km/h, the installation of roadside flashing beacons to reinforce the existing roadside signs is justifiable. The special crosswalk with roadside flashing beacons will be similar to the special crosswalk on Beta Ave at Brentwood Mall entrance and Brentwood Dr as shown on Figure 5, but without a centre median. Another difference would be the use of Rectangular Rapid Flashing Beacons (RRFB) now approved by TAC to replace the circular beacons. The RRFB is a newer technology that provides a higher intensity light that flashes rapidly to notify drivers of crossing pedestrians. They are more cost effective compared to the overhead flashing beacons and appropriate for roads with two travel lanes with a posted speed limit of 50 km/h. The four recommended locations will be the first to use this technology in Burnaby.

The improvements will help enhance the safety of pedestrians crossing the road by making them more conspicuous to approaching motorists. The upgrades will include yellow rapidly flashing rectangular beacons, new AC power supply, new poles with support bases, and pedestrian push buttons. The cost to implement the above work is estimated to be \$120,000 and funding is available from the Annual Capital Budget for Minor Traffic Management Projects (EMF.0063). Staff will also apply for funding contributions from the ICBC's Road Improvement Program and TransLink's Transit Related Road Improvement Program.
