**PUBLIC SAFETY COMMITTEE**

**SUBJECT: REQUEST FOR TRAFFIC SIGNAL AT CARIBOO ROAD AND  
CARIBOO DRIVE**

**PURPOSE:** To assess the need for traffic control and safety improvements at the Cariboo Road /Cariboo Drive intersection.

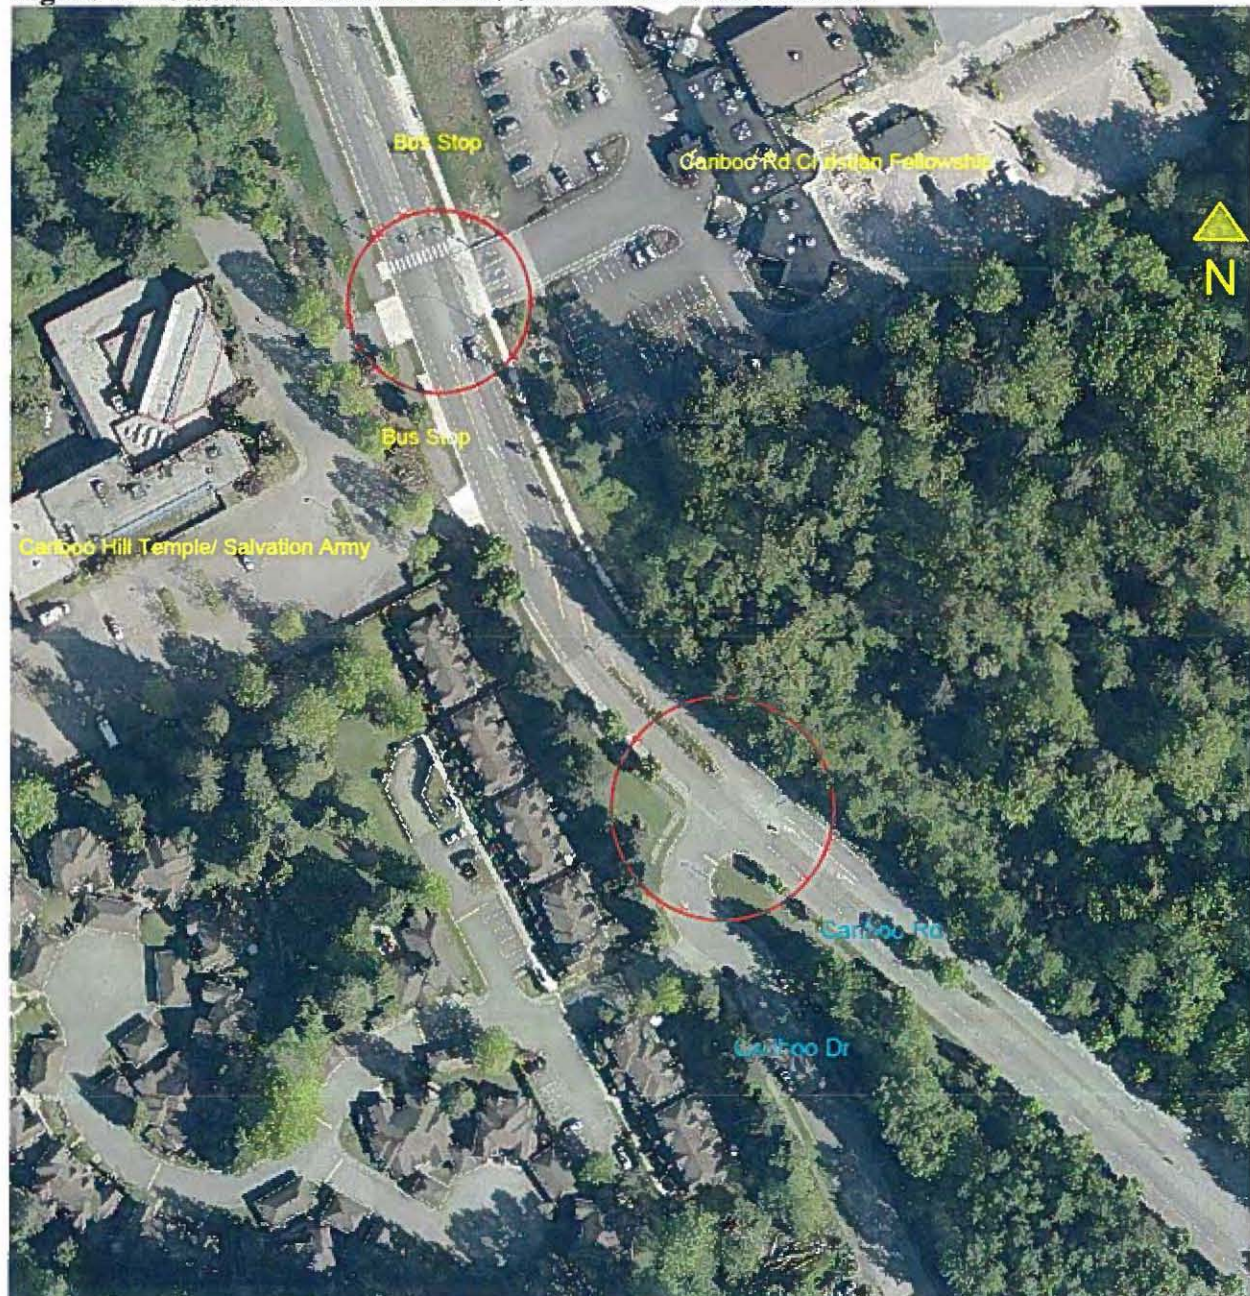
**Figure 1: Location of Cariboo Road/Cariboo Drive Intersection**

Figure 1 shows the location of the subject unsignalized 'T'-intersection of Cariboo Rd/Cariboo Dr. It is 240 metres south of the Trans-Canada Hwy overpass and 510 metres to the north of the signalized intersection of 16<sup>th</sup> Ave/Cariboo Rd. Figure 1 also shows two existing church accesses directly opposite to each other and an overhead signed crosswalk on Cariboo Rd 140 metres north of the subject 'T'-intersection. Transit bus stops are located on both sides of Cariboo Rd at the crosswalk.

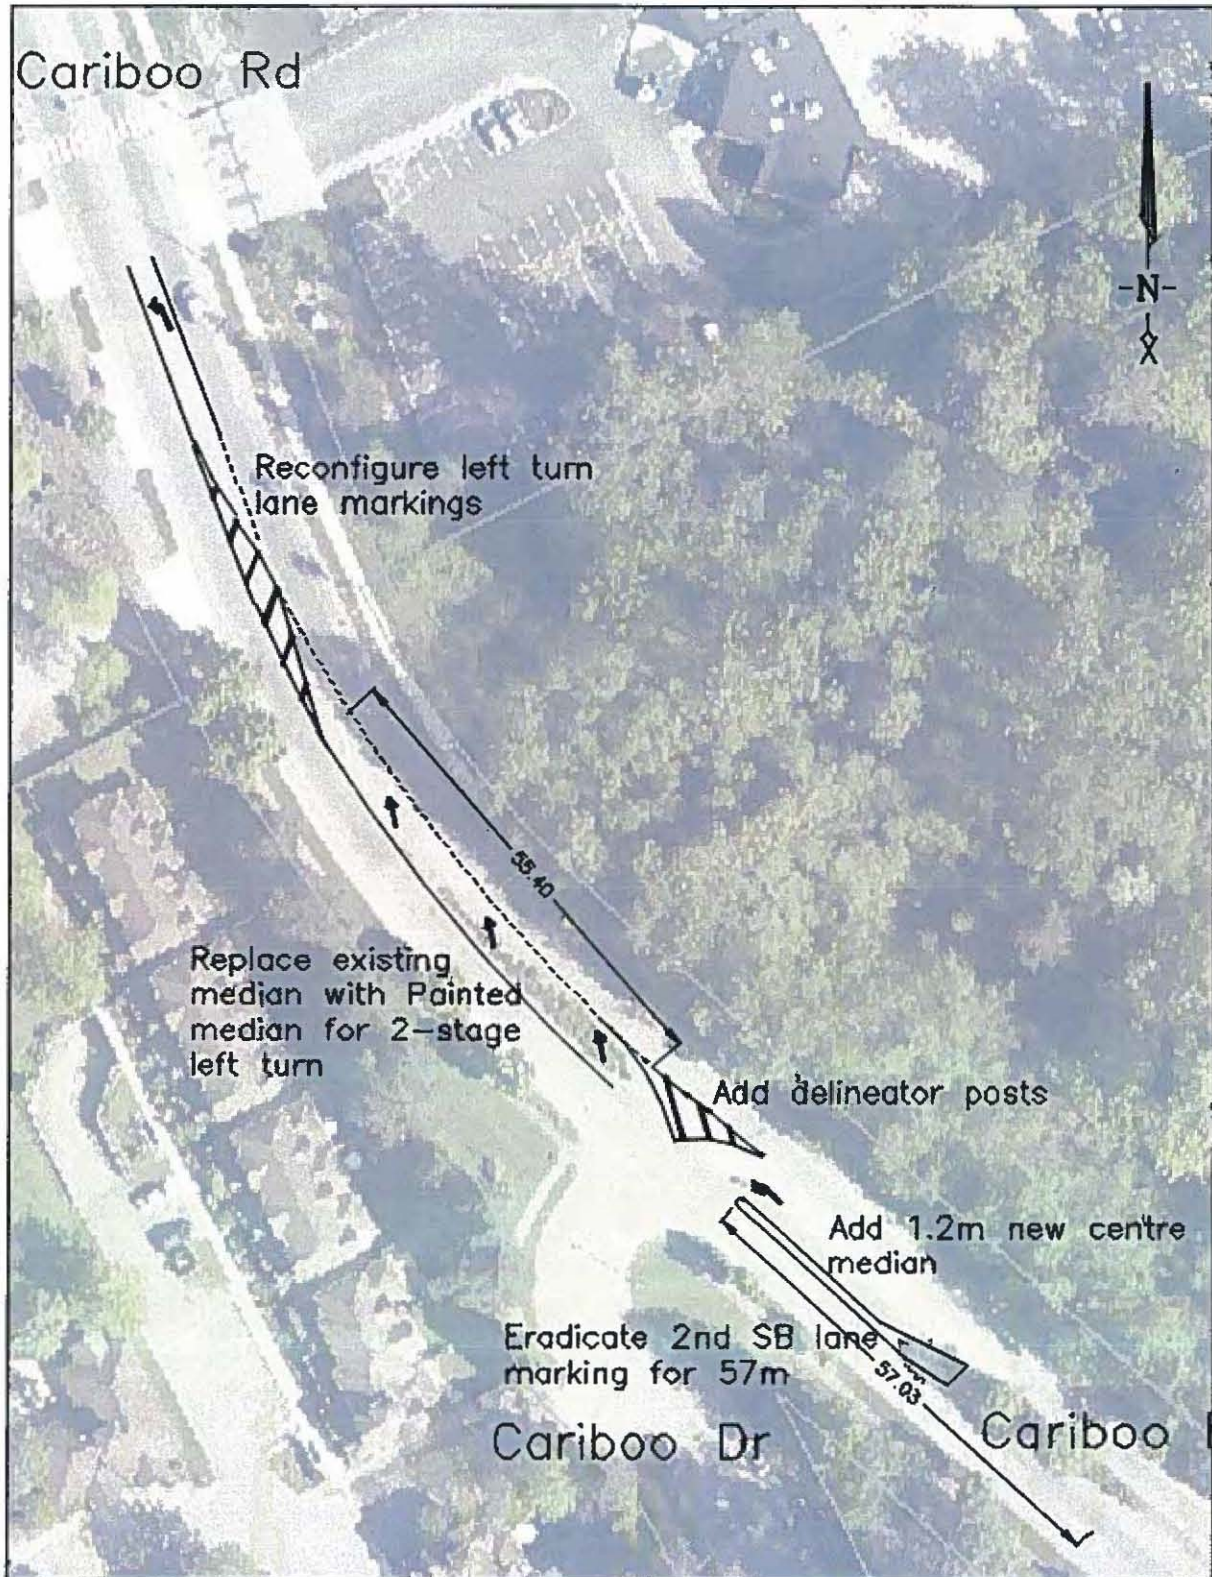
**Figure 2: Recommended Intersection Improvements**

Figure 2 shows the recommended intersection design modifications. The proposed two-stage left turn exit from Cariboo Dr should reduce delays to motorists making a left turn onto Cariboo Rd. The central merge lane allows vehicles to wait for a gap in traffic if necessary, and makes them clearly visible to northbound motorists. Delineation posts are used to guide left turning vehicles and help deter northbound vehicles from speeding. The modifications also shift the introduction of the second southbound lane further south along Cariboo Rd, thus deterring southbound motorists from speeding up the hill until well after the intersection of Cariboo Dr.

- i. The installation of a Speed Reader Board or speed feedback electronic sign in the northbound downhill direction on Cariboo Rd near Cariboo Dr to influence driver behaviour;
- ii. Speed enforcement by the RCMP as resources and priorities allow to improve speed limit compliance;
- iii. Intersection design modifications to provide a two-stage protected left turn exit from Cariboo Dr by means of a 55 metre long painted centre median / merge lane on Cariboo Rd;

The existing traffic volumes and pedestrian activity on Cariboo Dr are well below the standard warrant thresholds for a traffic signal to be installed at the Cariboo Dr/Cariboo Rd intersection. Instead, it is recommended that a two-stage protected left turn exit from Cariboo Dr be created. This along with the installation of a Speed Reader Board and speed enforcement by the RCMP as required should help to mitigate the traffic concerns at the intersection. The cost of the physical improvements is estimated to be approximately \$35,000.
