TO: CHAIR AND MEMBERS
COMMUNITY HERITAGE COMMISSION

DATE: 2020 June 10

SUBJECT: ALTA VISTA RESERVOIR VENT

PURPOSE: To seek authorization from the Community Heritage Commission to prepare a report on the Alta Vista Reservoir Vent, outlining its potential conservation and protection as a civic heritage feature.

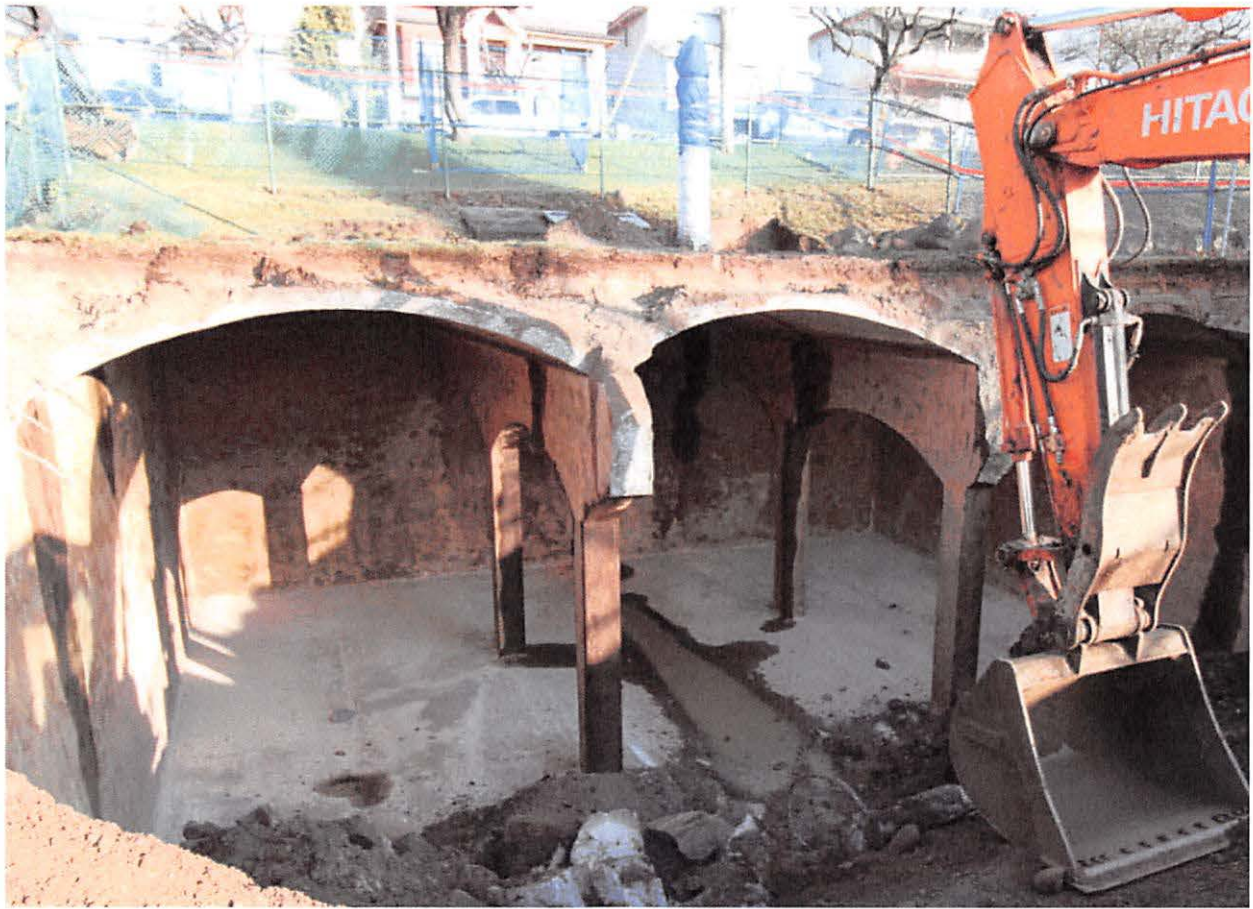
Attachment #1

Photograph of the interior of the reservoir taken during its demolition in November, 2019. The Alta Vista Reservoir Vent is visible at the top of the photograph, wrapped to protect it during removal.

The Alta Vista Reservoir was constructed from reinforced concrete, with pillars supporting an arched ceiling (*Attachment #1*). It consisted of a large central tank, with an intake chamber and outlet chamber on either end. All water entered the reservoir through the intake chamber, where a float valve system automated shut down of the flow of water into the reservoir to prevent over-filling. A large vent was constructed over the intake chamber to release air pressure.

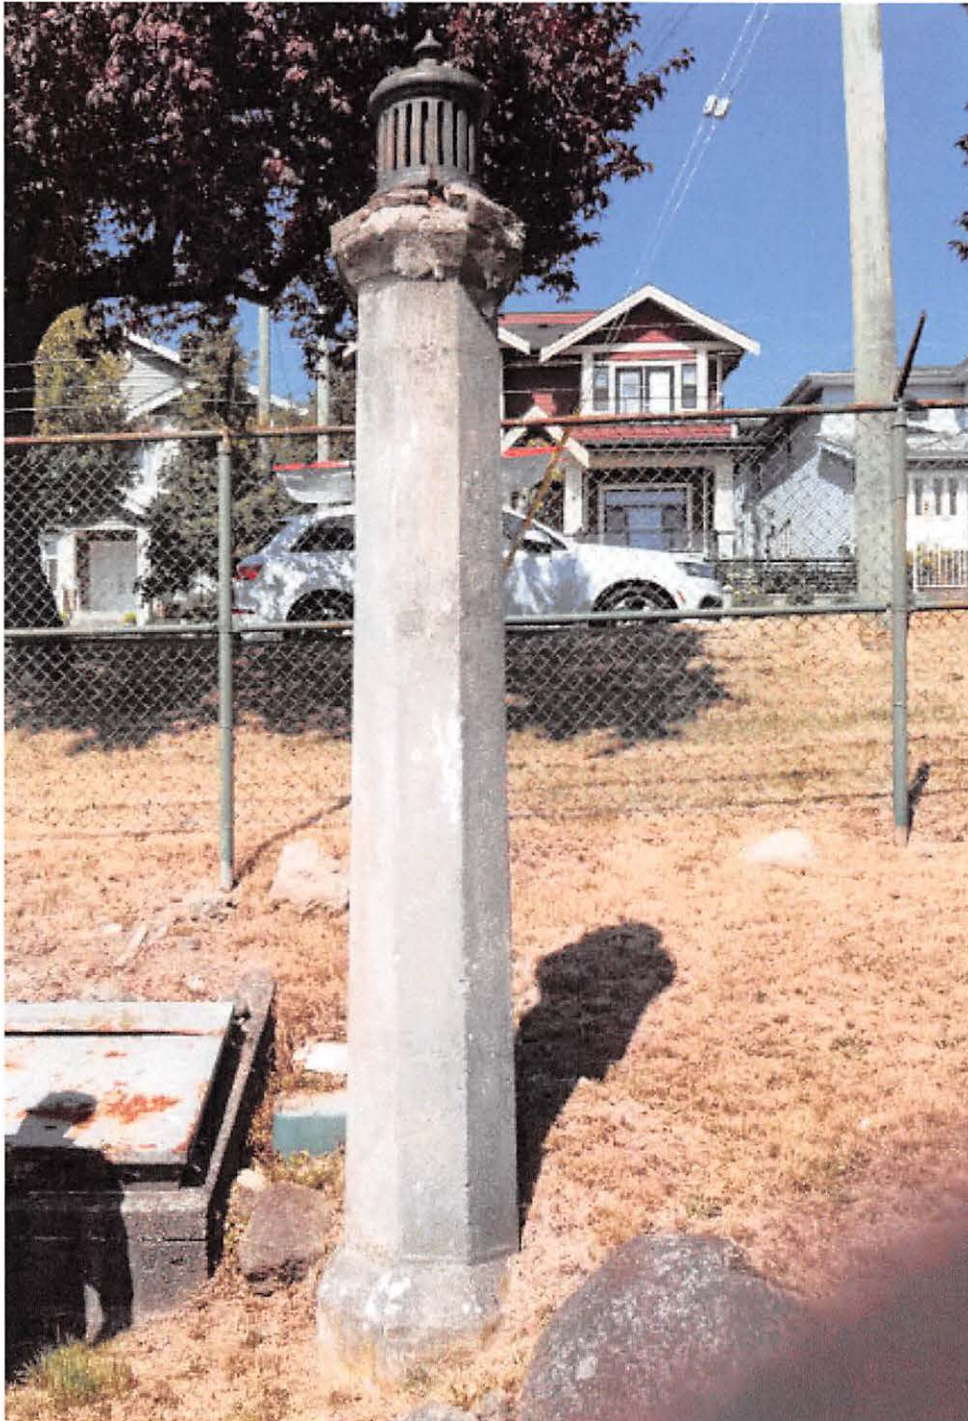
Attachment #2

The Alta Vista Reservoir Vent in its original location, prior to demolition of the reservoir.

The vent consists of a cast iron pipe inside a concrete column with a decorative cast iron grate at the top (*Attachment #2*). The contract documents for construction of the reservoir (which are in the collection of the City of Burnaby Archives) specified the purchase of the pipe and grate from the supply company Glenfield & Kennedy (*Attachment #3*). A tapered octagonal concrete column was constructed around the cast iron pipe, giving the vent a decorative quality. Standing at over 3.6 metres (12 feet) on a high point of land, the vent served as a visible reminder of the engineering works that lay beneath the ground, and was a landmark in the neighbourhood and unique feature of Alta Vista Reservoir Park (*Attachment #4*).

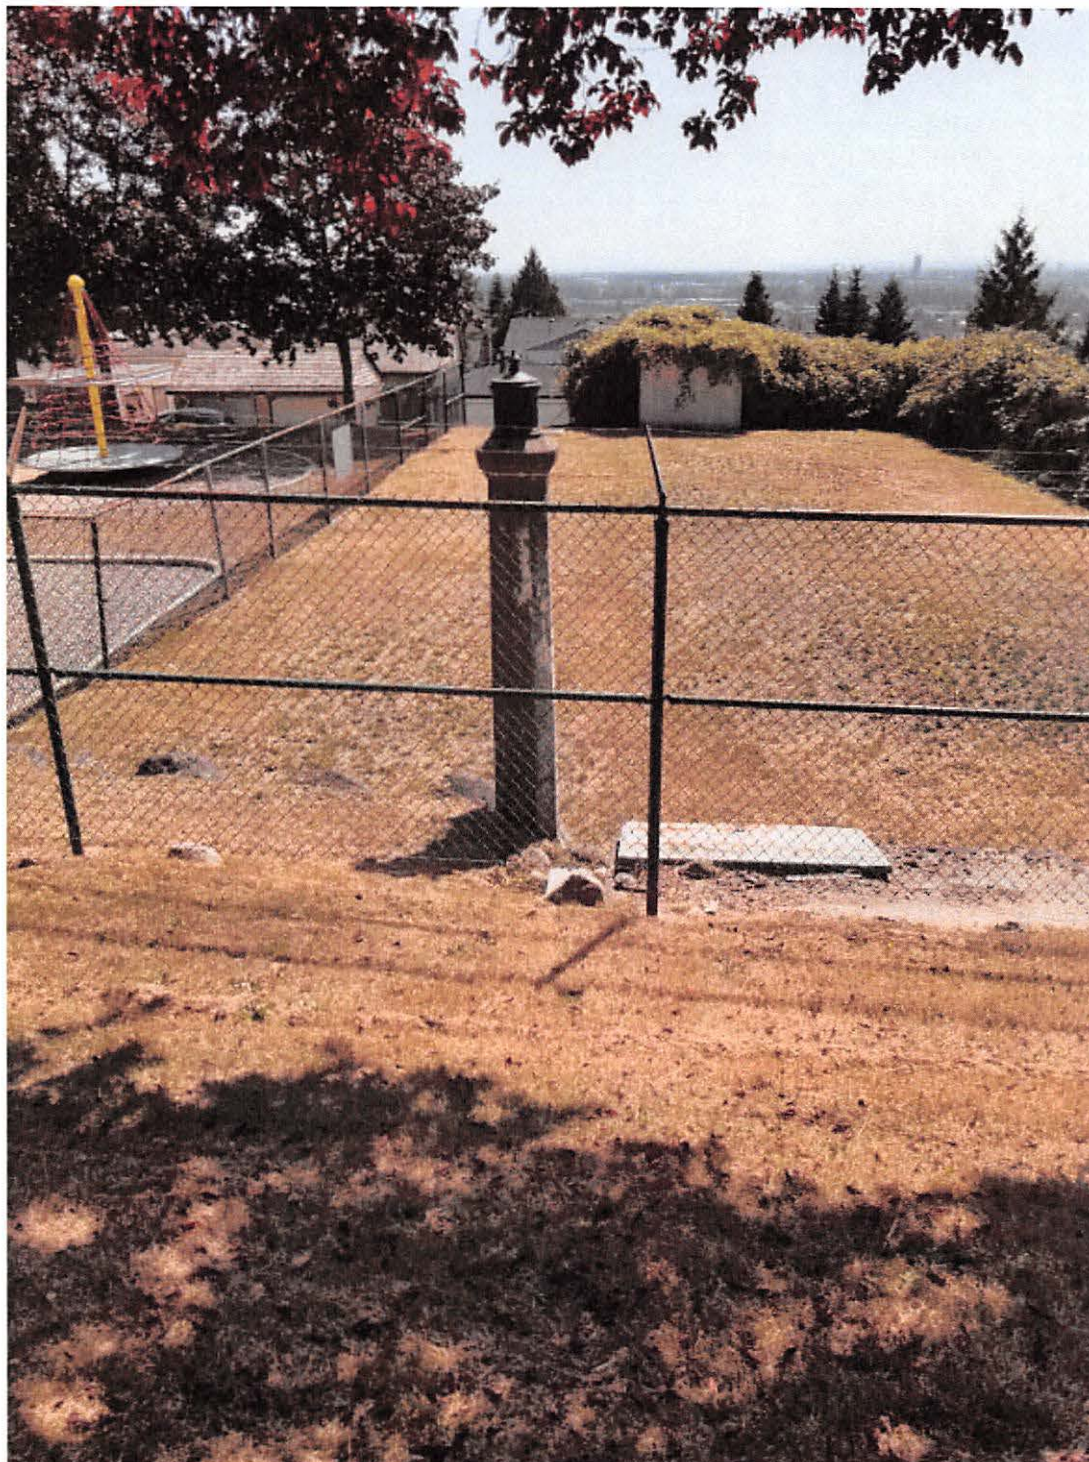
Attachment #4

The Alta Vista Reservoir Vent has been a landmark at the reservoir site since the reservoir was constructed in 1913.
