**SUBJECT: PROTECTION AND PRESERVATION OF THE ALTA VISTA
RESERVOIR VENT, 5172 MCKEE STREET**

PURPOSE: To seek Council authorization to conserve and designate the Alta Vista Reservoir Vent as a civic heritage feature.

R-05804.013
City of Burnaby Buildings |
Alta Vista Vent Condition
Assessment

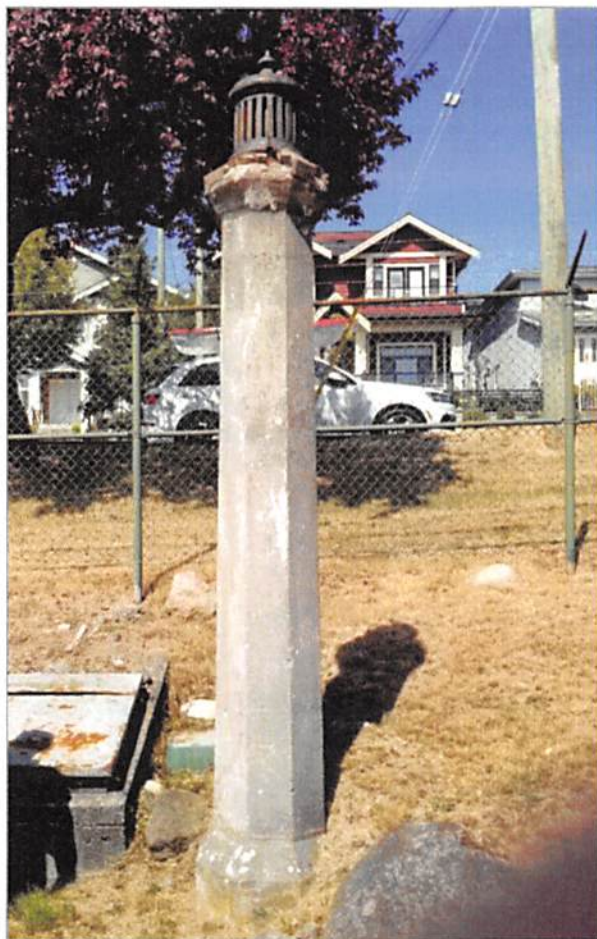
Figure 1.1

The Alta Vista vent is a concrete vent stack that was constructed as part of the Alta Vista reservoir in approximately 1913. The concrete vent stack is approximately 12' tall and tapers from a 24"± square at the base to approximately 16" at the top. The concrete vent encapsulates a 9" cast iron pipe to facilitate ventilation of the reservoir below. The top of the vent is fitted with a metal ventilator to cap the cast iron pipe.

An image of the Alta Vista vent provided by the City of Burnaby. The image was taken in approximately 2019, prior to its removal from the reservoir.

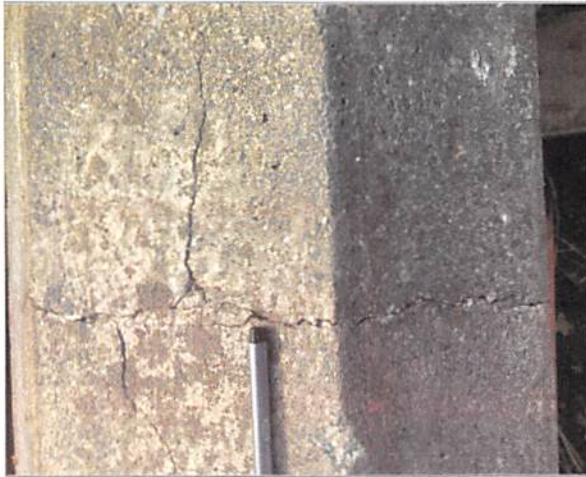
Figure 2.2

Some moderate cracking in the concrete was observed towards the top quarter of the structure. The cracking occurred radially around the perimeter of the structure, and are approximately 2mm wide. The concrete in the vicinity of the cracks is generally sound.

Localized cracking was observed near the top of the structure. While the concrete remained in sound condition adjacent to the cracking, the cracks should be addressed to prevent water ingress.

In addition to re-conditioning the exposed cast iron metal, the existing concrete requires repair in select locations. At the top of the structure adjacent to the ventilator head, the spalled and delaminated concrete should be removed to sound concrete, and prepped to receive new formed-in-place concrete. The cracking in the concrete should be addressed as part of the concrete repairs scope of work. Care will be required to ensure the new concrete is adequately bonded, and that the appearance of the new concrete best matches the existing. Given the natural porosity of concrete, a penetrating sealer should be applied to the exterior of the concrete to help improve its ability to shed water, and reduce the amount of moisture that infiltrates to the embedded reinforcing and cast iron pipe. Limiting the amount of corrosion that occurs within the concrete will help improve the longevity of the structure. It is importance to consider the vapour permeance of the concrete sealer to ensure that any incidental moisture doesn't get trapped within the concrete.
