**SUBJECT: PROTECTION AND PRESERVATION OF THE ALTA VISTA
RESERVOIR VENT, 5172 MCKEE STREET**

PURPOSE: To seek Council authorization to conserve and designate the Alta Vista Reservoir Vent as a civic heritage feature.

R-05804.013
City of Burnaby Buildings |
Alta Vista Vent Condition
Assessment

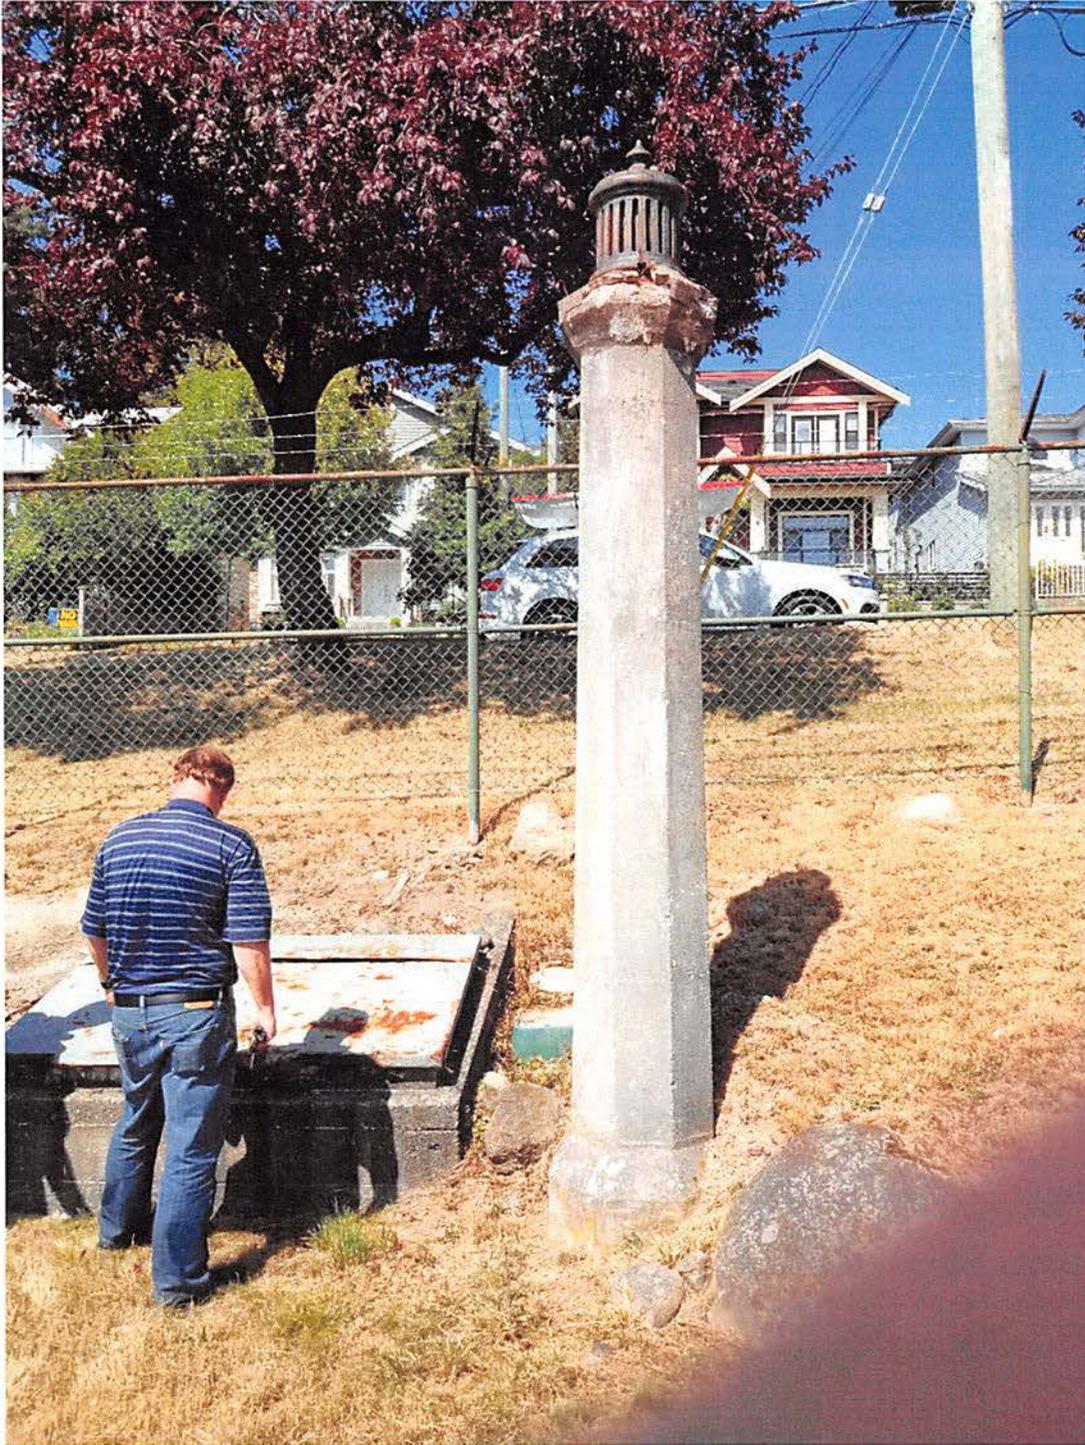
Alta Vista Reservoir Vent prior to demolition of the reservoir, 2019.

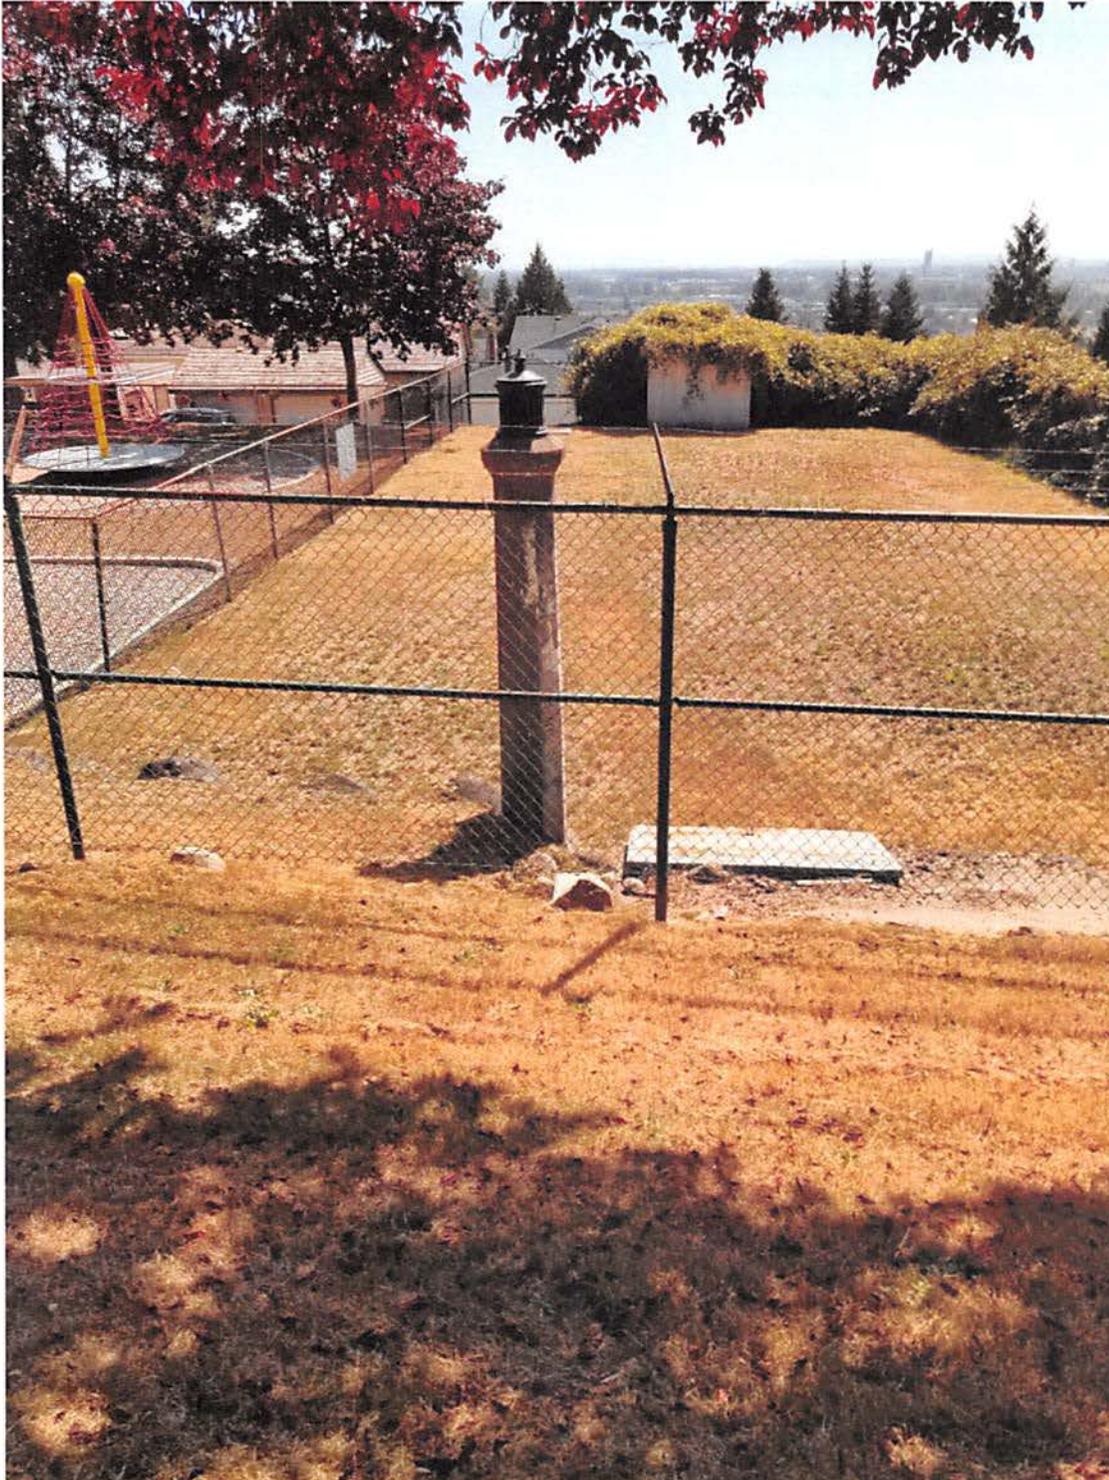
The Alta Vista Reservoir site in 2019, with the Alta Vista Reservoir vent in the foreground.

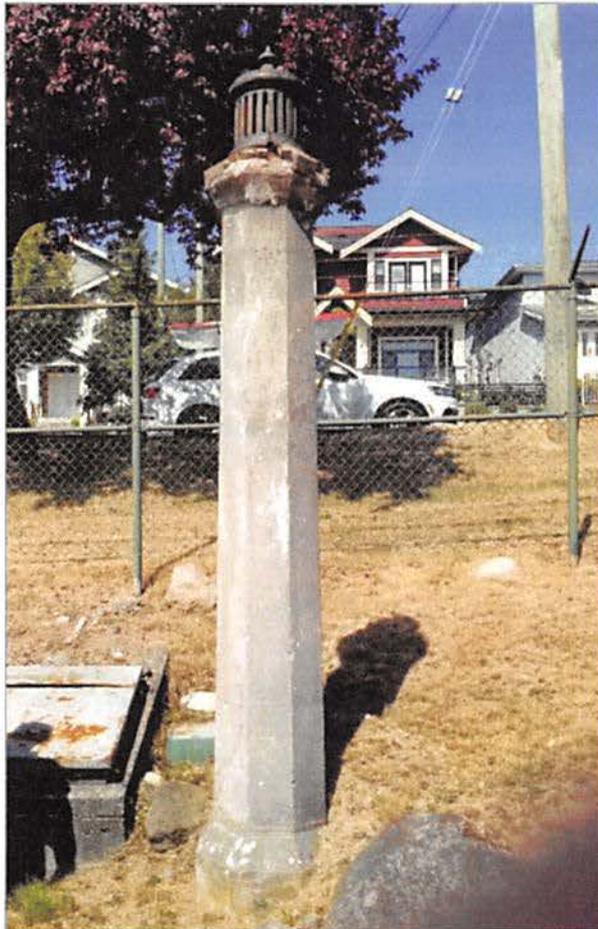
Figure 1.1

The Alta Vista vent is a concrete vent stack that was constructed as part of the Alta Vista reservoir in approximately 1913. The concrete vent stack is approximately 12' tall and tapers from a 24"± square at the base to approximately 16" at the top. The concrete vent encapsulates a 9" cast iron pipe to facilitate ventilation of the reservoir below. The top of the vent is fitted with a metal ventilator to cap the cast iron pipe.

An image of the Alta Vista vent provided by the City of Burnaby. The image was taken in approximately 2019, prior to its removal from the reservoir.

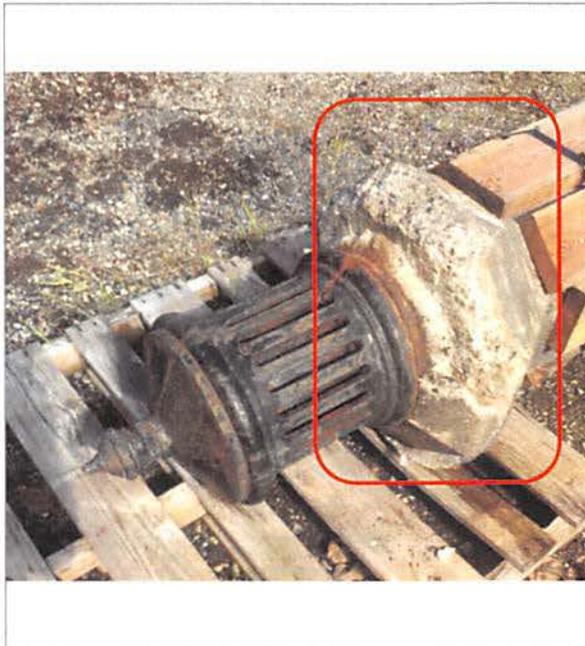
Figure 2.1

Given the age of the concrete vent, it generally appears to be in fair condition. A portion of the concrete near the cast iron vent head is delaminated, and a few pieces have spalled away. This has likely occurred due to some corrosion of the cast iron vent head, and the outward pressure the corrosion has applied on the concrete. While some corrosion of the exposed ventilator head was noted, it is in fair condition for its age. The exposed cast iron didn't show significant section loss due to the corrosion.

The concrete around the perimeter of the ventilator head is in poor condition, is delaminated and has spalled.

Corrosion of the cast iron ventilator head has contributed to deterioration of the adjacent concrete. This may be a long term concern and reducing the likelihood of additional corrosion should be prioritized. To achieve that, the existing ventilator head should be sandblasted to bare metal and painted or powder coated. If the ventilator head can be removed, the exposed underlying cast iron vent pipe should also be prepped and painted in-situ. Future maintenance of regular re-coating should be budgeted for.

In addition to re-conditioning the exposed cast iron metal, the existing concrete requires repair in select locations. At the top of the structure adjacent to the ventilator head, the spalled and delaminated concrete should be removed to sound concrete, and prepped to receive new formed-in-place concrete. The cracking in the concrete should be addressed as part of the concrete repairs scope of work. Care will be required to ensure the new concrete is adequately bonded, and that the appearance of the new concrete best matches the existing. Given the natural porosity of concrete, a penetrating sealer should be applied to the exterior of the concrete to help improve its ability to shed water, and reduce the amount of moisture that infiltrates to the embedded reinforcing and cast iron pipe. Limiting the amount of corrosion that occurs within the concrete will help improve the longevity of the structure. It is importance to consider the vapour permeance of the concrete sealer to ensure that any incidental moisture doesn't get trapped within the concrete.

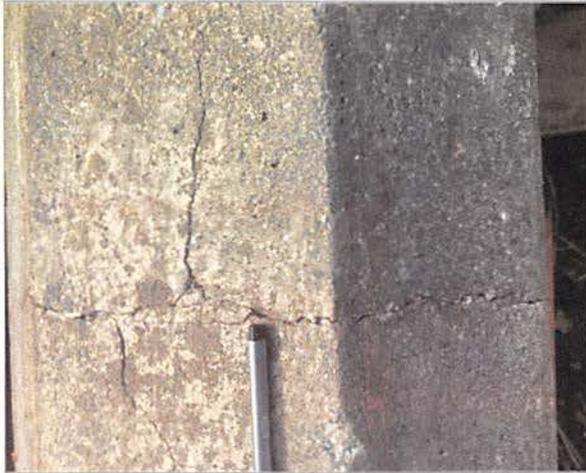
Figure 2.2

Some moderate cracking in the concrete was observed towards the top quarter of the structure. The cracking occurred radially around the perimeter of the structure, and are approximately 2mm wide. The concrete in the vicinity of the cracks is generally sound.

Localized cracking was observed near the top of the structure. While the concrete remained in sound condition adjacent to the cracking, the cracks should be addressed to prevent water ingress.

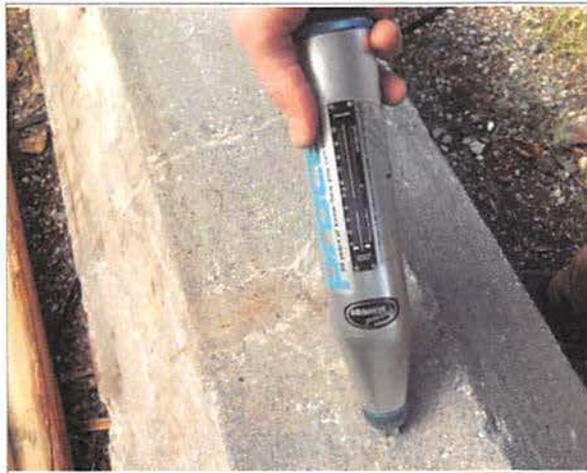
Figure 2.3

The concrete structure was sounded for delaminations using a chain-drag method and hammer sounding. Other than the delaminated concrete near the ventilator head, no other major concerns of delamination or spalled were noted. In addition to sounding, Schmidt-Hammer testing was utilized to estimate the strength of the concrete. Measurements were sampled at approximately 10 locations throughout the structure, and the resulting strength was approximately 40 MPa \pm 5 MPa. For the proposed purposes of the vent this is a sufficient concrete strength.

Concrete strength was estimated using a Proceq Schmidt-Hammer. Generally, the concrete strength was found to be approximately 40 MPa.
