**SUBJECT: PROTECTION AND PRESERVATION OF THE ALTA VISTA  
RESERVOIR VENT, 5172 MCKEE STREET**

**PURPOSE:** To seek Council authorization to conserve and designate the Alta Vista Reservoir Vent as a civic heritage feature.

**R-05804.013**  
**City of Burnaby Buildings |**  
**Alta Vista Vent Condition**  
**Assessment**

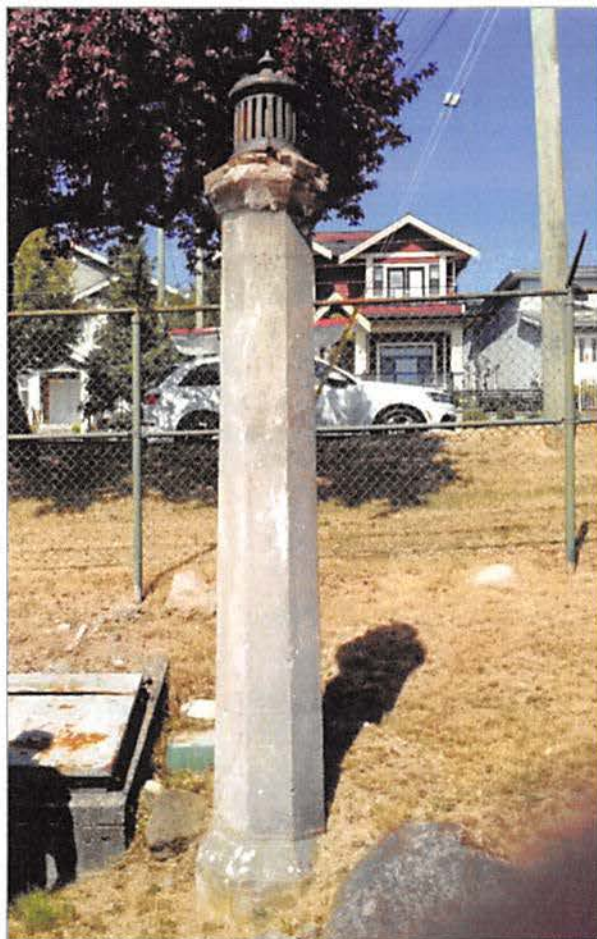
*Figure 1.1*

The Alta Vista vent is a concrete vent stack that was constructed as part of the Alta Vista reservoir in approximately 1913. The concrete vent stack is approximately 12' tall and tapers from a 24"± square at the base to approximately 16" at the top. The concrete vent encapsulates a 9" cast iron pipe to facilitate ventilation of the reservoir below. The top of the vent is fitted with a metal ventilator to cap the cast iron pipe.

*An image of the Alta Vista vent provided by the City of Burnaby. The image was taken in approximately 2019, prior to its removal from the reservoir.*

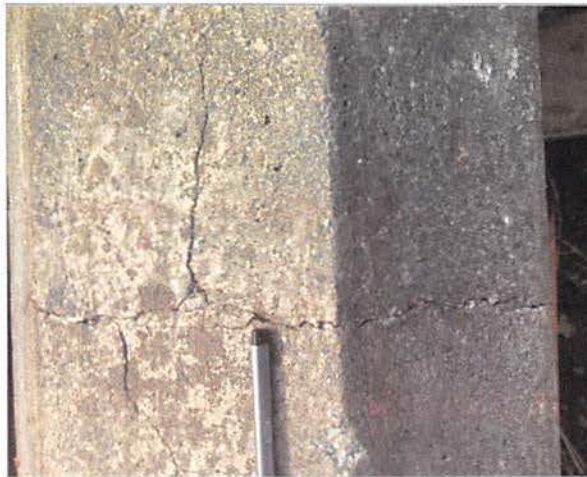
**Figure 2.2**

Some moderate cracking in the concrete was observed towards the top quarter of the structure. The cracking occurred radially around the perimeter of the structure, and are approximately 2mm wide. The concrete in the vicinity of the cracks is generally sound.

*Localized cracking was observed near the top of the structure. While the concrete remained in sound condition adjacent to the cracking, the cracks should be addressed to prevent water ingress.*

In addition to re-conditioning the exposed cast iron metal, the existing concrete requires repair in select locations. At the top of the structure adjacent to the ventilator head, the spalled and delaminated concrete should be removed to sound concrete, and prepped to receive new formed-in-place concrete. The cracking in the concrete should be addressed as part of the concrete repairs scope of work. Care will be required to ensure the new concrete is adequately bonded, and that the appearance of the new concrete best matches the existing. Given the natural porosity of concrete, a penetrating sealer should be applied to the exterior of the concrete to help improve its ability to shed water, and reduce the amount of moisture that infiltrates to the embedded reinforcing and cast iron pipe. Limiting the amount of corrosion that occurs within the concrete will help improve the longevity of the structure. It is importance to consider the vapour permeance of the concrete sealer to ensure that any incidental moisture doesn't get trapped within the concrete.
