SUBJECT: **PRESERVATION AND REPAIR OF CENOTAPHS AND HERITAGE  
LANDSCAPE FEATURES**  
(ITEM 5.2., REPORTS, COUNCIL 2021 June 28)

**SUBJECT: PRESERVATION AND REPAIR OF CENOTAPHS AND HERITAGE  
LANDSCAPE FEATURES**

**SUBJECT:** PRESERVATION AND REPAIR OF CENOTAPHS AND HERITAGE  
LANDSCAPE FEATURES

**PURPOSE:** To provide an update on work underway to preserve and maintain cenotaphs and heritage landscape features that have been identified as civic heritage resources.

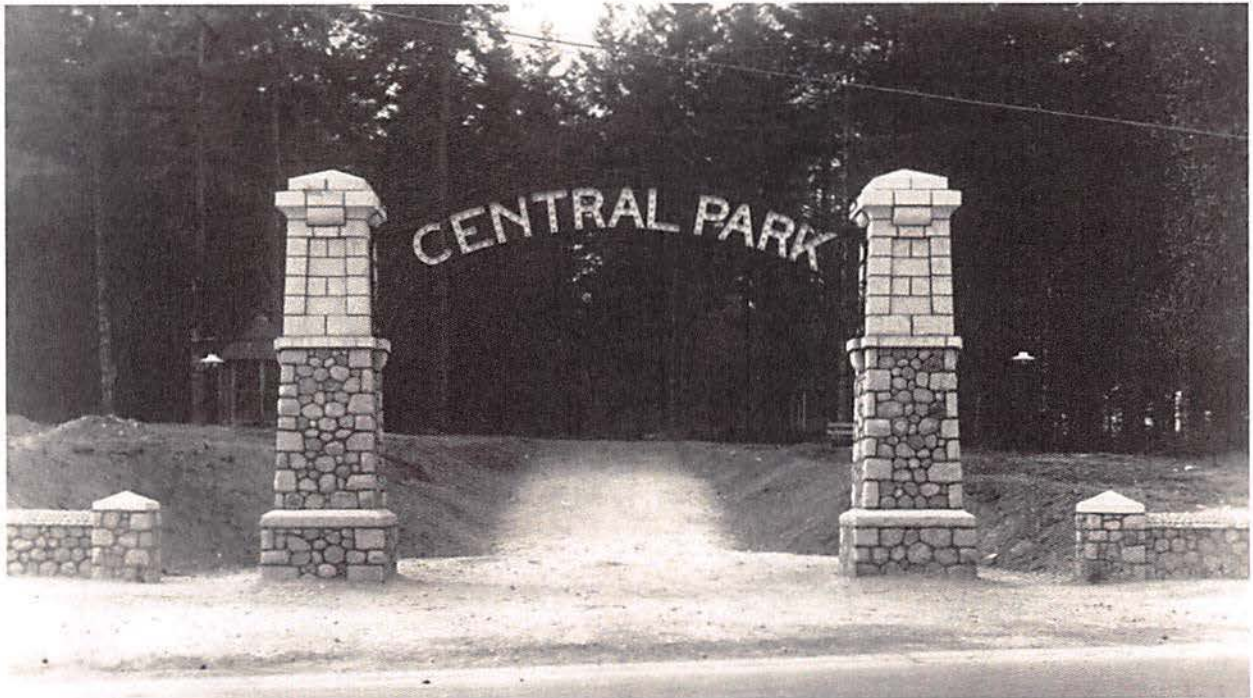
*Attachment #1*

The Central Park Entrance Gate in 1914, shortly after it was constructed. A lit sign was mounted on a wrought iron arch between the gate pillars (CBA 449-002)

The Central Park Entrance Gate was constructed in 1913 by B.C. Electric Railway in exchange for additional right of way within the park. It consists of two massive stone pillars that originally supported a decorative wrought-iron arch with a lit sign that read “Central Park” (see *Attachment #1*). The resource also includes adjacent gate posts, and a low flanking stone wall with a cobblestone cap that curves into the park to the east (see *Attachment #2*).

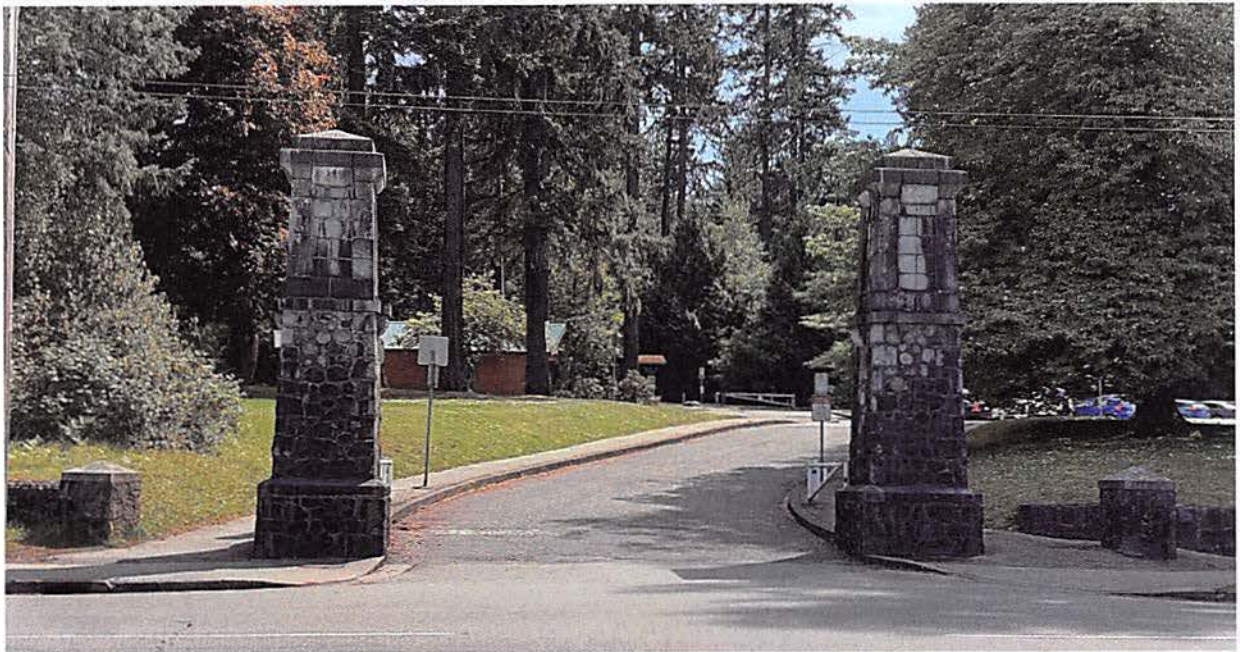
Current condition of the Central Park Entrance Gate pillars

The priority repair work identified in the Iredale Report for the gate pillars and posts includes extensive repointing of mortar joints, cleaning and application of a rust-proof finish to iron elements, and overall cleaning to remove organic material. The masonry work will be performed by a skilled heritage mason, following specifications developed by a heritage consultant.

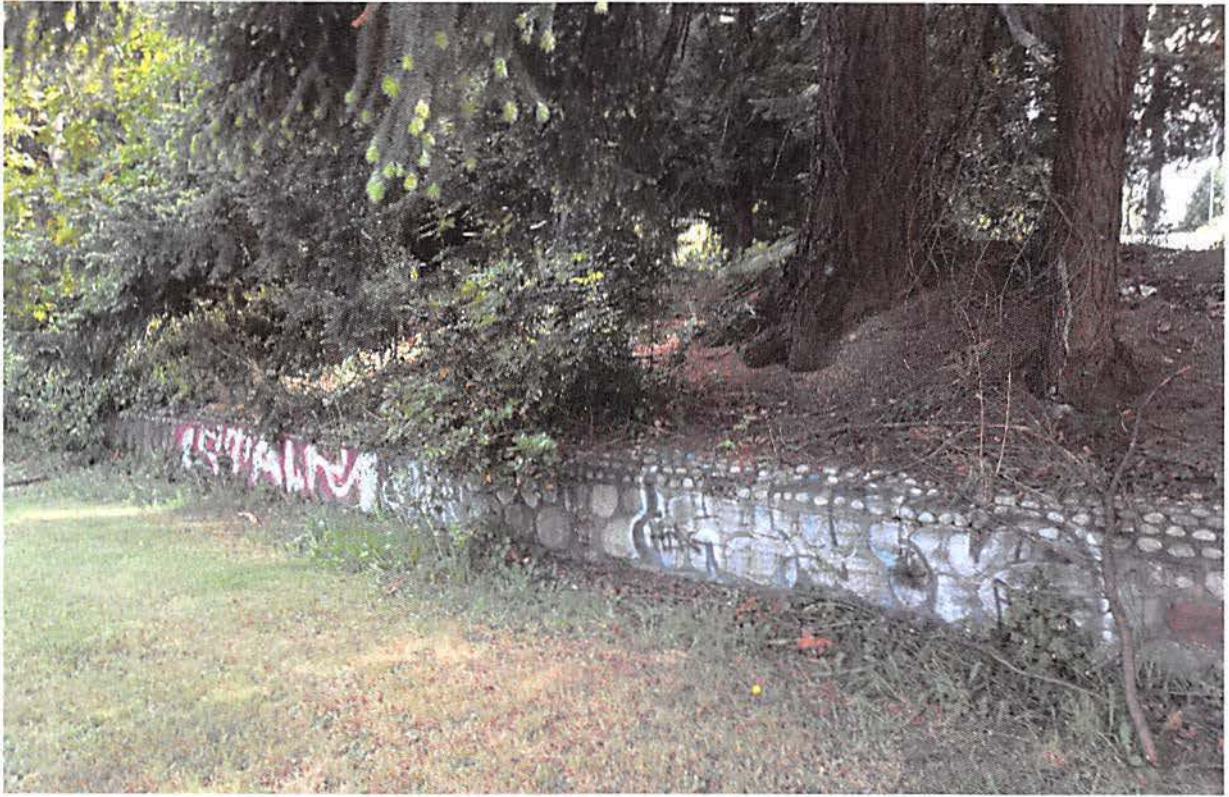
Flanking wall of the Central Park Entrance Gate feature

The flanking wall requires repointing and repair of mortar, and cleaning to remove graffiti and organic material. Significant decay was noted in the flanking wall, particularly at the south end where it makes a 90 degree turn to the east (see *Attachment #3*). The 90 degree turn marks the site of the original B.C. Electric Railway interurban station on the west side of the tracks.

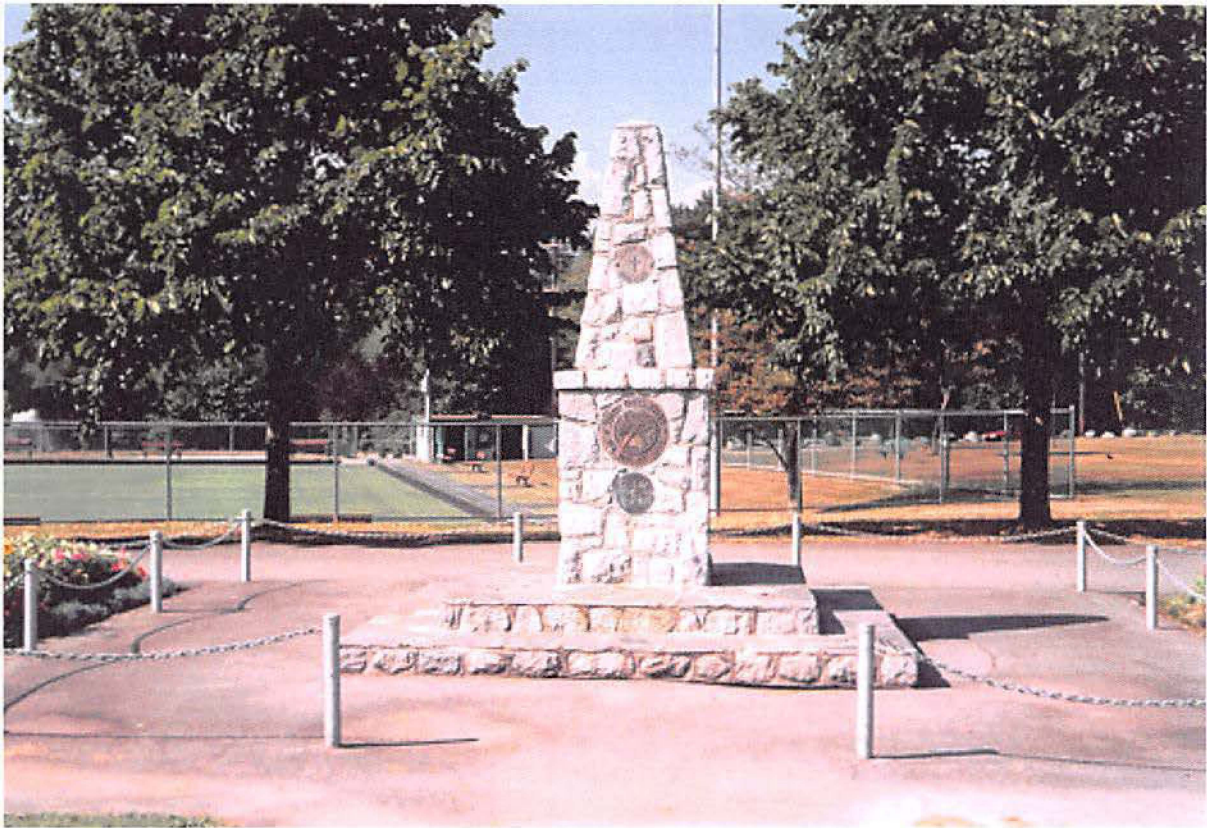
The North Burnaby Cenotaph

The North Burnaby Cenotaph was constructed in 1953 and is a protected heritage resource designated by Bylaw 9807 in 1992. The priority work identified for this resource is repointing of its mortar joints. The report also noted the original granite steps of the monument have been covered in slate (see *Attachment #3*). While the slate is stable and in good condition, future consideration could be given to removing the slate to restore the original condition of the monument.

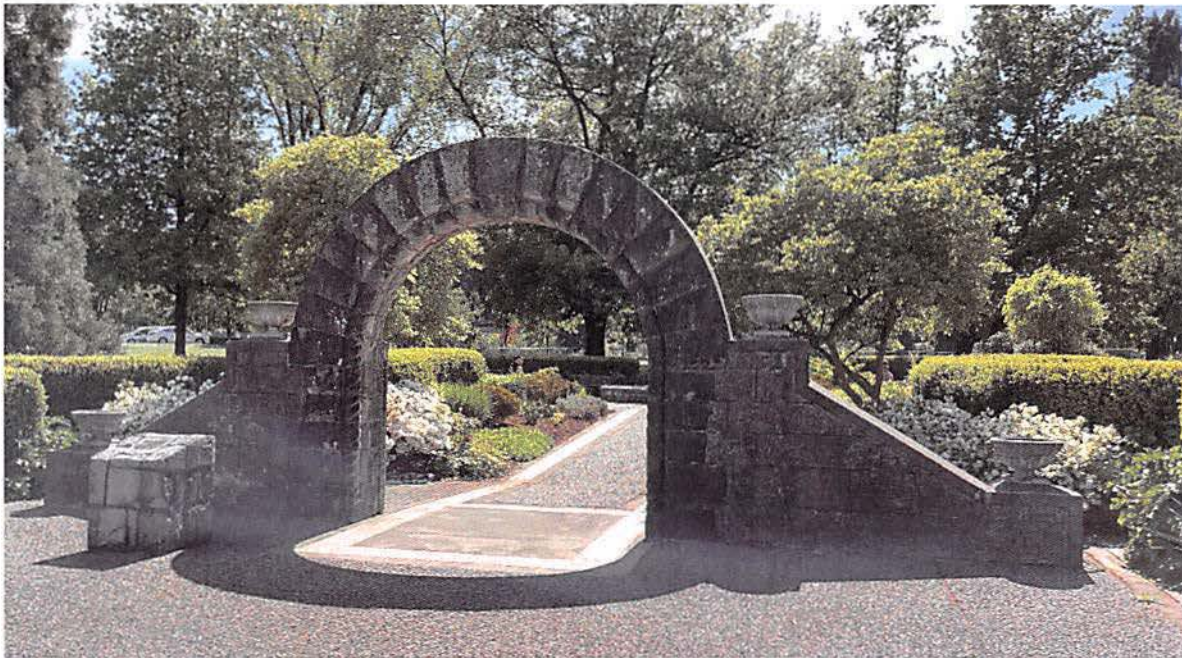
*Attachment #4*

As part of regular review and maintenance, staff observed fractures and cracks in the arch feature and deterioration of the mortar. As a result, heritage consultant team McGinn Engineering & Preservation was retained to review the resource and provide costing and specifications for repair. Required repairs include:

The Jubilee Grove Arch

- **Structural stabilization of the arch feature:** rods will be inserted above the side piers of the arch structure and strength will be added to the inside soffit of the arch to increase stability.
- **Repointing the arch and flanking walls:** the mortar joints will be refilled to protect the resource from water ingress.
- **Repair and cleaning of the stone and masonry:** areas where there has been loss of sandstone will be patched, and the entire structure will be cleaned, including the granite flanking walls and the plaza and fountain area.

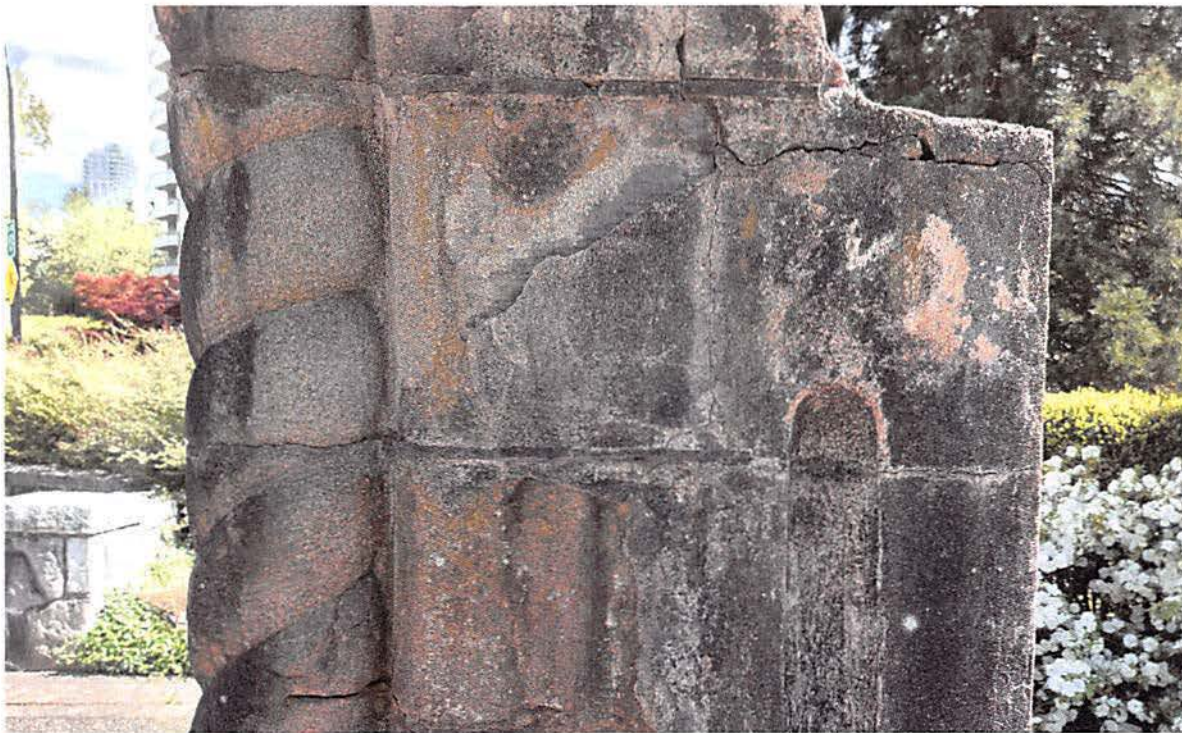
Detail image of area to be repaired through repointing of masonry and stabilization to prevent fractures

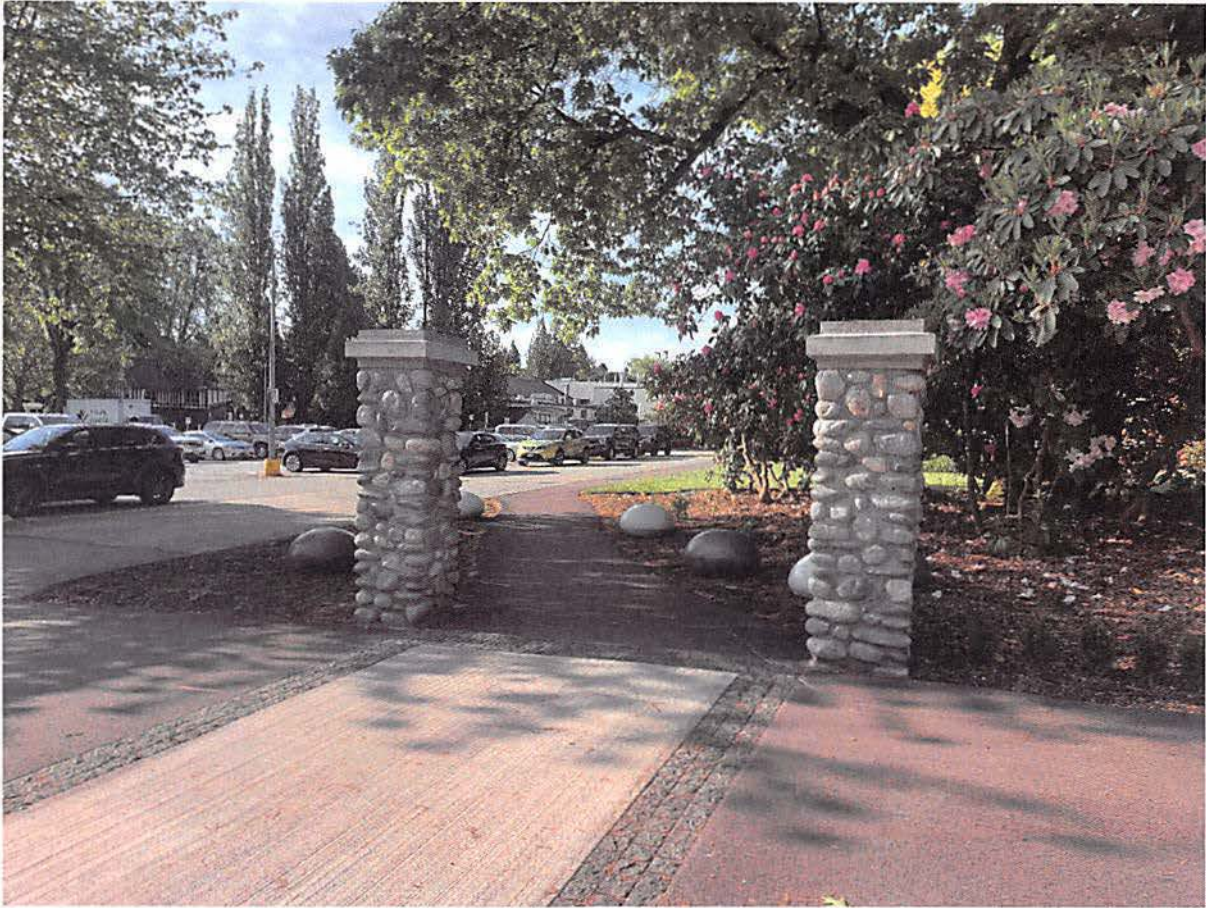
Replica gate pillars adjacent to the driveway to the Shadbolt Centre surface parking lot

Recent paving and urban trail upgrades to Deer Lake Avenue included installation of replica Estate Gate pillars at the location of the eastern end of the original driveway entry to the Fairacres Estate (see *Attachment #5*) and re-grading of the area adjacent to the surviving gate pillar at the original location of the western entrance to the driveway to the Fairacres Estate (see *Attachment #6*). The re-grading at this location eliminated a step, making this pathway an accessible pedestrian entry to the estate grounds. A new entry path was poured in asphalt as a temporary condition, to enable future upgrades to the path and associated landscaping in conjunction with conservation of the Fairacres Estate Gate.

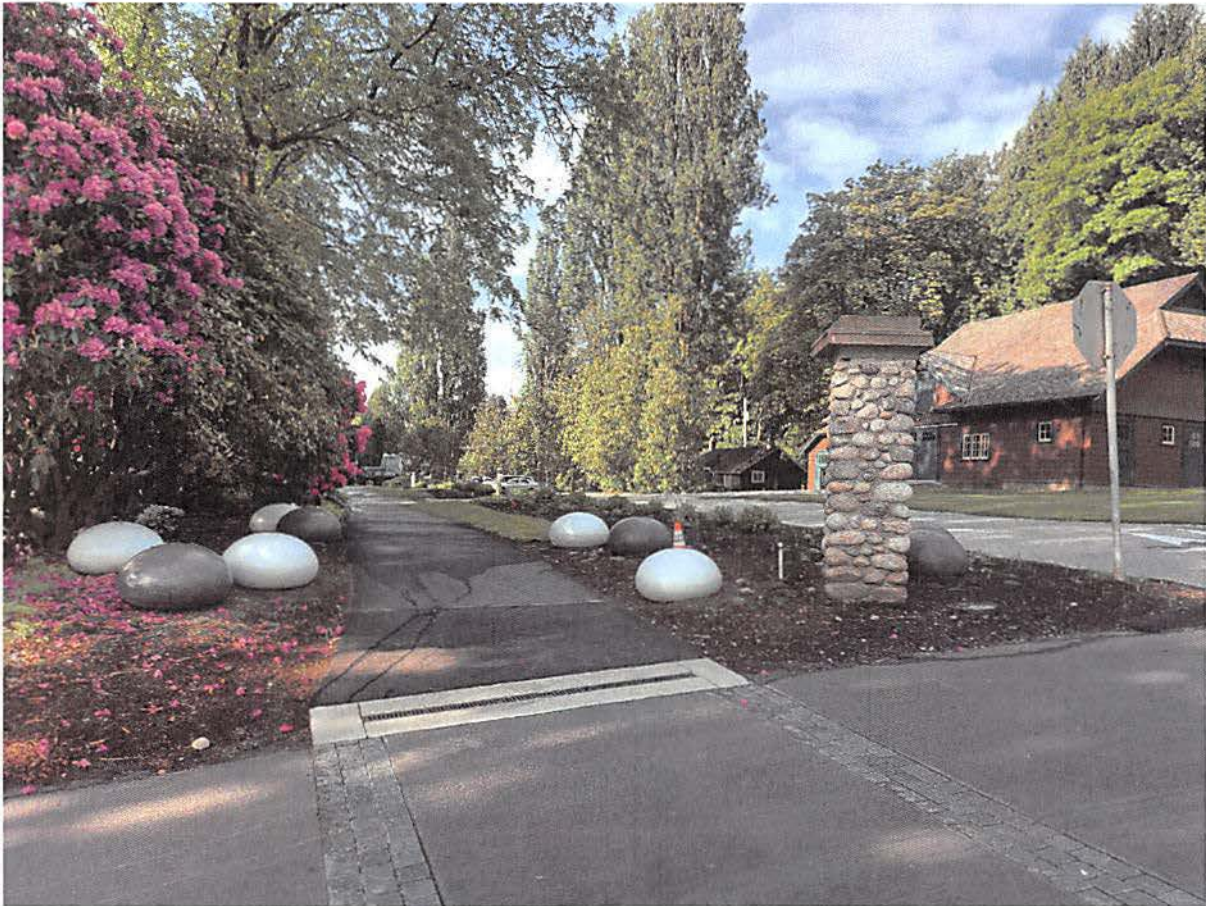
***Attachment #6***

Extant gate post adjacent to the entry driveway to the Burnaby Art Gallery parking lot

Further conservation and interpretation planning for the Fairacres Estate and its heritage landscape features will include development of a conservation plan to restore the original entry gate at the western end of the original driveway, including reconstruction of the missing gate pillar and replacement of the asphalt path at the gate with materials more compatible with the historical

context. The conservation plan will also recommend interventions to repair and conserve the extant gate pillar, and to stabilize and repair the Greenhouse Foundation Wall.

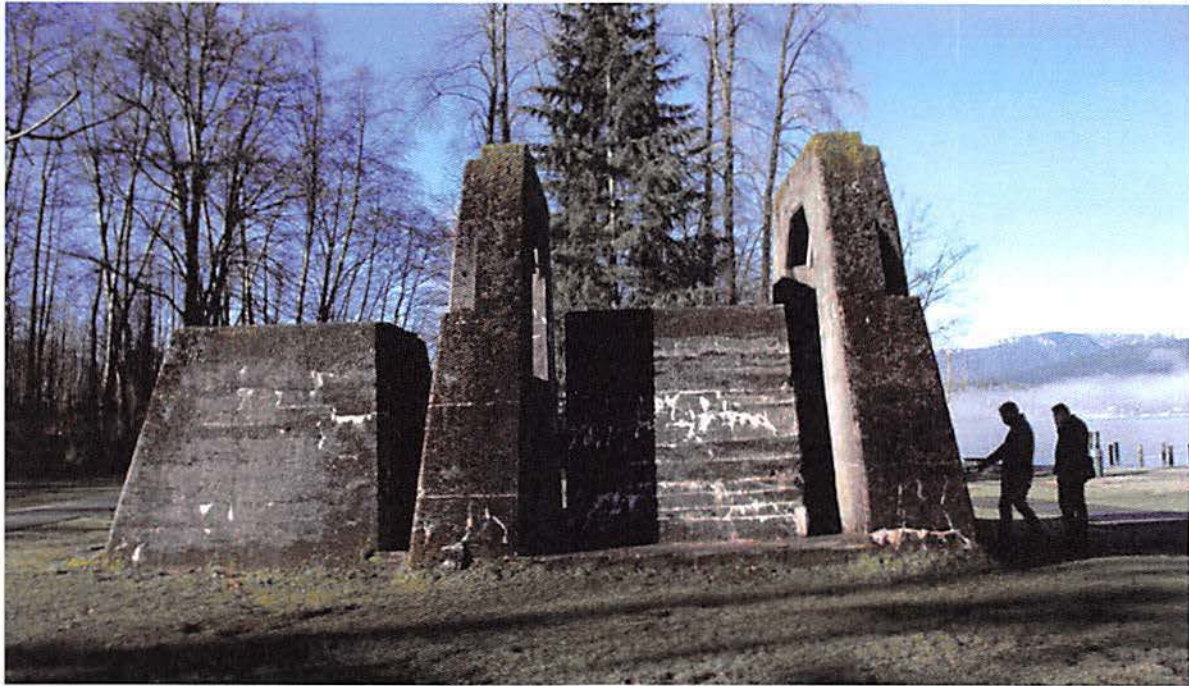
*Attachment #7*

Engine stand base from the North Pacific Lumber Mill at Barnet Marine Park.

The condition of the North Pacific Lumber Company ruins at Barnet Marine Park were reviewed by Iredale, including the engine stand and the base of the sawmill burner (see *Attachment #7*). These resources are on the City's heritage inventory, but a commitment to their long term preservation has not been made through a heritage designation bylaw.

A heritage consultant will be retained in Phase III to guide the City in a process to consider the future retention, interpretation, and use of these resources, including identifying conservation works required for their retention. Recommendations from the study will be advanced to Council upon recommendation of the Community Heritage Commission. Conservation work supported by Council and included in the 5-Year Financial Plan would form Phase IV of the project.

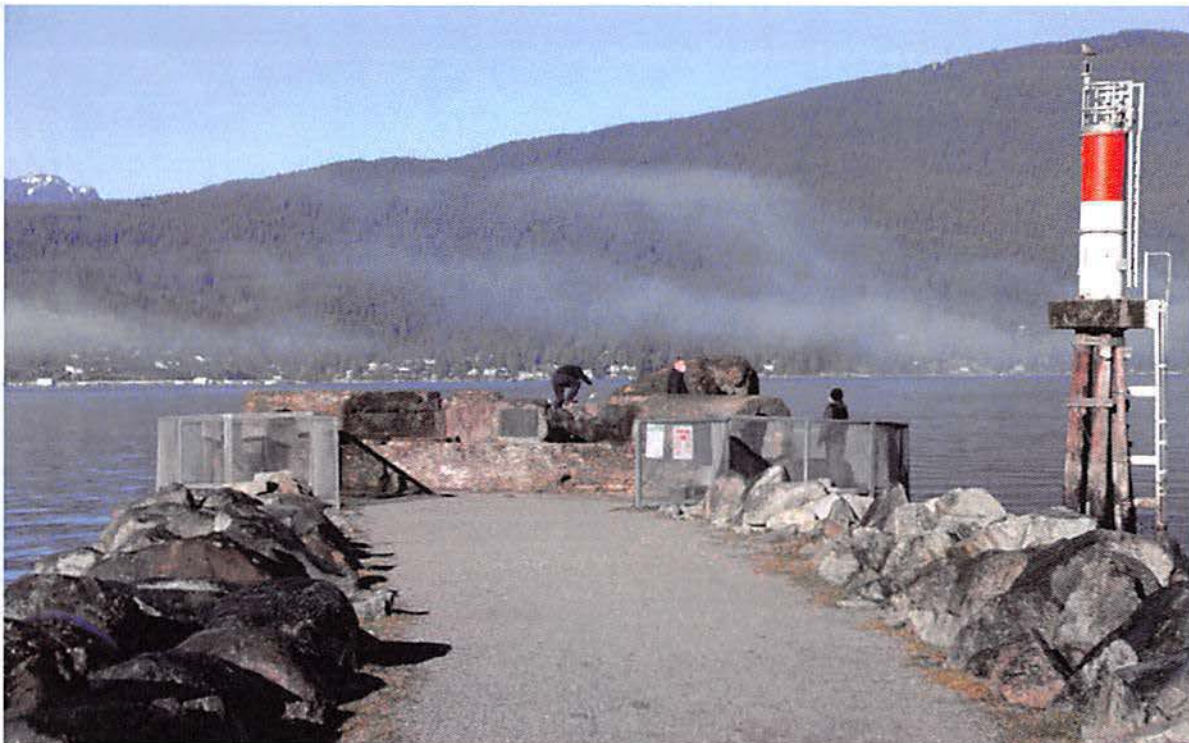
Remains of the sawmill burner from the North Pacific Lumber Mill at Barnet Marine Park
