**Heritage Conservation Plan  
Arthur Long Residence  
7828 Stanley Street  
Burnaby, BC**

**May 2021  
Updated January 2023**

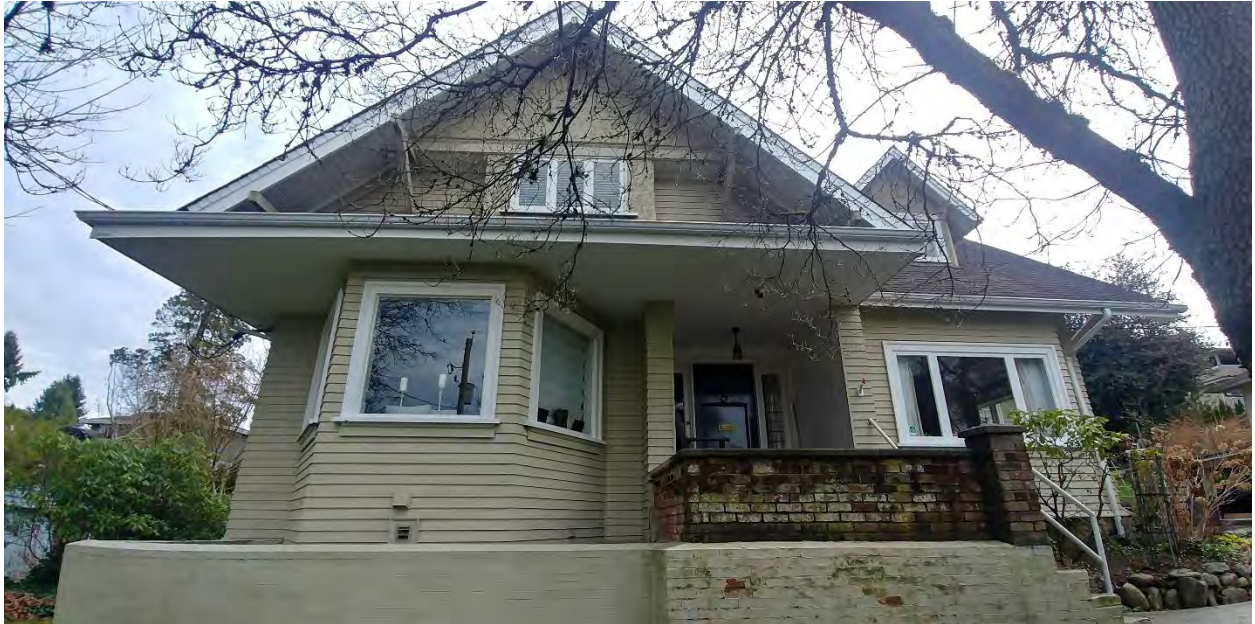
*North (front) elevation*

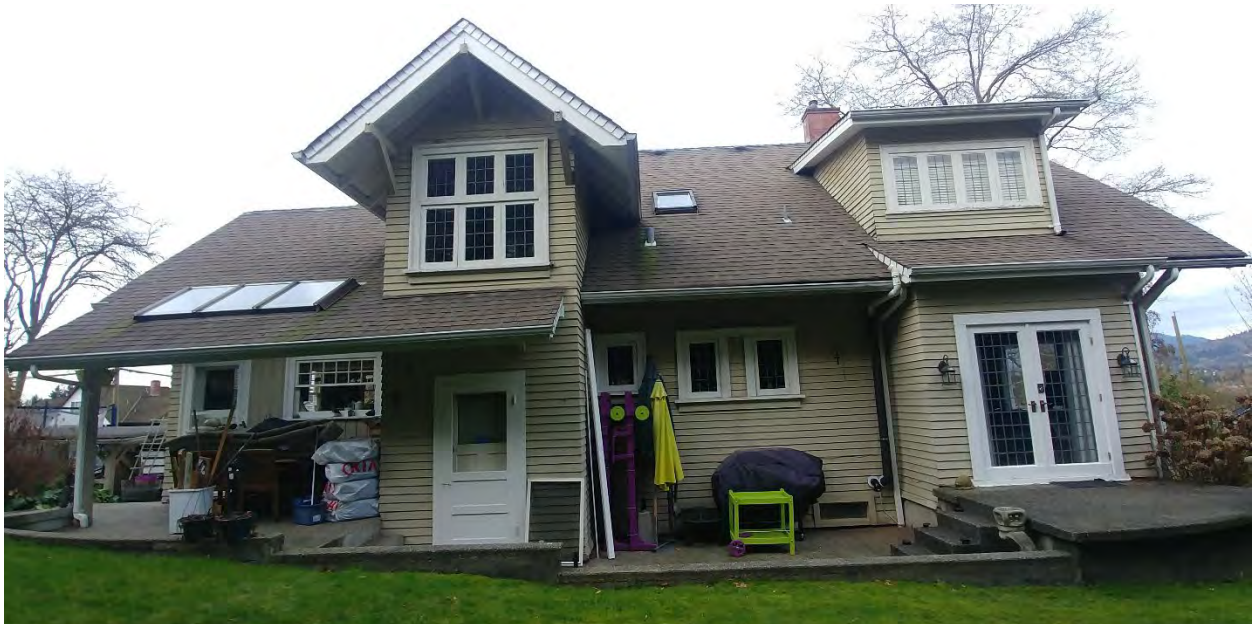
*South (rear) elevation*

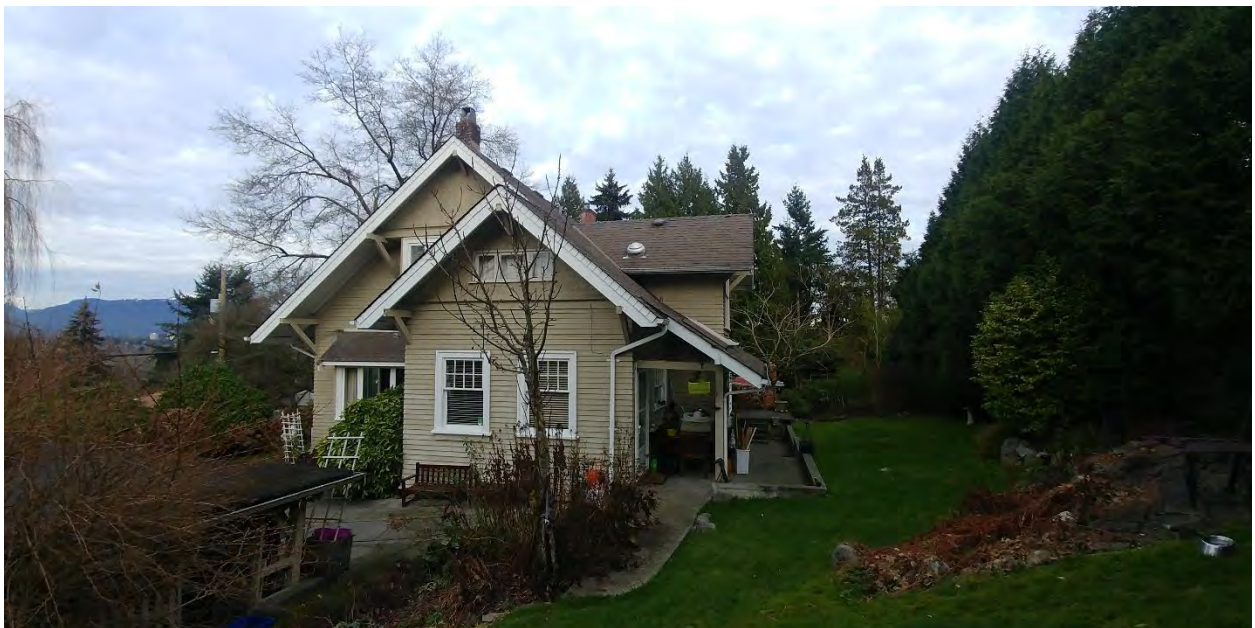
*West elevation*

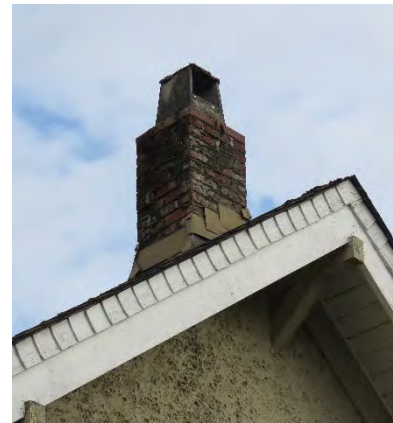
The chimney on the east side of the house is a rectangular shape, is comprised of brick in a Flemish garden wall bond style, and has a corbelled chimney cap, as well as a vent. The chimney on the west side of the house is square and comprised of brick in a running bond pattern and is topped with a square chimney pot.

*Chimney on west side of the house.*

The chimneys appear to be in good condition but should be inspected at some point by a qualified mason who can assess the condition of the overall chimneys as well as individual components such as the bricks, grout, flashing, and whether or not there is any moss growth. The chimney on the west side

Any repointing that is needed for the chimneys should match the current in terms of colour, width and consistency. Any new bricks should be of a matching size and colour to the existing. If the flashing needs replacement, ensure that there is a counterflashing. Any moss growth on the chimney should be carefully removed, and if needed, the bricks can be cleaned using a natural bristle brush and a mild rinse detergent. Do not power wash, sand blast or use abrasive cleaning methods.

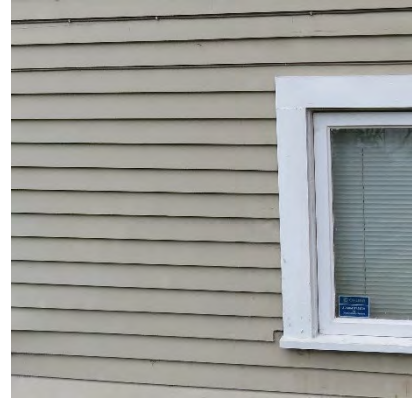
The side elevations are clad in what appears to be the original clapboard siding with a 4-inch profile and should be retained. The siding is in good condition.

If individual boards become damaged or fail in some way over time, it may be possible to repair or replace just those individual boards. Upon removal, special attention should be given to the condition of the material underneath to determine if there is any water damage or other damage to the underlying material which explains why the board(s) failed. The situation should then be corrected. Any replacement pieces should match the existing in terms of design, size, profile and material. The goal is to avoid the appearance of patching.

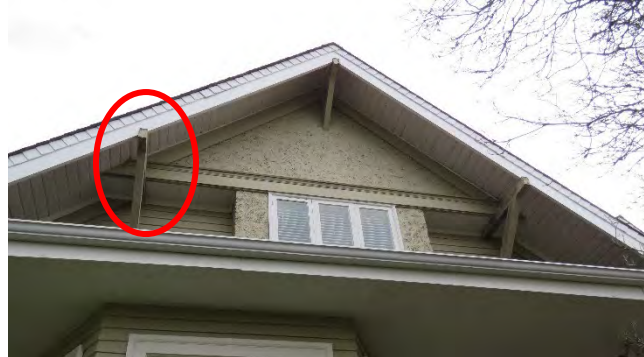
The triangular wooden brackets in the gable ends on all four elevations, that give the appearance of supporting the eaves, look to be in good condition, but a close-up inspection at some point would be a good idea to accurately determine their condition.

If individual brackets are found to be damaged, first try to repair them. If they cannot be repaired, then they should be replaced with replicas that match the existing in terms of design, size, profile and material. The goal is to avoid the appearance of patching.

As with other original material that needs replacing, look at the condition of the material underneath to determine if there is any reason (water damage, for ex.) which explains the damage. Correct the underlying situation before installing the new brackets.

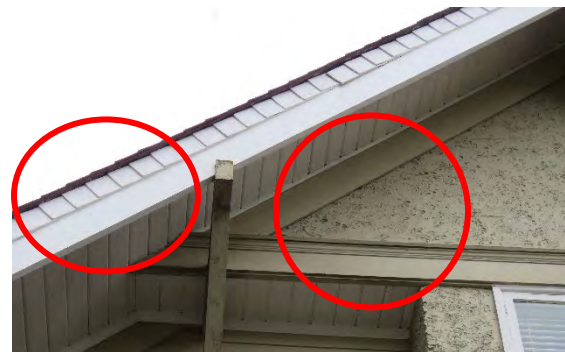
The crown moldings and friezes are simple additions to the elevations that provide a quiet yet effective level of decoration and are in keeping with the intention of the Arts & Crafts style.

They appear to be in good condition, but a close-up inspection at some point would be a good idea to accurately determine their condition. As with the brackets and other original material, any elements that are damaged should first be repaired. If they cannot be repaired, then they should be replaced with replicas that match the existing in terms of design, size, profile and material. The goal is to avoid the appearance of patching.

As with other original material that needs replacing, look at the condition of the material underneath to determine if there is any reason (water damage, for ex.) which explains the damage. Correct the underlying situation before installing the new elements.

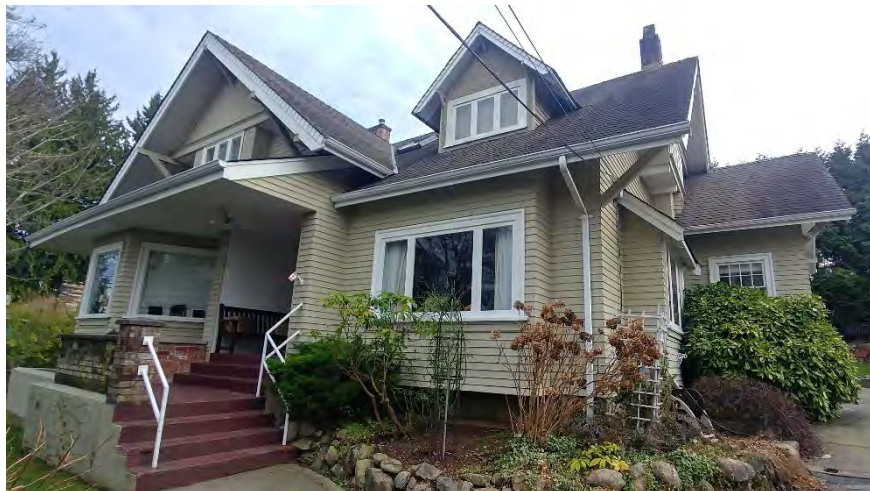
The front elevation has the following types of windows:

- a large, triple sash picture window to the right of the front door
- three single, fixed windows on a three-sided projecting bay to the left of the front door
- a small, triple sash window in a small bump-out in the gable end
- a small, triple sash window in the dormer located on the western side of the front elevation
- a small, single window with a multi-pane upper sash on the large bump-out to the west side of the house

Ideally the location, size, and design of all the historic windows on the house would be retained as they are an important aspect of the heritage value of the house. Unfortunately, due to the requirements noted by the Approving Officer, the setback for the side yard on the west side of the house must be a minimum of 1.5 metres. This has resulted in the percentage of unprotected openings on that elevation being over the allowable as per the BC Building Code, thus necessitating the removal of one or possibly both of the historic windows on the main floor level. Although unfortunate, it is a reasonable solution to a difficult situation.

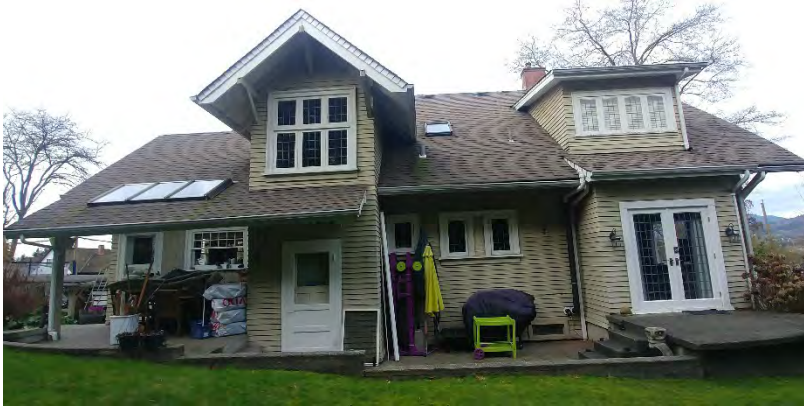
The rear elevation appears to have some newer windows as well as what might be original windows, and consist of the following:

- a single, horizontal window with a multi-paned upper sash on the main level of the west side
- a set of three, single, multi-paned casement windows in the middle of the main level of the elevation
- a large, triple, multi-pane window in the gable dormer
- a quad, multi-pane window in the shed dormer

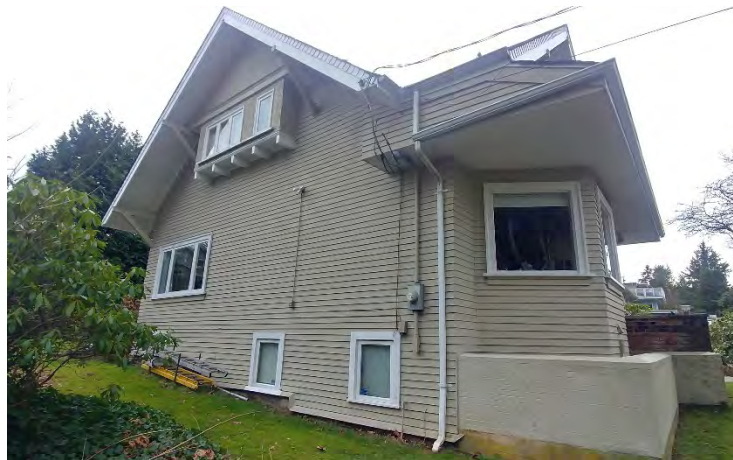
The east elevation has the following window types:

- three, small, square, single windows along ground level
- a medium-sized, triple sash window to the south side of the main level
- a medium-sized, triple sash window and a single window on the bump-out on the upper level

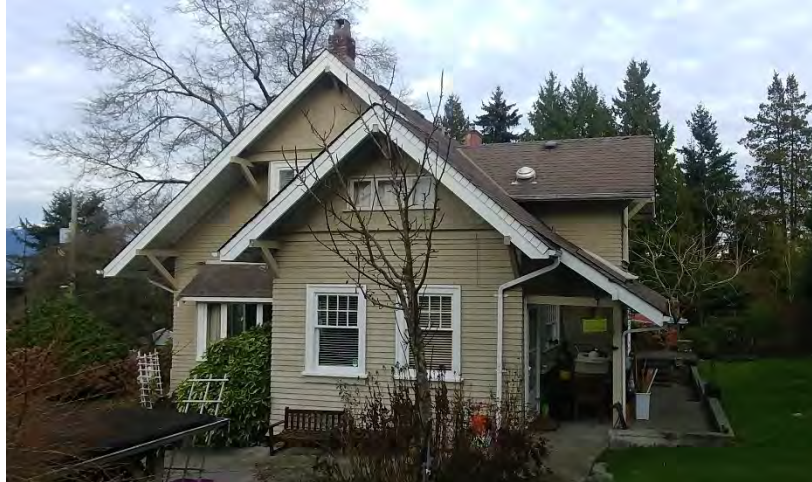
The west elevation has the following window types:

- a medium-sized, triple sash window in the shed bay at the front (north) side of the main level
- two single, side-by-side, windows with multi-pane upper sashes on the main level of the large bump-out
- a medium-sized, double window beside a single window within the same casing on the bump-out on the upper level
- a small, triple window in the gable of the large bump-out

In this event, the empty space(s) will be made good by installing siding that matches the siding next to it in terms of design, size, profile and material.

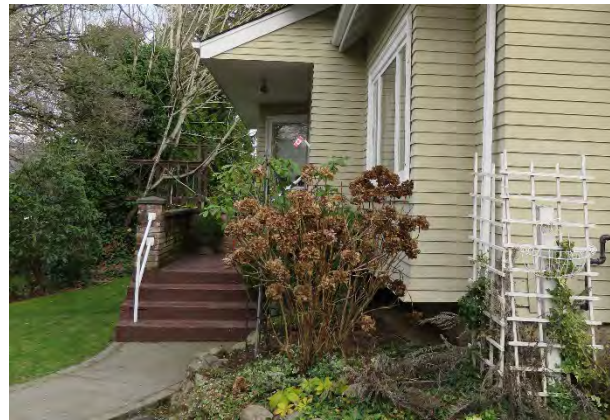
In the photographs below, it is clear that the front porch is now completely different. The original roof has been removed and the porch posts and picket railing system are gone. The stairs are oriented differently, and it is possible that the height of the two deck levels of the porch might be slightly different as well. In the historic photographs, it appears that there are six or seven risers to the porch's lower deck and at least one more to the upper decking. At present, there are four risers to reach the lower decking and a further three risers to reach the upper decking and the front door. With different landscaping and walkway materials being added over time, this is not much of a surprise.

*Photo taken January 2021 by the author.*

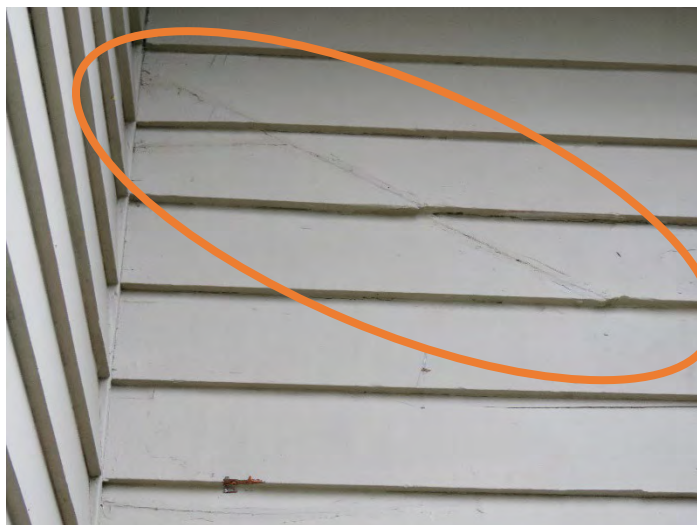
The photograph below is a close-up of the area shown in the photograph above on the right, specifically of the area at which the orange arrow is pointing. It shows the marks of something that has been removed. As this wall would have been new when the bump-out was widened, it is unclear what was here between then and now, perhaps a different roof system?
