PROJECT: **HILL COTTAGE**

SERVICE: **AS-FOUND HERITAGE REPORT**

6570 DEER LAKE AVENUE, BURNABY, BC ADDRESS:

DATE: January 2025

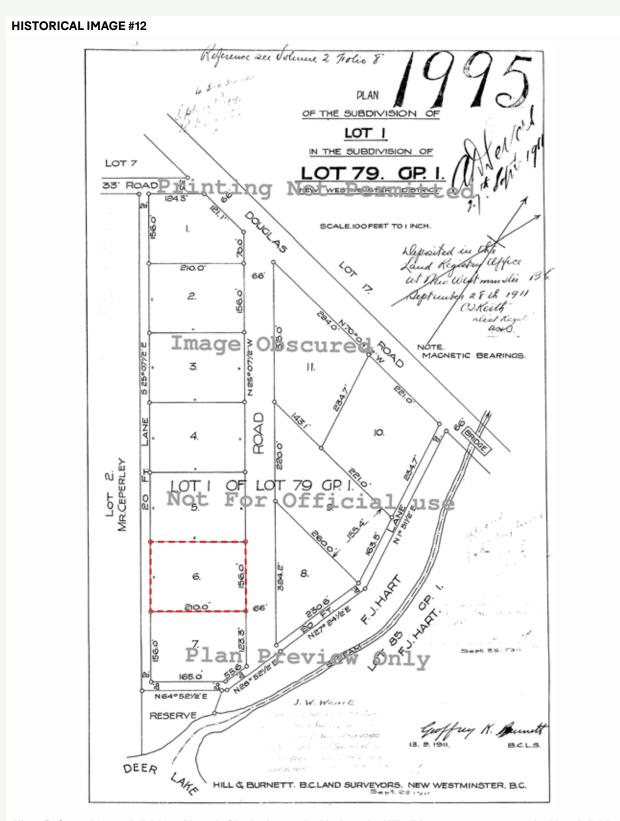
Albert D. Severs' 1911 subdivision of Lot 1 in District Lot 79. At this time, the Hills did not own any property in this subdivision, though their former *Brookfield* home was still extant and located on Lot 8 of this subdivision. The Hill Cottage would be built on Lot 6 (noted), and the Peers family had their home on Lot 7. *Land Title and Survey Authority of British Columbia Plan NWP1995*

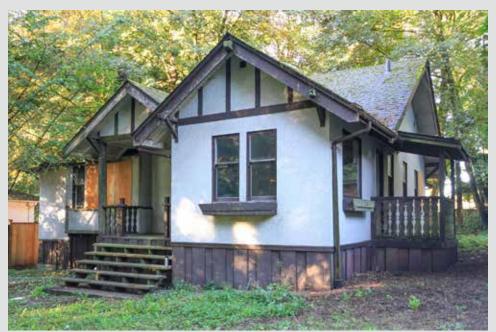
SITE PHOTO #1

View of the front (centre) and north (right) elevations of the Hill Cottage.

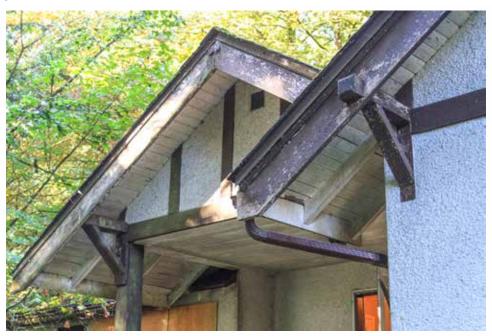
SITE PHOTO #2

Detail of the gables on the front elevation of the Hill Cottage, showing their original wood brackets, fascia, raftertails, soffit, and stickwork

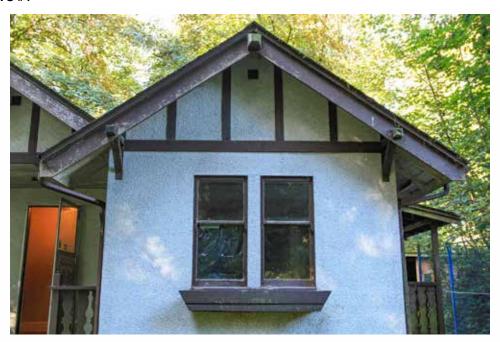
SITE PHOTO #4

$\label{thm:continuous} \mbox{Detail of the cross gable extension on the front elevation of the Hill Cottage}.$

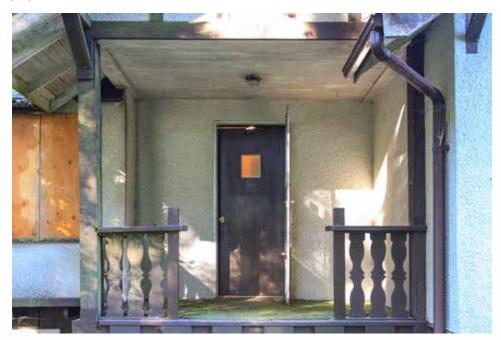
SITE PHOTO #6

Detail of the porch on the front elevation of the Hill Cottage.

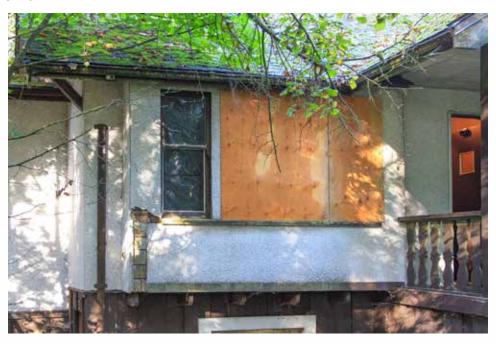
SITE PHOTO #10

Detail of the square oriel window on the front elevation of the Hill Cottage.

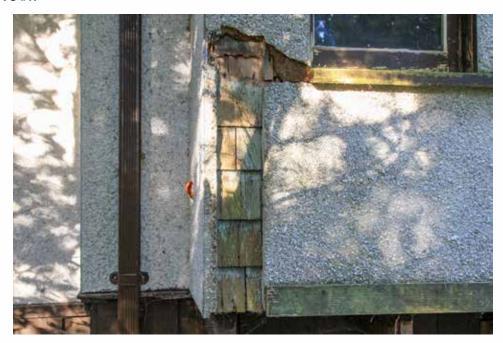
SITE PHOTO #11

Detail of exposed original wood shingle cladding on the square oriel window on the front elevation of the Hill Cottage.

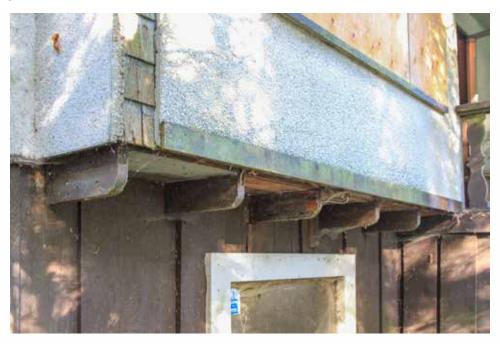
SITE PHOTO #12

Detail of round corner wood joists below the square oriel window on the front elevation of the Hill Cottage.

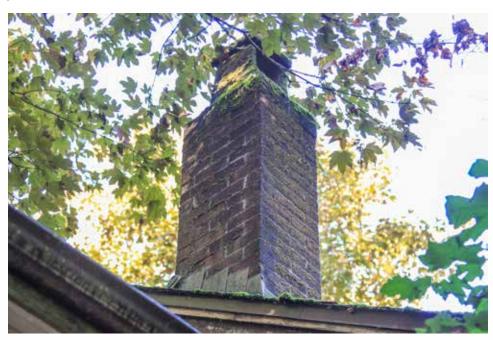
SITE PHOTO #14

Detail of an original external brick chimney stack, which was visible along the entire height of the south elevation of the Hill Cottage prior to the construction of the 1931 south addition.

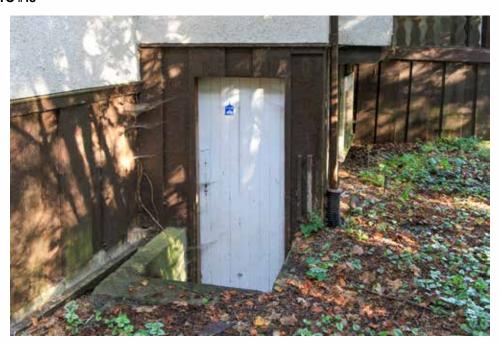
SITE PHOTO #15

Detail of an exterior doorway providing access to the basement of the Hill Cottage on its original south elevation.

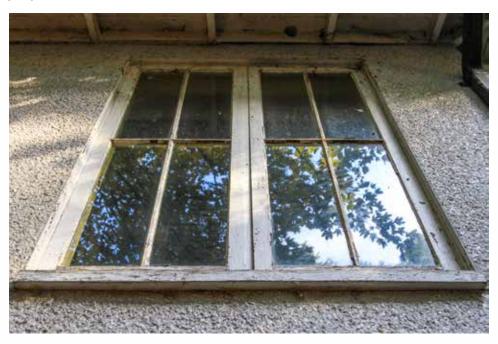
SITE PHOTO #16

Detail of a double assembly window with 4-light wood sashes on the south elevation of the 1931 addition constructed on the south side of the Hill Cottage.

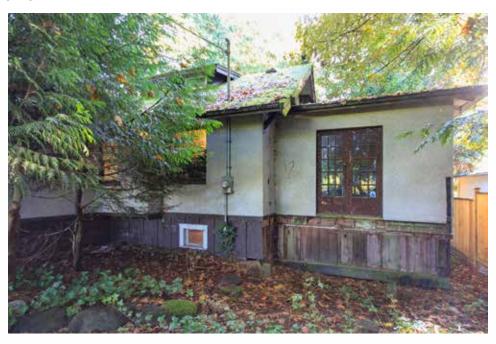
SITE PHOTO #18

Detail of the rear elevation of the south-half of the Hill Cottage, with the south 1931 additions on the right.

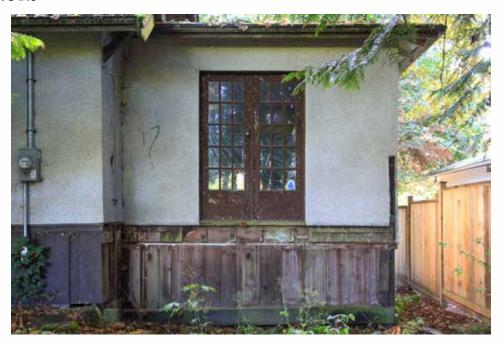
SITE PHOTO #19

Rear elevation of the south 1931 addition to the Hill Cottage.

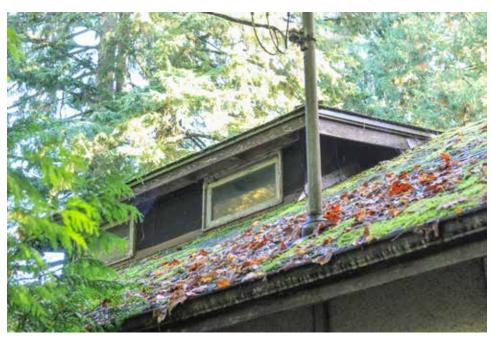
SITE PHOTO #20

Detail of a low-profile shed-roof dormer on the rear elevation of the Hill Cottage.

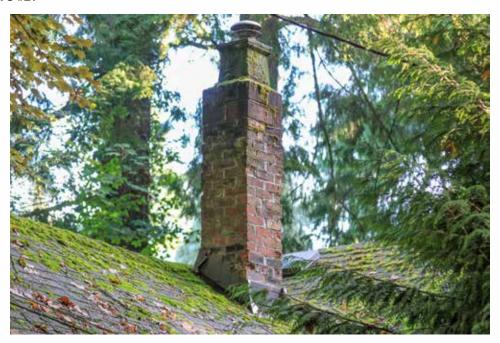
SITE PHOTO #21

Detail of a brick chimney stack along the roof ridge of the 1931 rear addition to the Hill Cottage. It is unknown whether this chimney stack is original to the Hill Cottage.

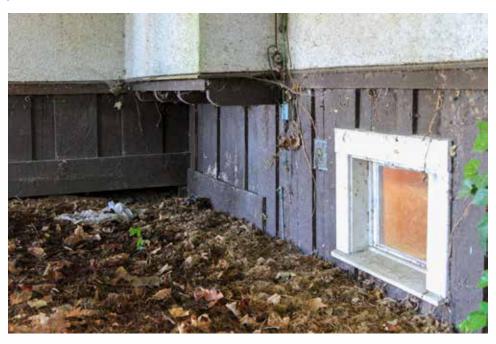
SITE PHOTO #22

Detail of the wood belly band along the 1925-constructed Hill Cottage (centre/right), and its rear 1931 addition (left). The rounded corner joists supported the rear oriel window are also visible.

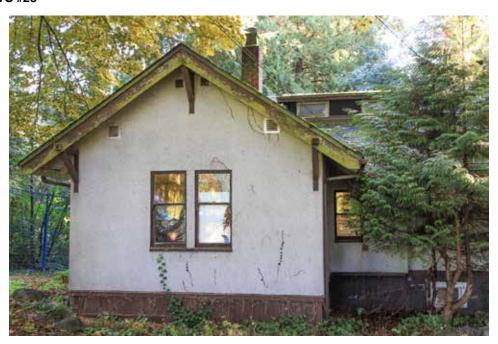
SITE PHOTO #23

Detail of the gable extension of the 1931 rear addition to the Hill Cottage.

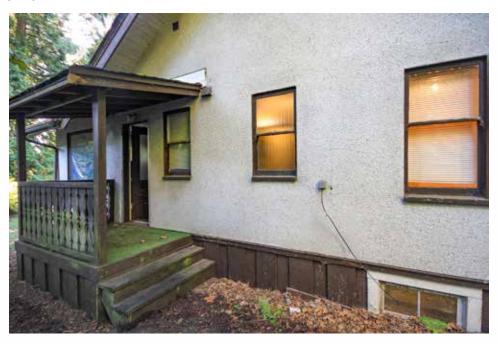
SITE PHOTO #26

Detail of the original north elevation of the Hill Cottage. It is unknown if the secondary entrance at this location is original or a later alteration.

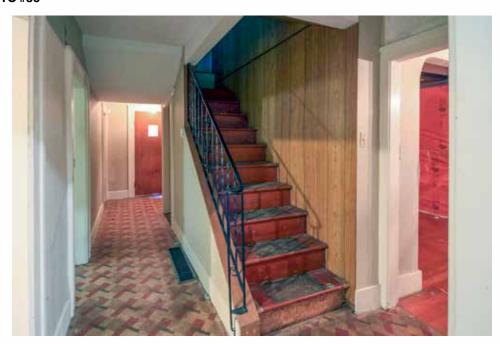
SITE PHOTO #35

Detail of the staircase to the upper storey in the Hill Cottage, looking to the southeast.

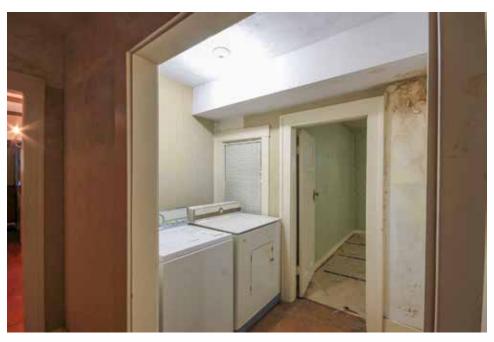
SITE PHOTO #36

View toward the original rear oriel window of the Hill Cottage, which was altered to accommodate the rear 1931 addition, of which the room through the doorway in the centre-right of the image enters into. Looking to the southwest.

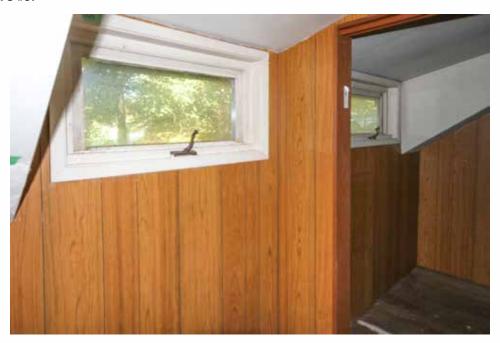
SITE PHOTO #57

Detail of the two single-light, wood sash windows of the shed-roof dormer from the interior of the Hill Cottage.

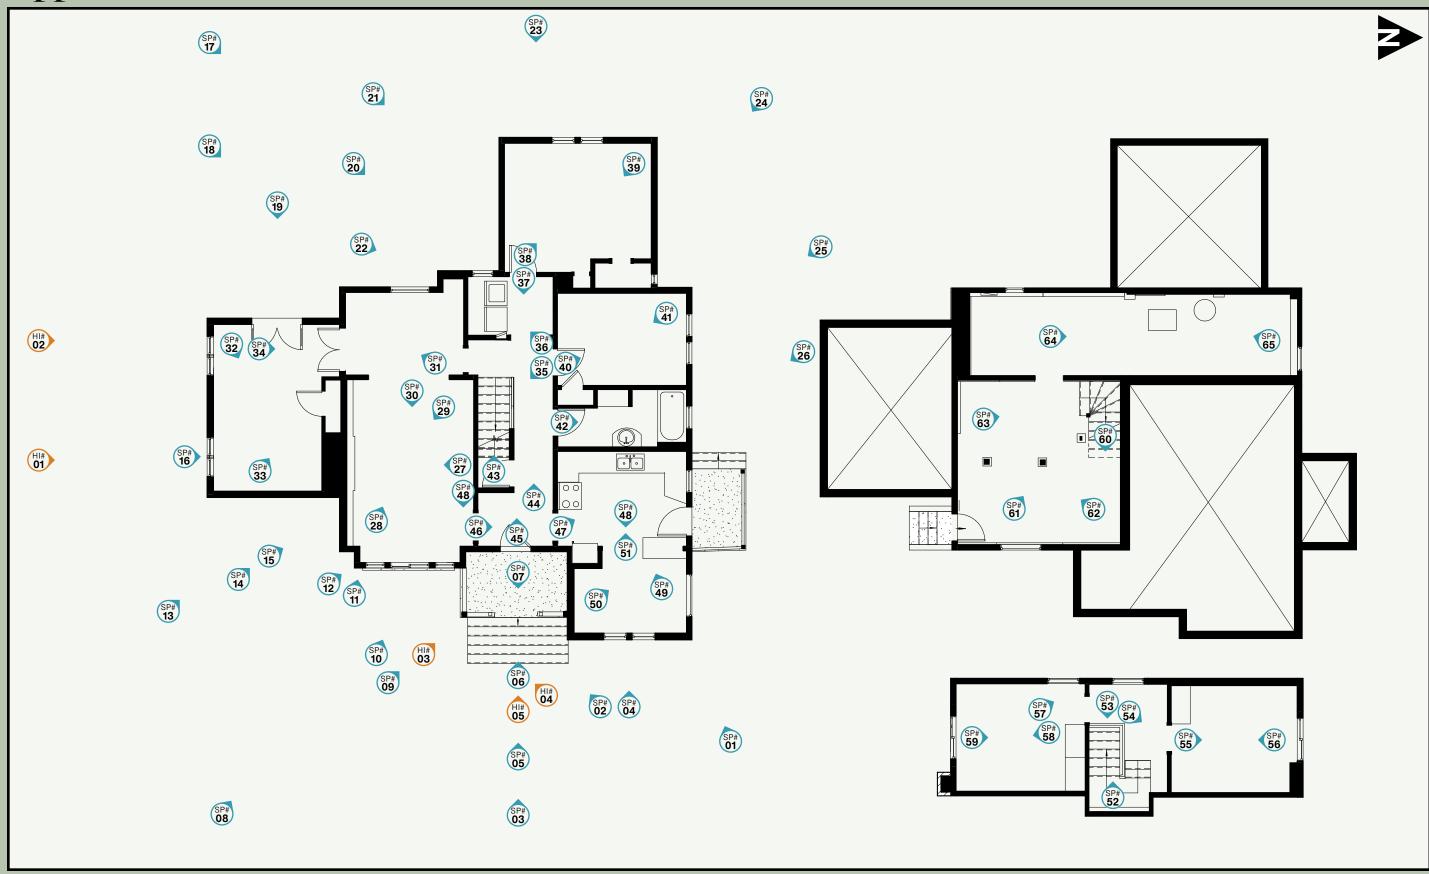
Appendix A: As-Built Floor Plans with Photo Reference

As-built floor plans of the Hill Cottage: Ground floor (right); upper storey (top-right); and basement (bottom-right). UNIQ Dimensions
