The W.J. Mathers house in 1912. The original cedar shingle roof and two of three original chimneys are visible in the photograph. PHOTO: HV985.57.1 (BURNABY VILLAGE MUSEUM).

The W.J. Mathers house with its new cedar roof. The chimneys have been temporarily dismantled above the roofline due to concerns about their stability.

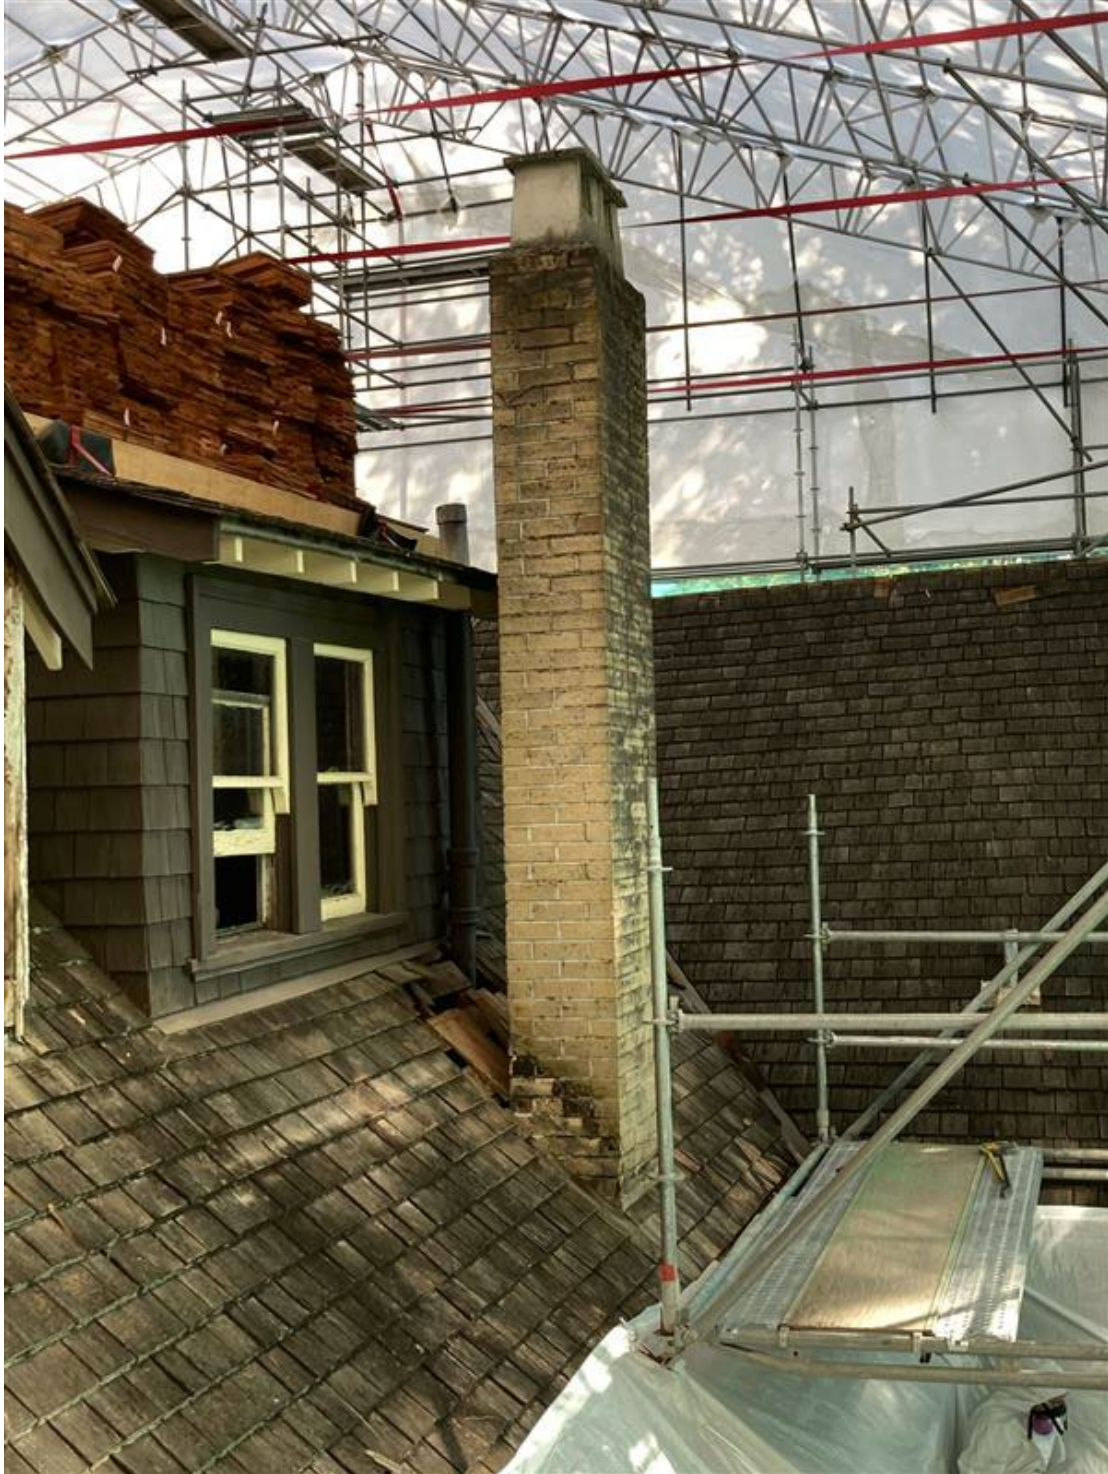
A photograph from early 2024 shows the condition of the roof prior to replacement of the shingles. Replacing the flashing between the chimney and the roof was part of the scope of the project.

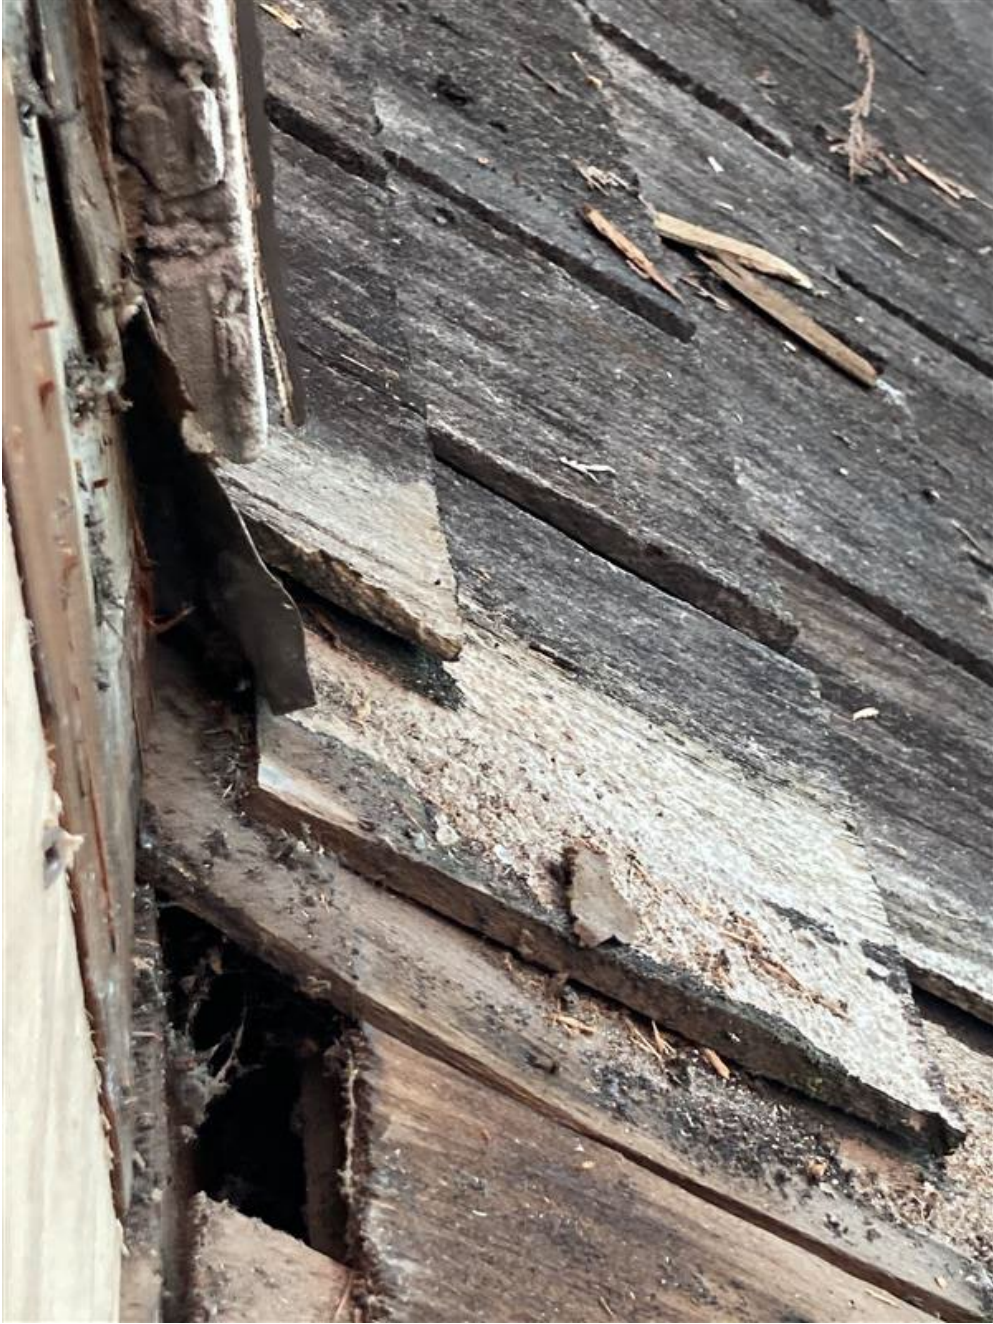
Detail of the shingles, prior to replacement.

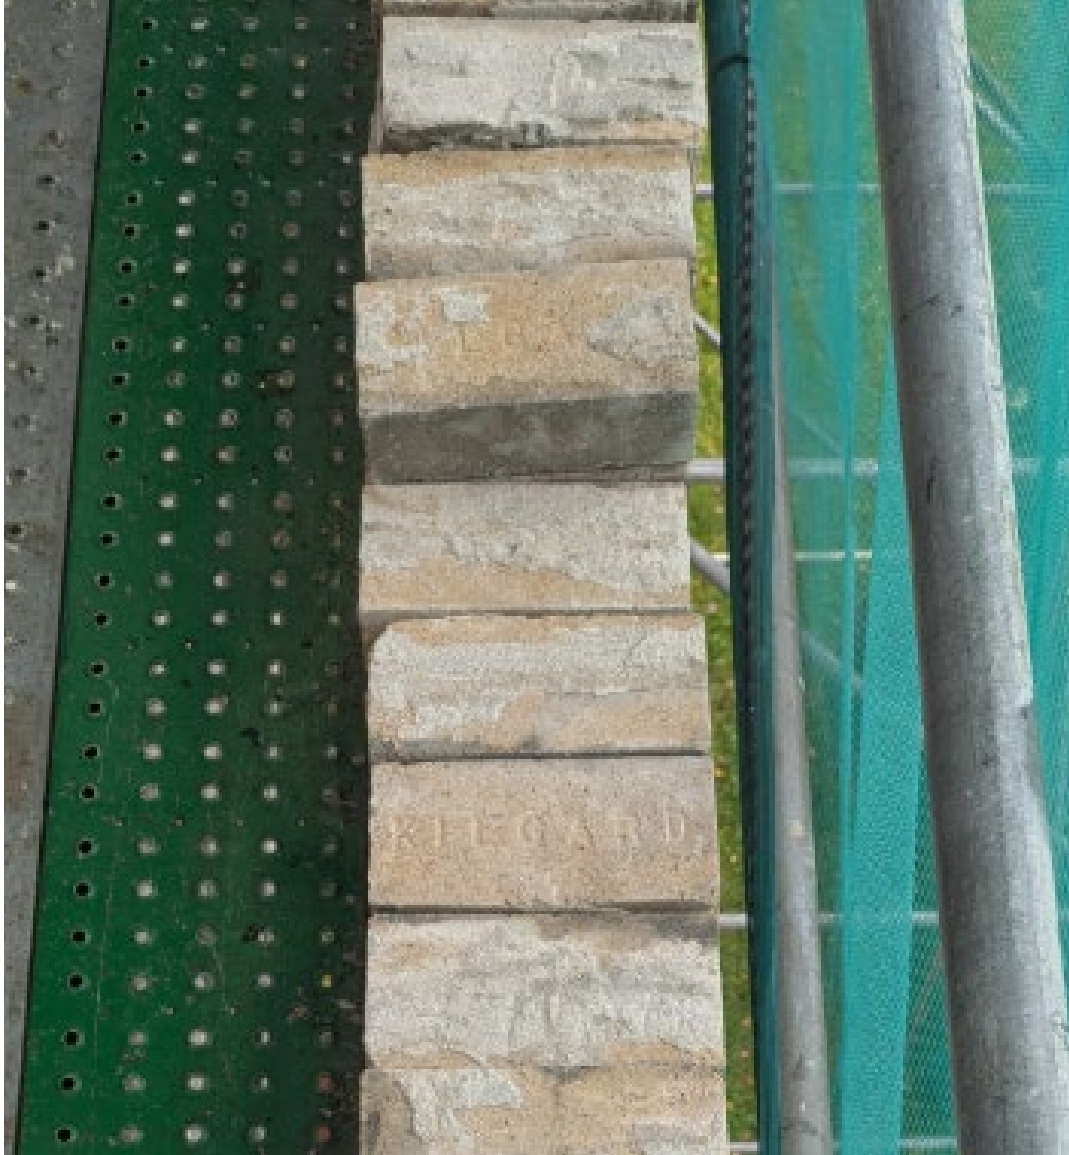
Bricks from one of the dismantled chimneys, stamped "Kilgard." It was previously believed that the chimneys were constructed with brick manufactured at the Clayburn Company brickyards in Abbotsford. Clayburn produced approximately 90% of all brick in British Columbia at that time. This discovery increases the historical value of the three chimneys, which were all constructed with Kilgard bricks.
