COMMISSION REPORT

**SUBJECT: REMEDIATION AND RESTORATION OF CAPITOL HILL
CONSERVATION AREA – UNAUTHORIZED BMX TRAIL
CONSTRUCTION**

PURPOSE: To provide a remediation and restoration plan for Capitol Hill
Conservation Area due to unauthorized BMX trail construction.

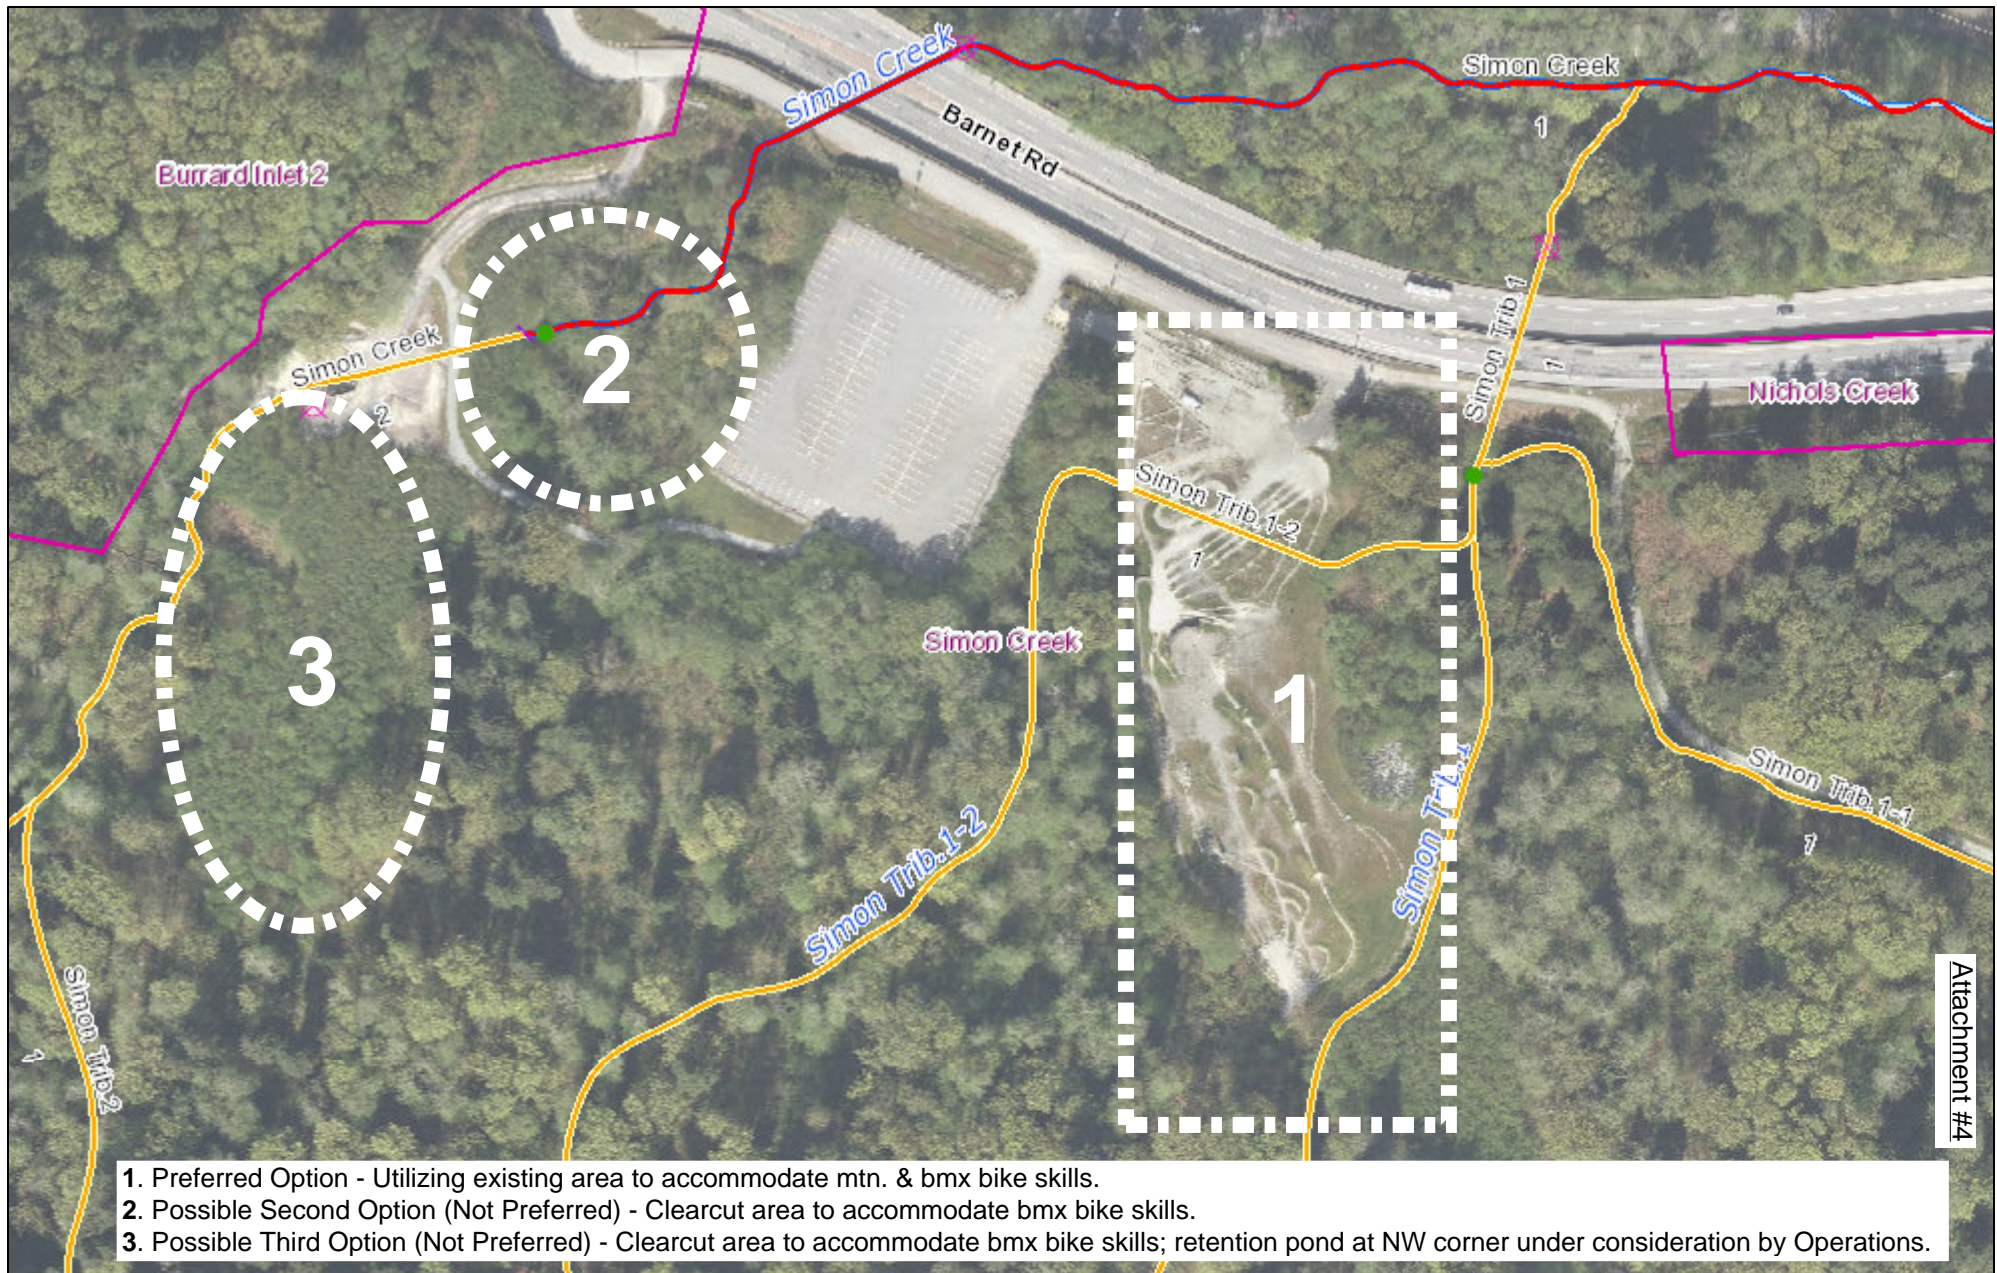
The unauthorized development of the bike track in question has damaged an area approximately 7500 Sq Meters in size starting from the road access point at Adrian St and Glasgow Ave and extending eastward roughly 375 meters.

Due to the activities of the individuals who constructed the bike track the above mentioned cycle has been disrupted, they have removed all leaf litter, disrupted all of the natural water flow, and damaged vast numbers of trees root systems via excavation. The net effect of these activities will be tree hazards, tree and plant mortality, sediment runoff, and the introduction and quick establishment of invasive species. It would be reasonable to say that if no further activities were to take place and no remediation of the land was undertaken this location will lose most of the trees that have been damaged within ten years.

Forestry's perspective regarding this site is that with support we could not only remediate the damage that has occurred but leave the location in better condition than what it was originally, thus giving this section of the Capitol Hill Conservation Area a stronger environmental benefit to the City of Burnaby and its residences. The following information is a cost estimate derived from the information known at this time to complete the forest restoration for the land that has been damaged.
