**SUBJECT:** CROSSWALK – OAKLAND ST AT DUFFERIN AVE

**PURPOSE:** To review pedestrian safety concerns at the intersection of Oakland and Dufferin.

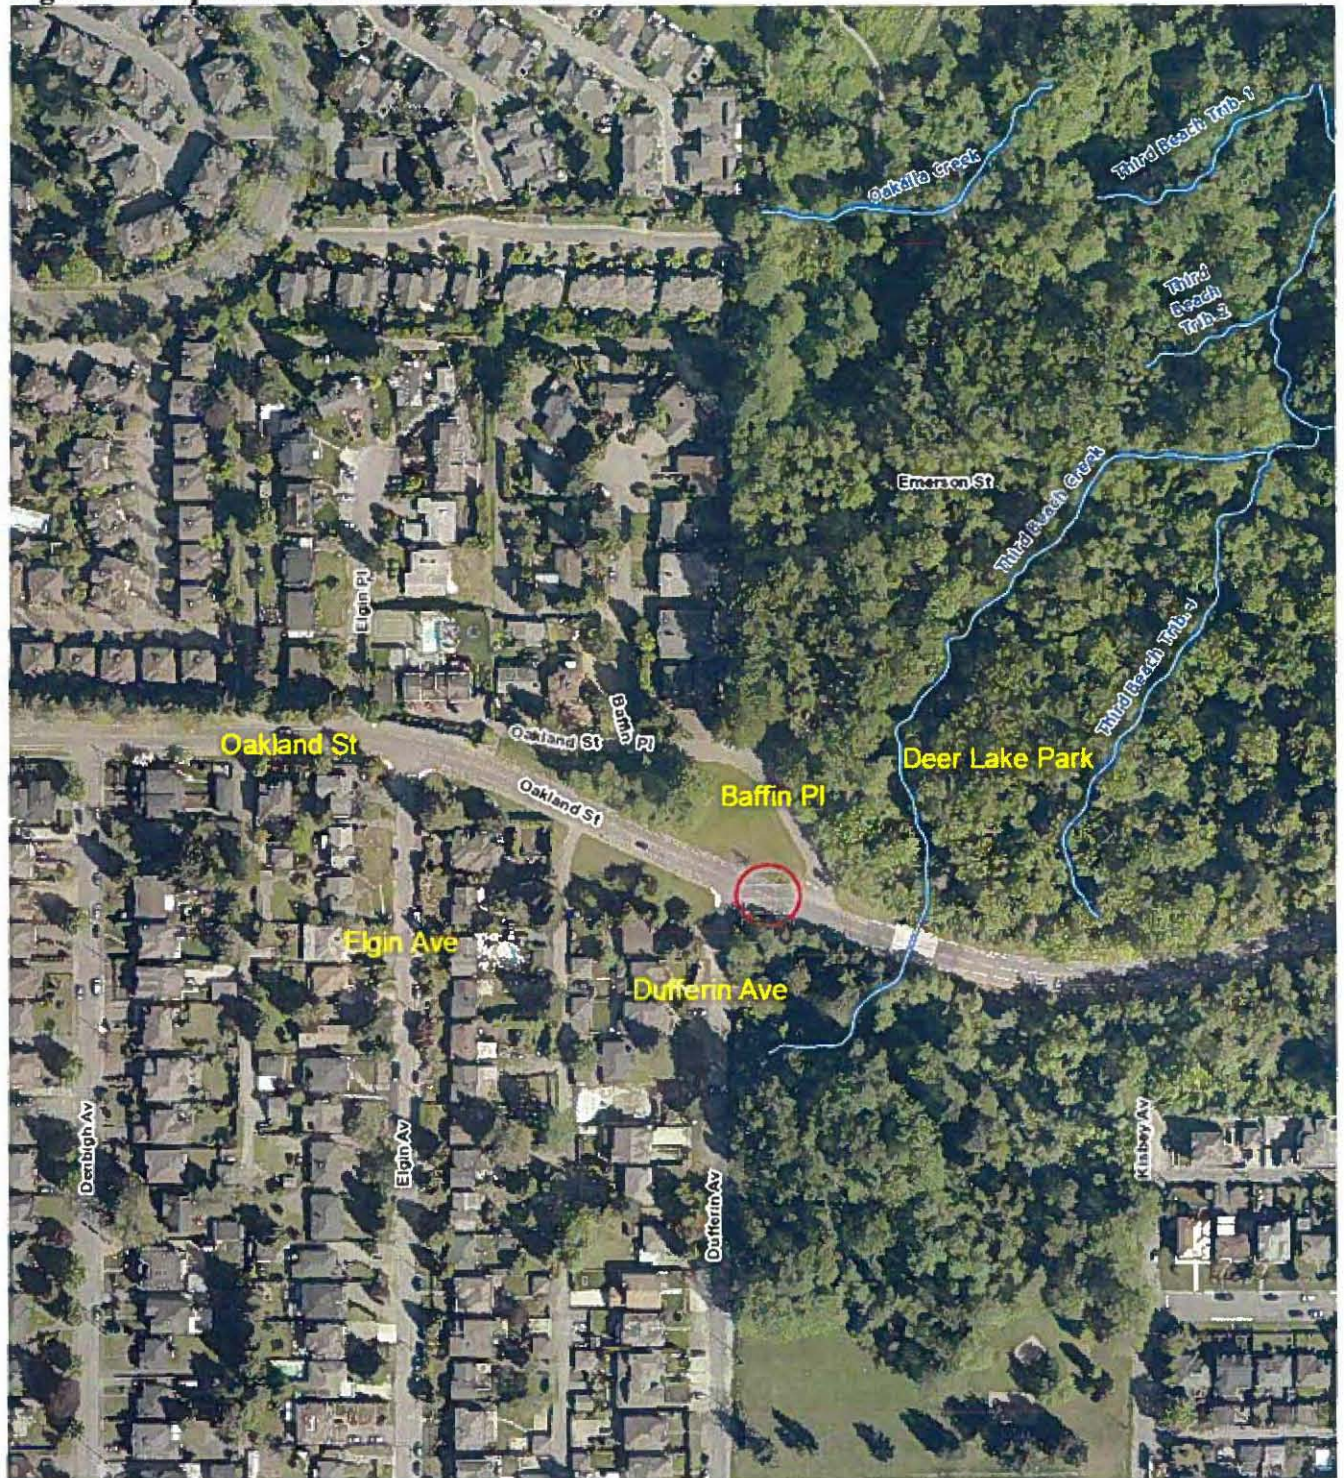
### Figure 1: Requested Crosswalk Location

Figure 1 shows the location of the requested crosswalk at the unsignalized intersection of Oakland Street/Dufferin Avenue/Baffin Place. The nearest crosswalks along Oakland St are 620 m to the west at Royal Oak Ave and 570 m to the east at Gilley Ave.
