SUBJECT: HERITAGE REVITALIZATION AGREEMENT/HERITAGE
DESIGNATION BYLAW, ALICE AND ROBERT TRAVERS RESIDENCE,
7828 STANLEY STREET

**Heritage Conservation Plan
Arthur Long Residence
7828 Stanley Street
Burnaby, BC**

**May 2021
Updated January 2023**

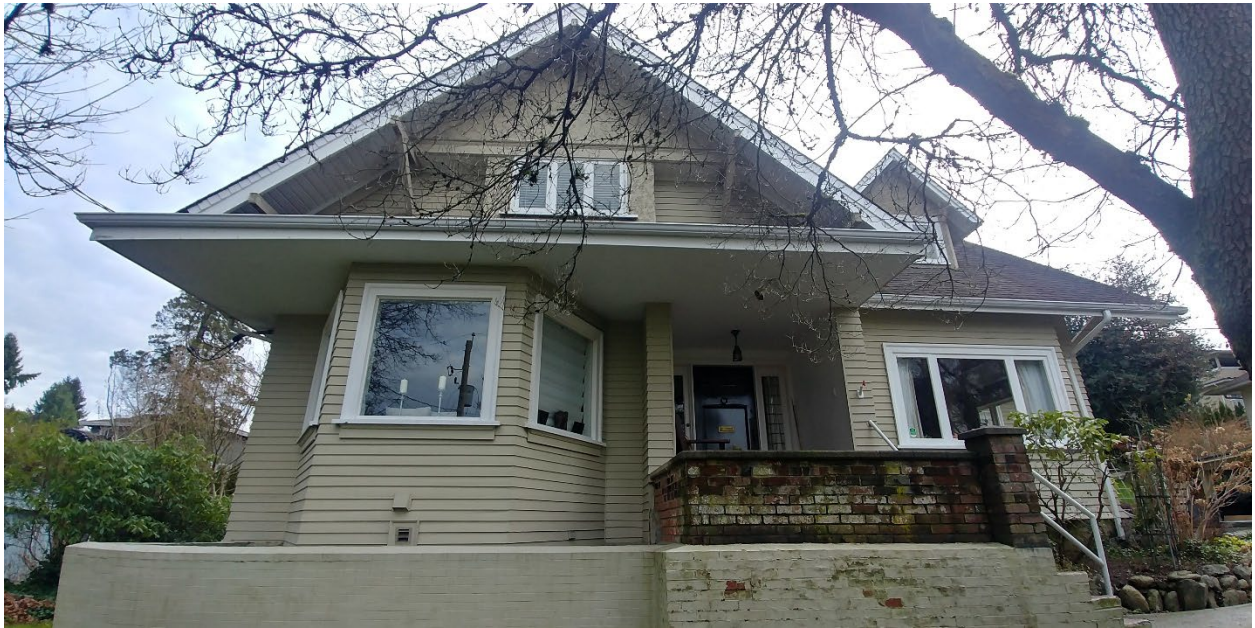
North (front) elevation

The Arthur Long Residence is located at 7828 Stanley Street in Burnaby, British Columbia. It is a two-storey, wood-frame building with a cross-gable roof and dormers on the front and back elevations. The house is multi-planed on each façade and is primarily clad in horizontal wood clapboard siding, with rough stucco in the gable ends. The windows, many of which are triple-sash, are wood frame.

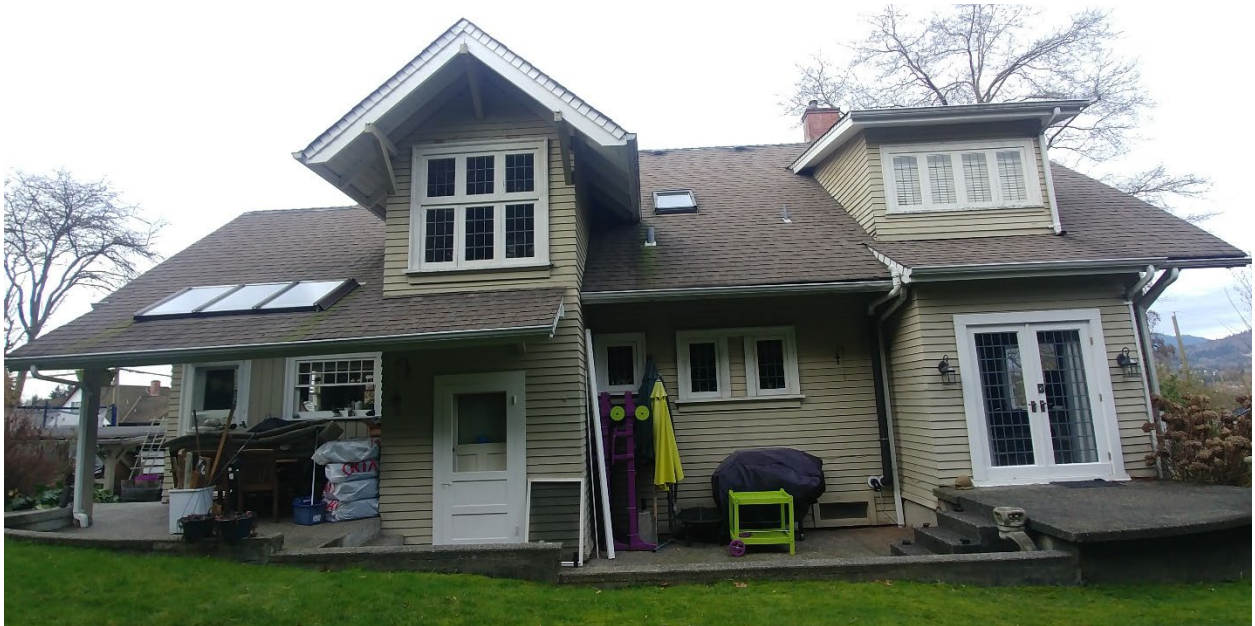
South (rear) elevation

The rear elevation appears to have some newer windows as well as what might be original windows, and consist of the following:

- a single, horizontal window with a multi-paned upper sash on the main level of the west side
- a set of three, single, multi-paned casement windows in the middle of the main level of the elevation
- a large, triple, multi-pane window in the gable dormer
- a quad, multi-pane window in the shed dormer

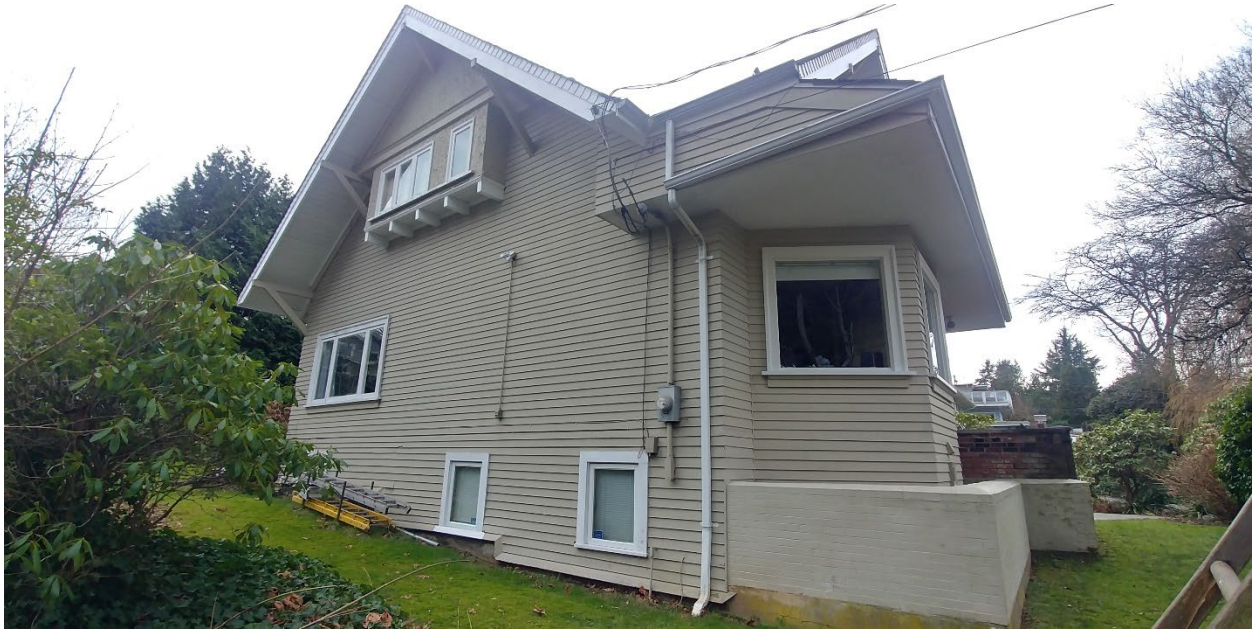
East elevation

The east elevation has the following window types:

- three, small, square, single windows along ground level
- a medium-sized, triple sash window to the south side of the main level
- a medium-sized, triple sash window and a single window on the bump-out on the upper level

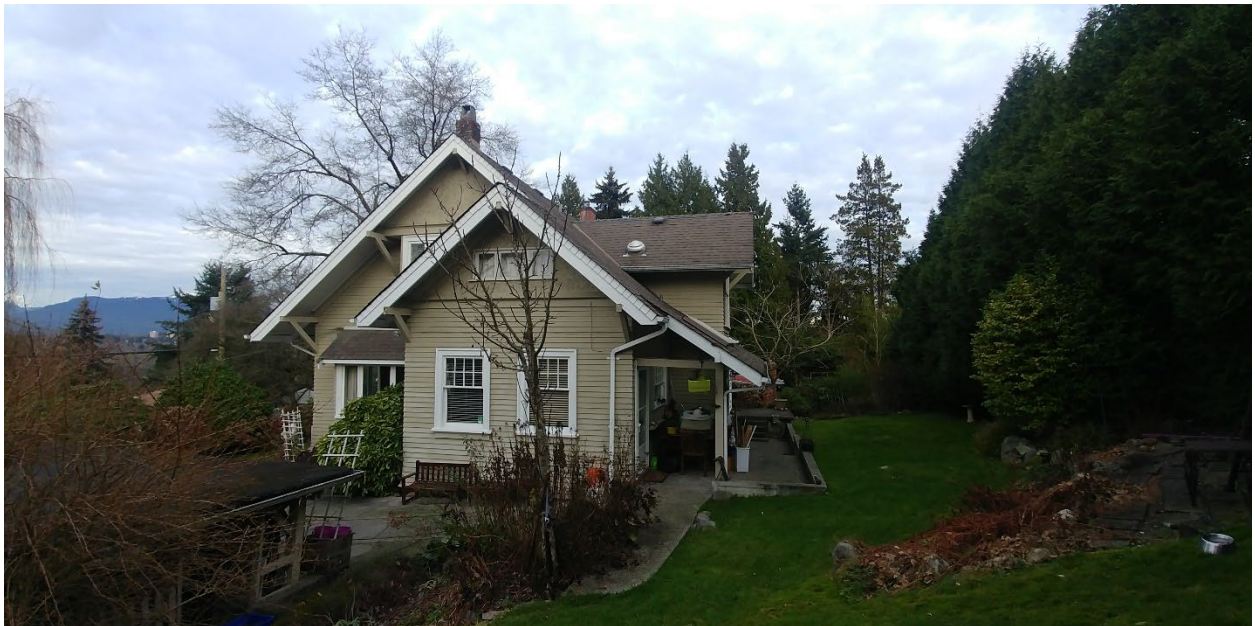
West elevation

The west elevation has the following window types:

- a medium-sized, triple sash window in the shed bay at the front (north) side of the main level
- two single, side-by-side, windows with multi-pane upper sashes on the main level of the large bump-out
- a medium-sized, double window beside a single window within the same casing on the bump-out on the upper level
- a small, triple window in the gable of the large bump-out

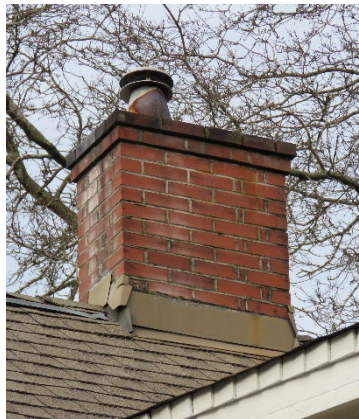
The chimney on the east side of the house is a rectangular shape, is comprised of brick in a Flemish garden wall bond style, and has a corbelled chimney cap, as well as a vent. The chimney on the west side of the house is square and comprised of brick in a running bond pattern and is topped with a square chimney pot.

Chimney on east side of the house.

Chimneys are important elements of historic buildings and should be retained; however, the fireplaces (or other uses) they serve do not actually need to be working. In some projects for example, homeowners choose to remove the fireplaces but retain the chimneys. The intention of the current homeowners is to retain both chimneys. The use that each chimney serves is not relevant to this report.

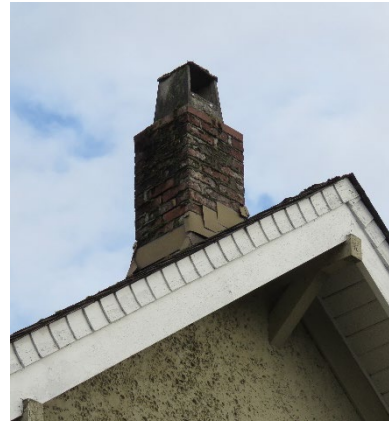
Chimney on west side of the house.

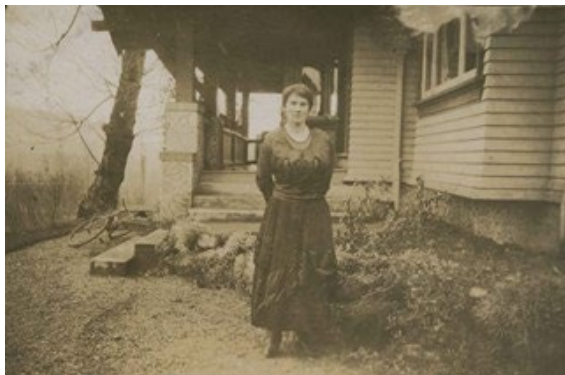
The existing front porch is not the original. At some point in the past, the original porch was removed and replaced with concrete steps and decking. The roof over the porch was also changed at some point. According to historic photographs, the original roof had deep-set eaves and was supported on square wooden posts.

Photo of Alice Travers standing in front of the original front porch, 1921.

The intention is to replicate the original front porch and add a new roof system to it, while at the same time making it obviously new, so as to meet the principles of heritage conservation.

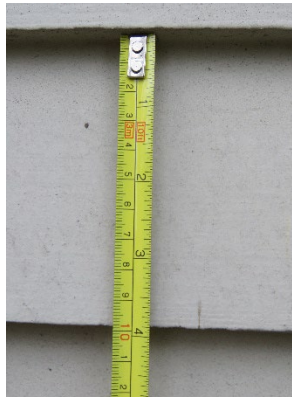
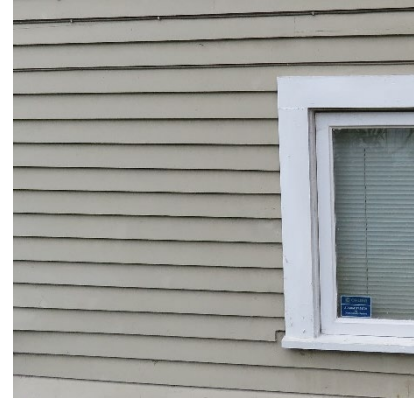
The side elevations are clad in what appears to be the original clapboard siding with a 4-inch profile and should be retained. The siding is in good condition.

If individual boards become damaged or fail in some way over time, it may be possible to repair or replace just those individual boards. Upon removal, special attention should be given to the condition of the material underneath to determine if there is any water damage or other damage to the underlying material which explains why the board(s) failed. The situation should then be corrected. Any replacement pieces should match the existing in terms of design, size, profile and material. The goal is to avoid the appearance of patching.

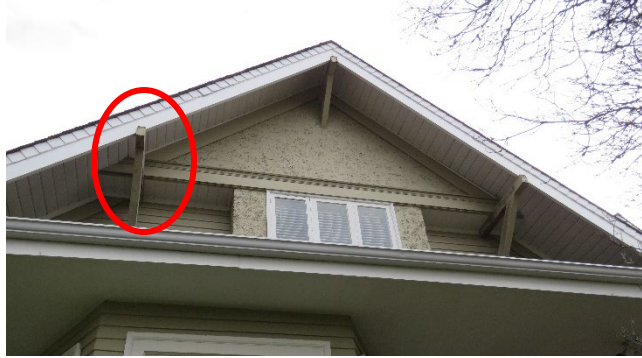
The triangular wooden brackets in the gable ends on all four elevations, that give the appearance of supporting the eaves, look to be in good condition, but a close-up inspection at some point would be a good idea to accurately determine their condition.

If individual brackets are found to be damaged, first try to repair them. If they cannot be repaired, then they should be replaced with replicas that match the existing in terms of design, size, profile and material. The goal is to avoid the appearance of patching.

As with other original material that needs replacing, look at the condition of the material underneath to determine if there is any reason (water damage, for ex.) which explains the damage. Correct the underlying situation before installing the new brackets.

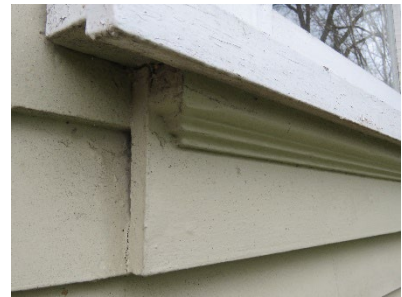
The windows appear to be in good condition. Those on the north (front) and side elevations look to be original and have wood casings and wood frames. Many of them have extra detailing below the sills (see photo at right), which should be retained.

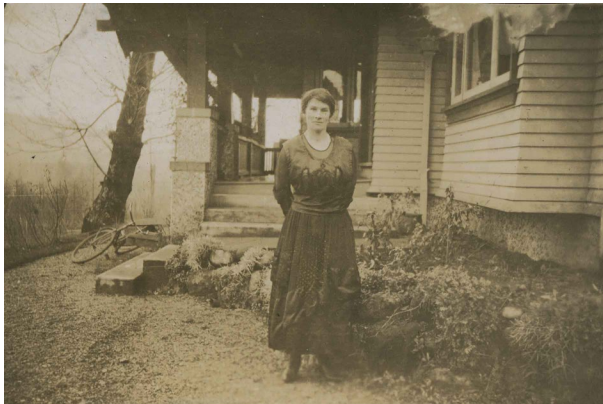
In the photographs below, it is clear that the front porch is now completely different. The original roof has been removed and the porch posts and picket railing system are gone. The stairs are oriented differently, and it is possible that the height of the two deck levels of the porch might be slightly different as well. In the historic photographs, it appears that there are six or seven risers to the porch's lower deck and at least one more to the upper decking. At present, there are four risers to reach the lower decking and a further three risers to reach the upper decking and the front door. With different landscaping and walkway materials being added over time, this is not much of a surprise.

Photo of Alice Travers standing in front of the original front porch, 1921.

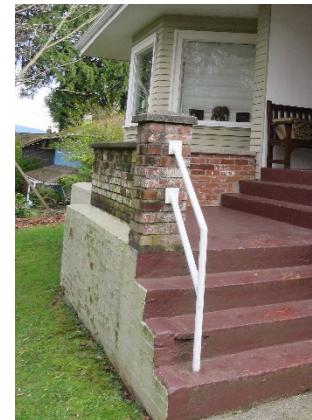
It is possible that the brick clad pedestal that is on the lower decking might have been re-used from the original porch, or even left in place, when the new porch was constructed. But this is mere speculation and was more likely new as part of the renovations. Without proof that it is an original component, there is no reason to retain and re-use it as part of this project.
